## 10.0 Lowman, Idaho, Disposal Site

The Lowman, Idaho, Uranium Mill Tailings Radiation Control Act (UMTRCA) Title I Disposal Site (site) was inspected on June 13, 2019. No changes were observed on the disposal cell or in the associated drainage features. Inspectors identified a minor maintenance need but found no cause for a follow-up inspection. Groundwater monitoring is not required and was discontinued in 2004.

Figure 10-1. 2019 Annual Inspection Drawing for the Lowman, Idaho, Disposal Site

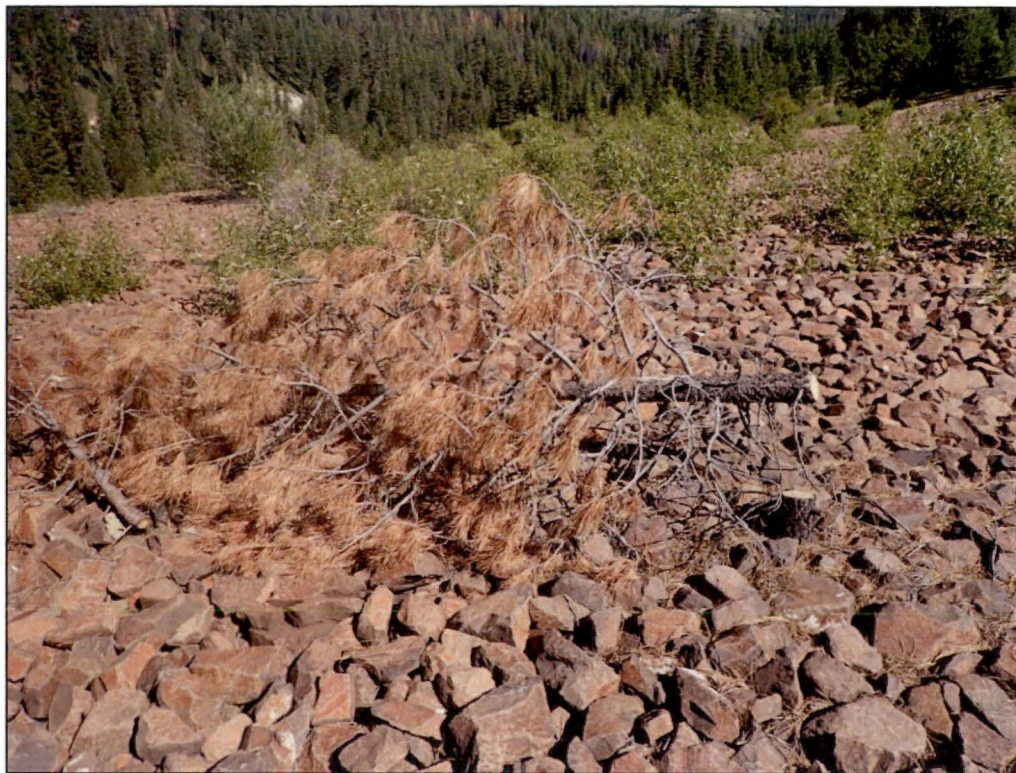
*PL-5. Treated and Fallen Ponderosa Pine*

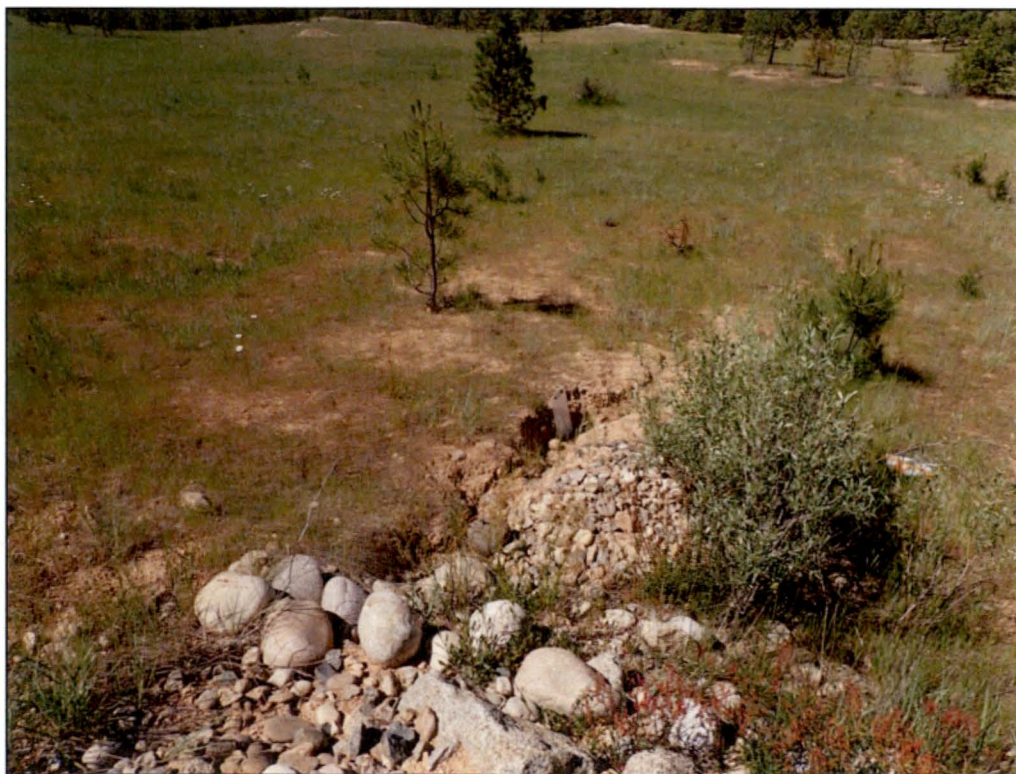
*PL-6. Bench 1 Erosion*

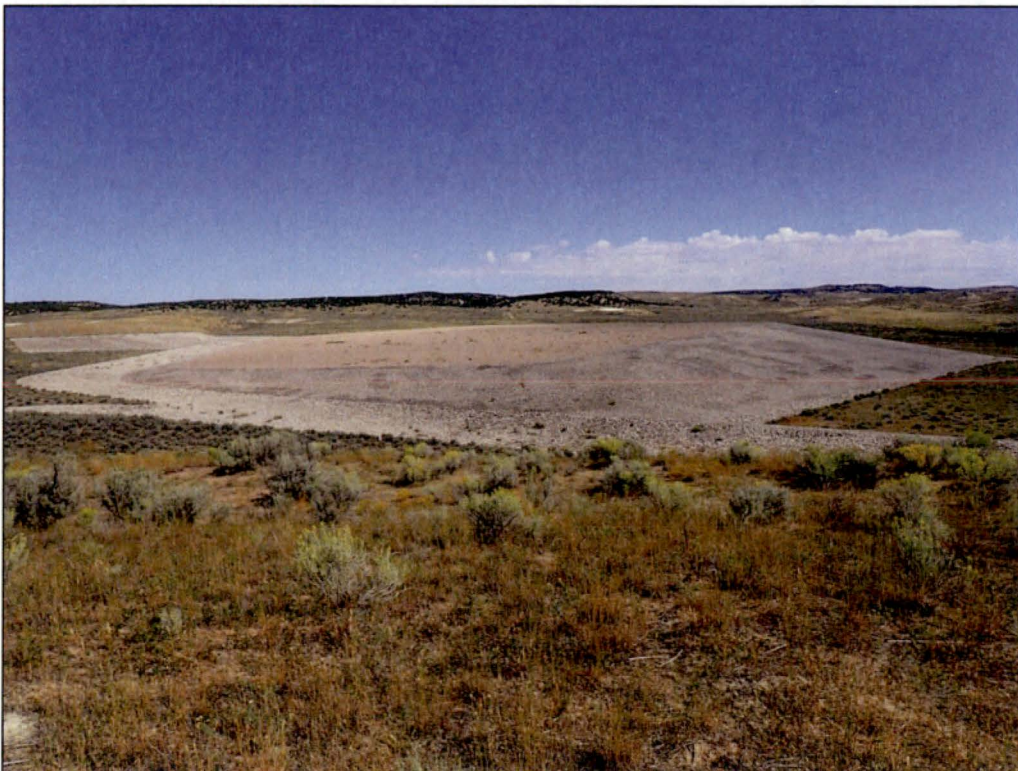
The disposal cell, completed in 1998, occupies 66 acres. The disposal cell is armored with riprap to control erosion and deter animal and human intrusion (PL-6 and PL-7). There was no evidence of erosion, settling, slumping, rock degradation, or other modifying processes that might affect the integrity of the disposal cell. Scattered shallow-rooted plants continue to establish on the disposal cell top and side slopes (PL-8); these plants do not affect the integrity of the cell. Deep-rooted plants and noxious weeds are controlled as required by the LTSP.

*PL-6. Disposal Cell with Diversion Channel No. 1 in Foreground*

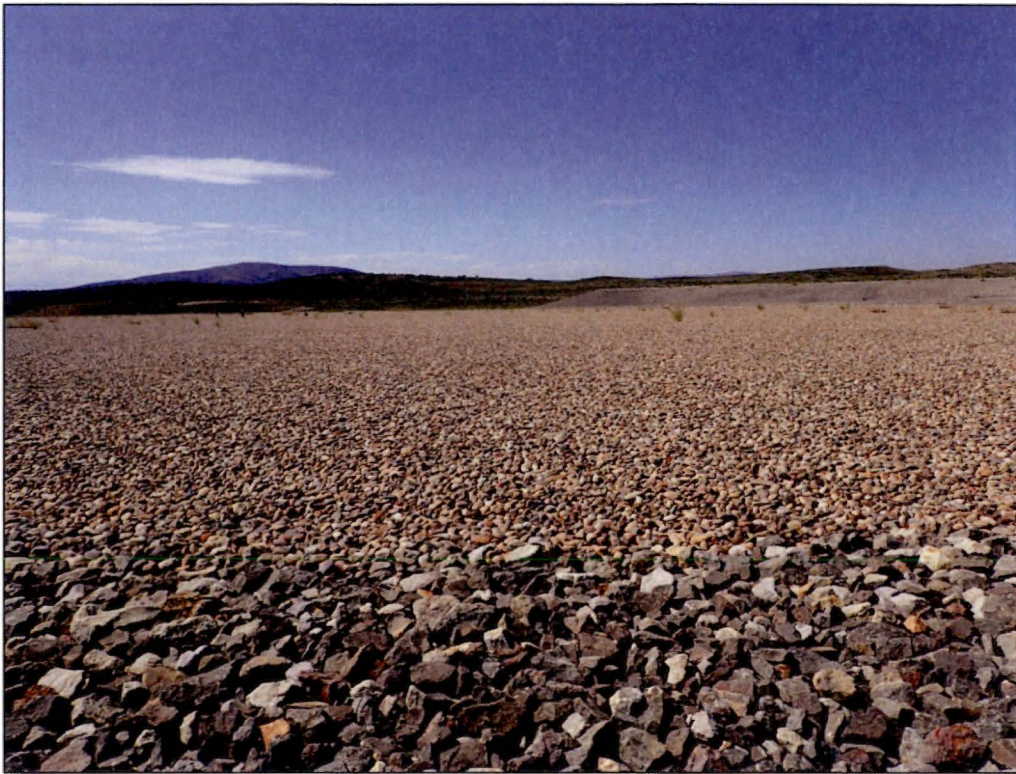
*PL-7. Top Slope of Disposal Cell*

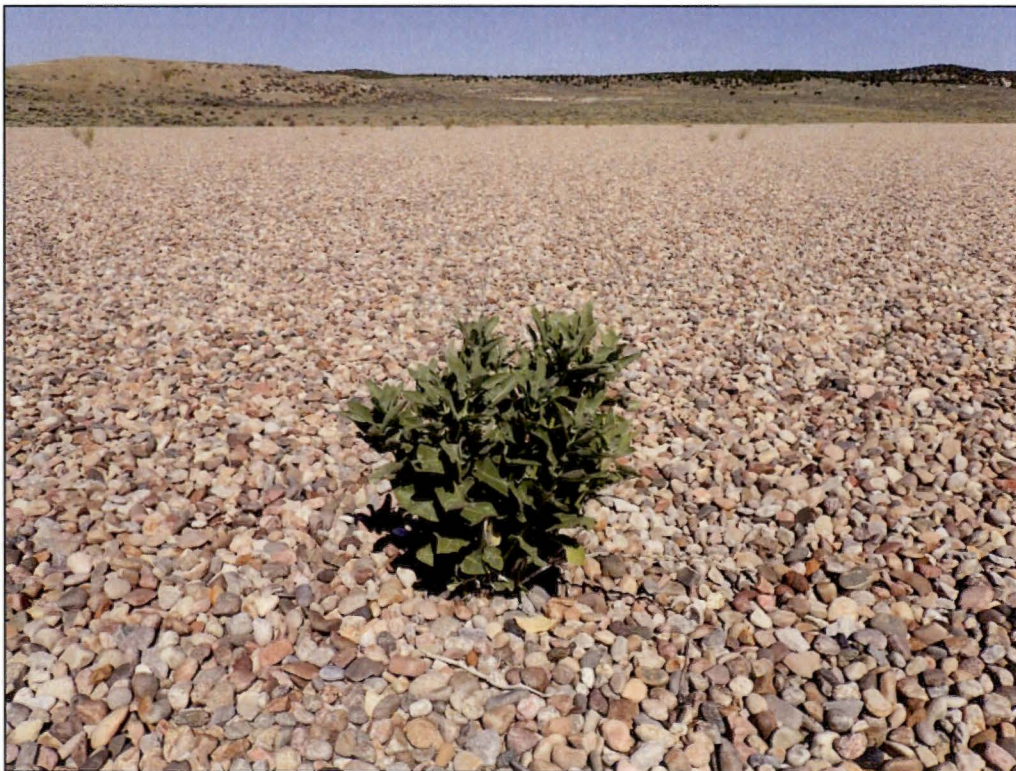
*PL-8. Milkweed Plant on Top Slope of Disposal Cell*

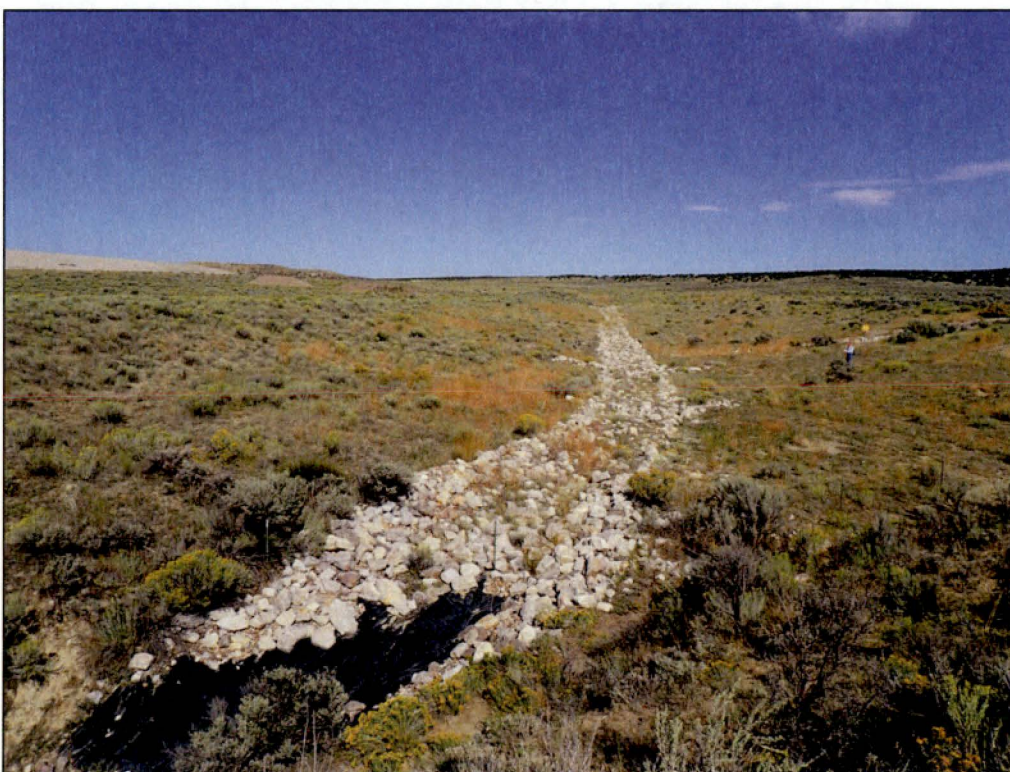
The surface conditions at the site are a combination of rock-armored drainage and diversion channels, along with contouring of soil surfaces to achieve the necessary surface water drainage control to protect the disposal cell from erosion. The rock-armored diversion channels, swales, and gullies are performing as designed (PL-10 and PL-11). Erosion directly downgradient of the

*PL-10. Exposed Geotextile at Outlet to Swale No. 1*

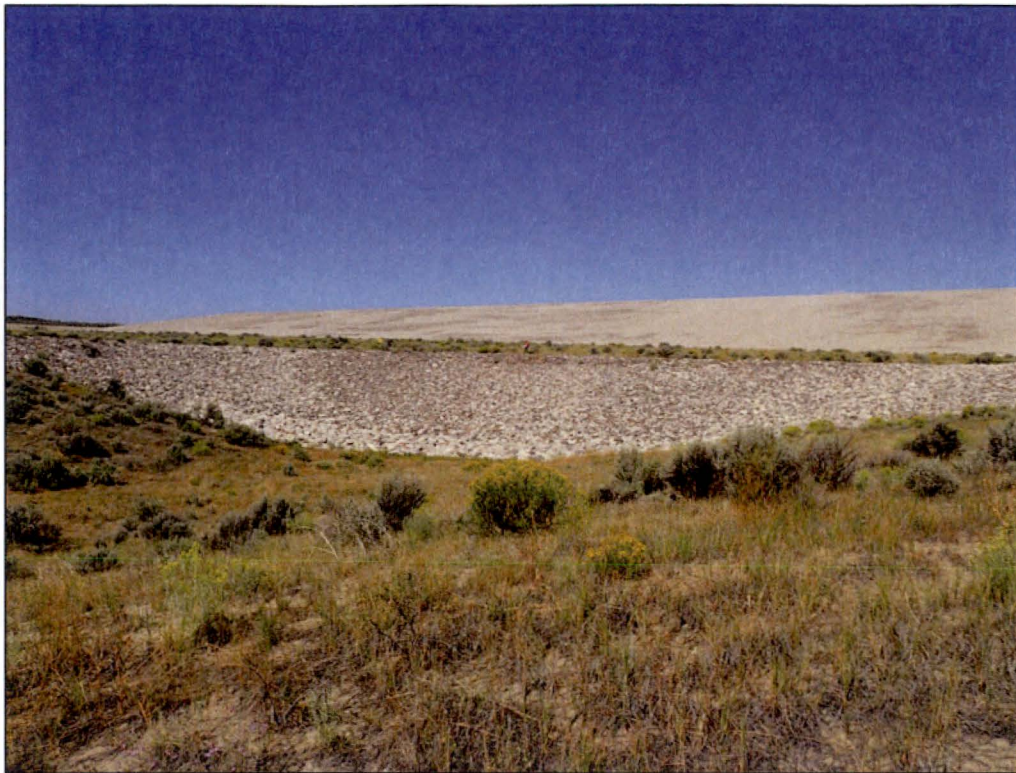
*PL-11. Outlet to Gully No. 2*

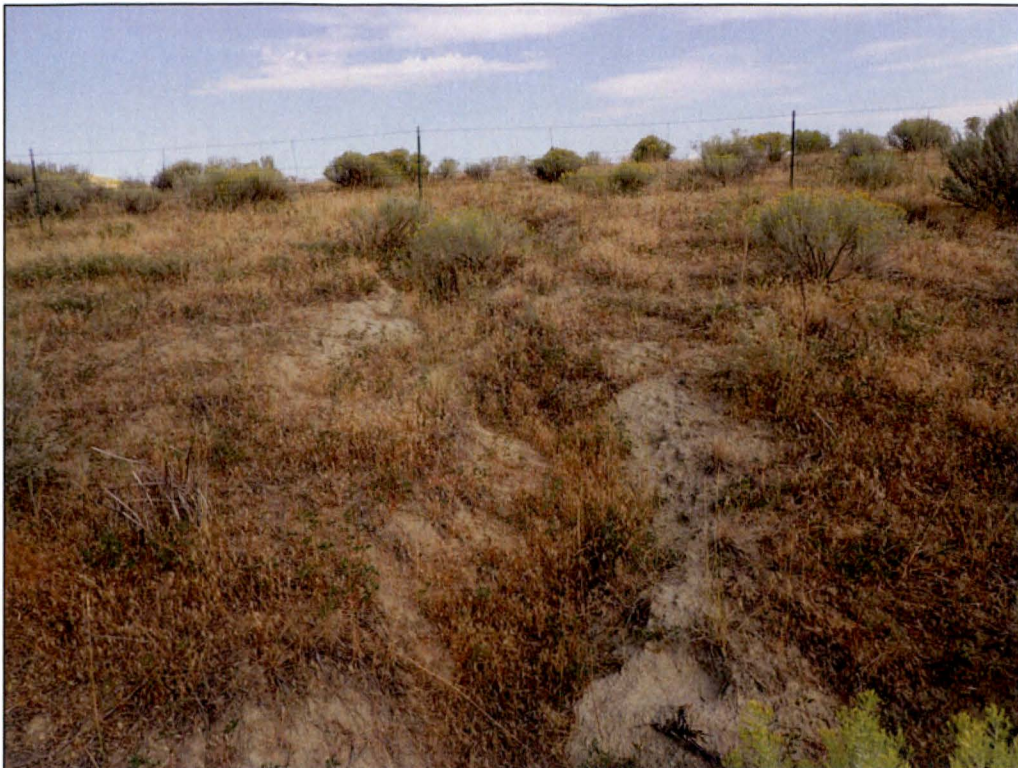
*PL-13. Minor Erosion Along Northern Perimeter Fence*

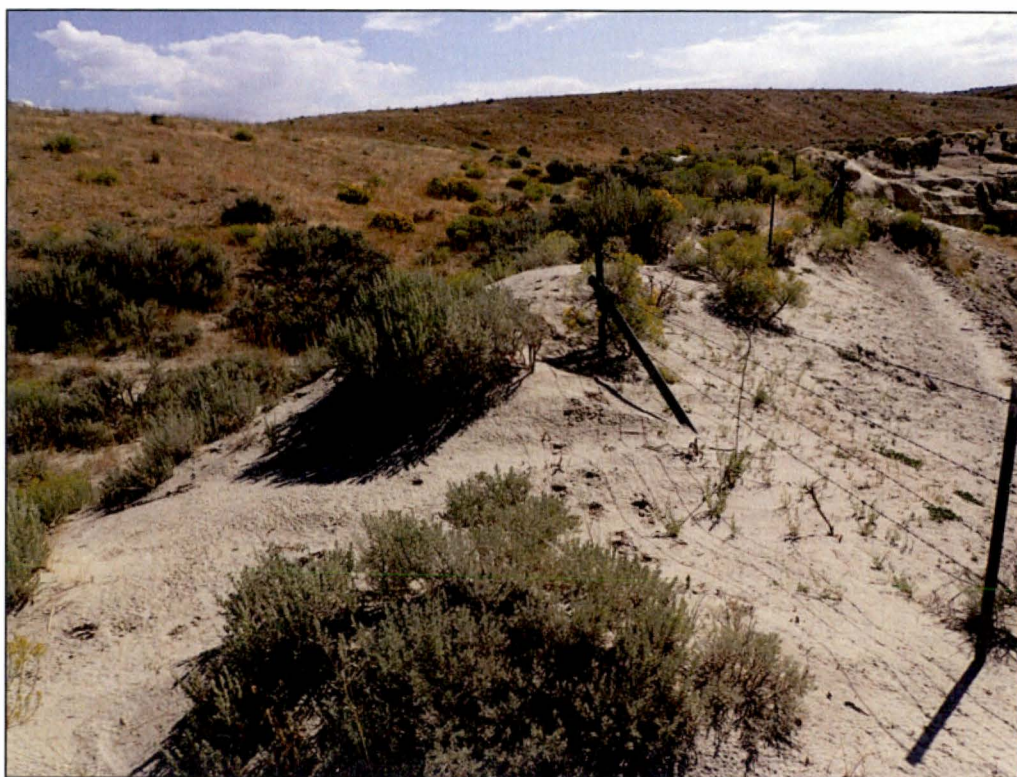
*PL-15. Sand Buildup Around Perimeter Fence near Johnson Pit*

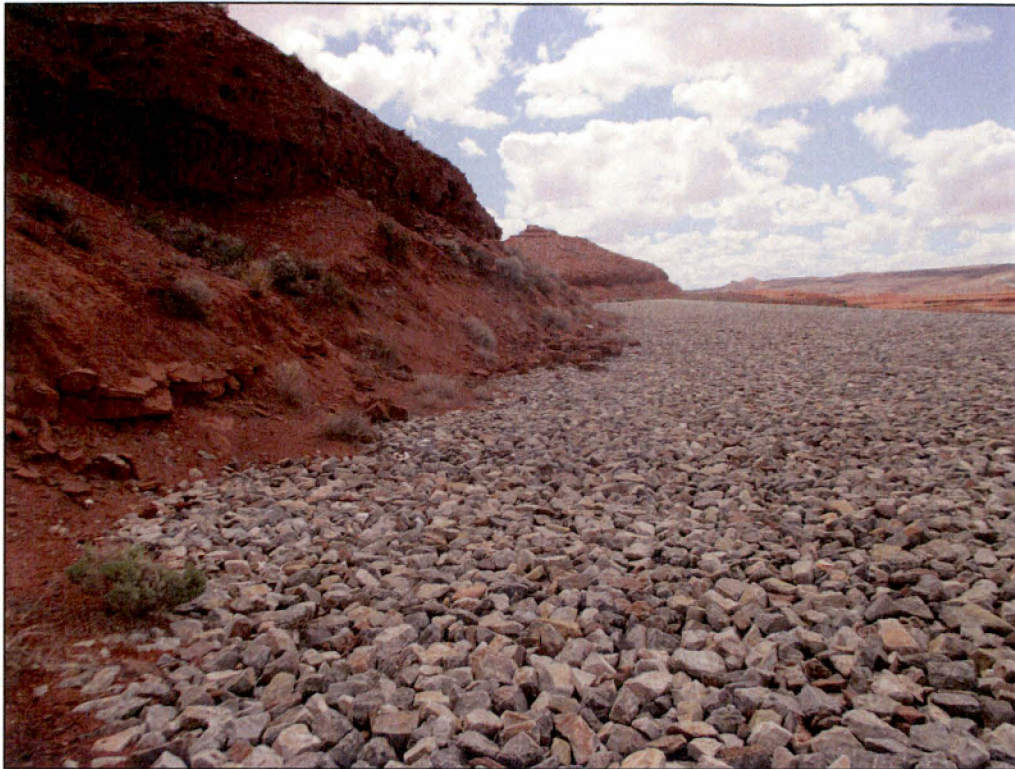
*PL-5. Sloughed Rock on South Apron of Disposal Cell*

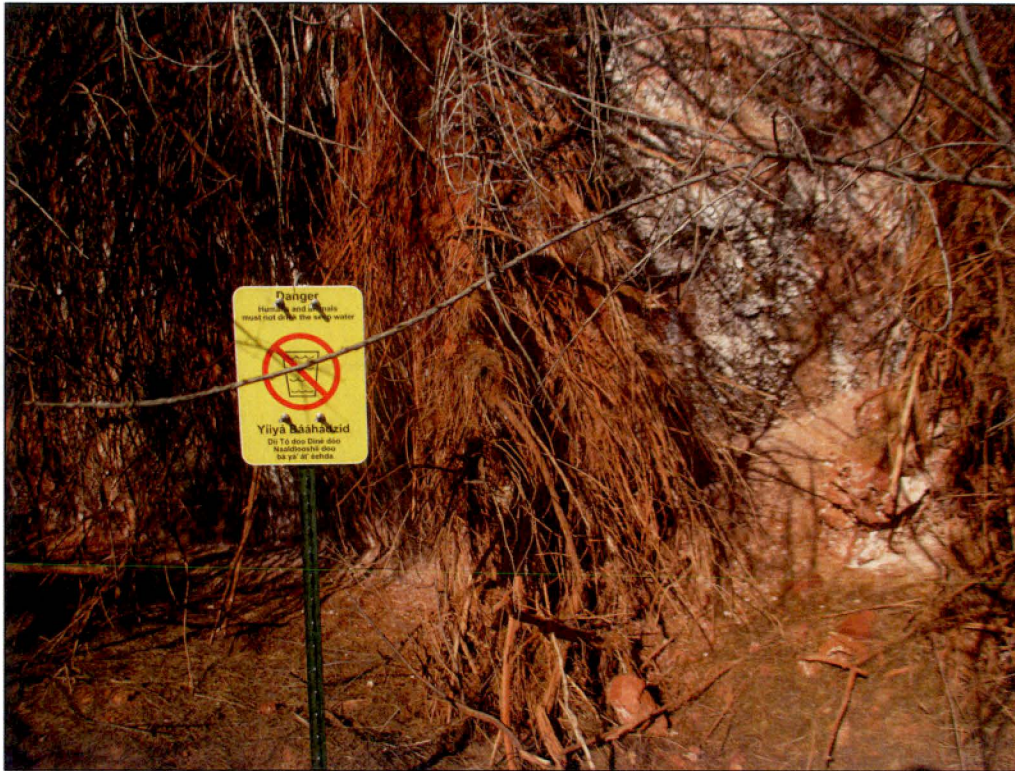
Since 2010, groundwater discharge from seeps had only been observed at cross-gradient Seep 0248, which typically exhibits dripping conditions. During the inspection, Seep 0248 was observed dripping; since the seep was only dripping and did not exhibit steady flow, an estimated flow rate was not evaluated. Additionally, Seeps 0251 and 0264 were damp, and upgradient (background) Seep 0261 was observed to be flowing during the inspection. Seep 0261 is approximately 0.50 mile upstream of Seep 0248 in Gypsum Creek.

*PL-7. Seep 0248 (Limited Dripping)*

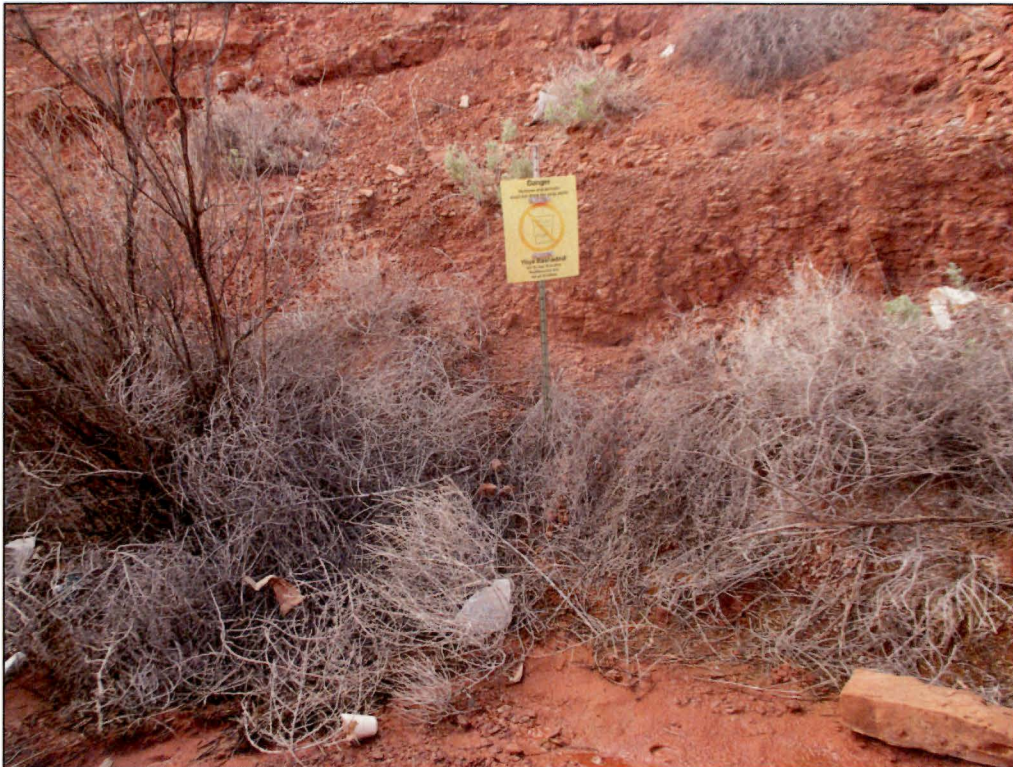
*PL-9. Seep 0251 (Damp)*

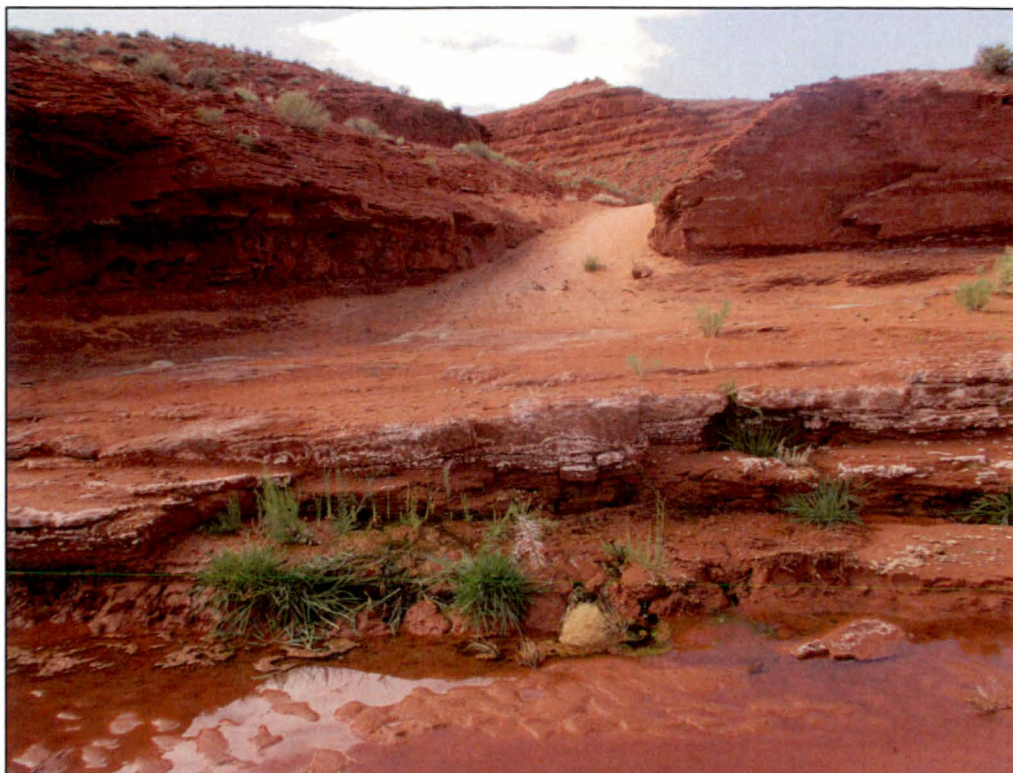
*PL-11. Background Seep 0261 (Flowing)*

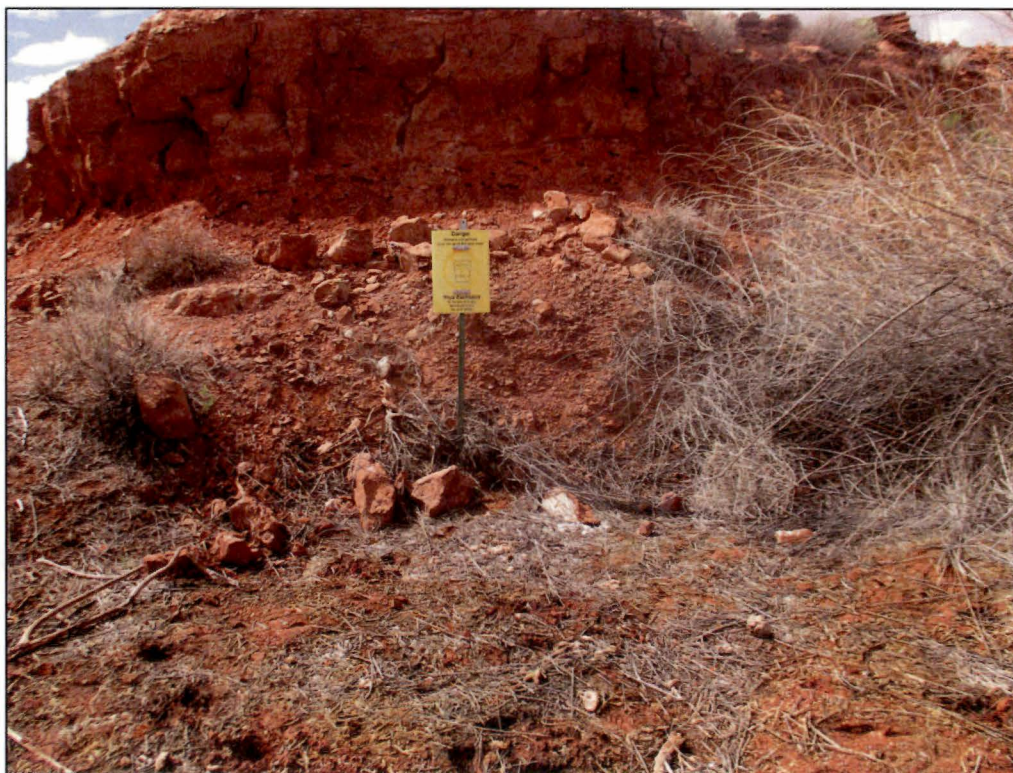
*PL-12. Seep 0264 (Damp)*

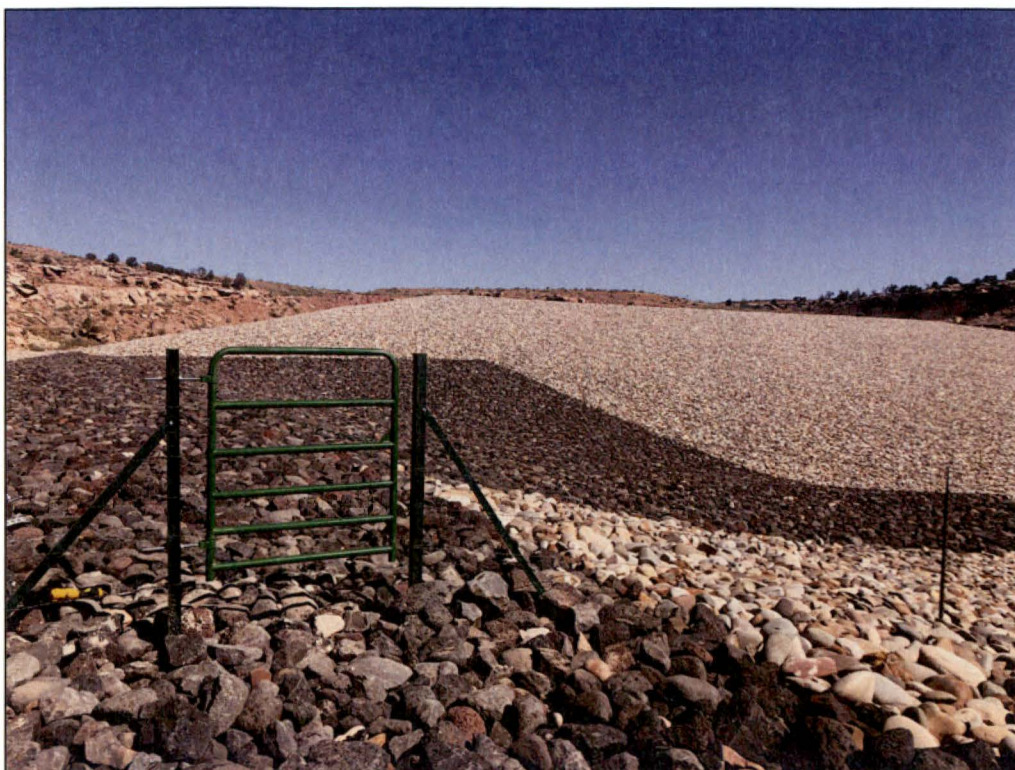
A barbed-wire perimeter fence encloses the site. Three aging wooden stiles identified in the 2018 inspection (DOE 2019a) were replaced with two pedestrian gates following the 2019 inspection (PL-1). A large bush growing in the western perimeter fence line was removed to prevent damage to the fence (PL-2). Inspectors identified a loose fence strand and a detached fence bracket; both were repaired following the inspection.

*PL-1. New Pedestrian Gate on Disposal Cell*

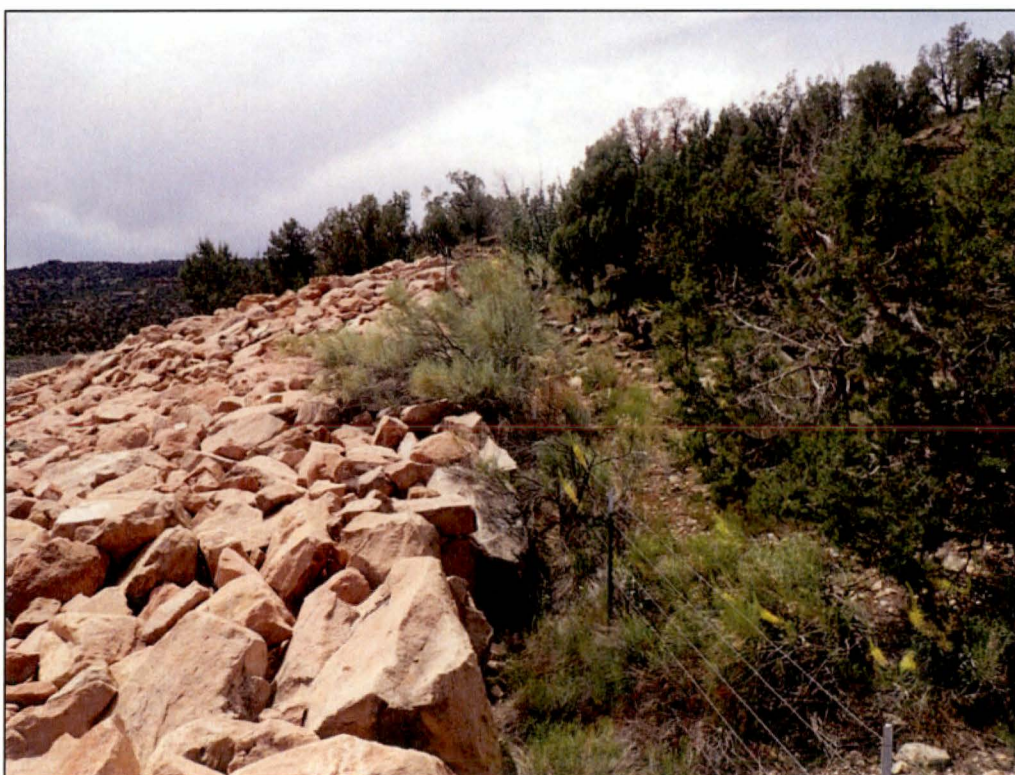
*PL-2. Vegetation Growing in Fence Line*

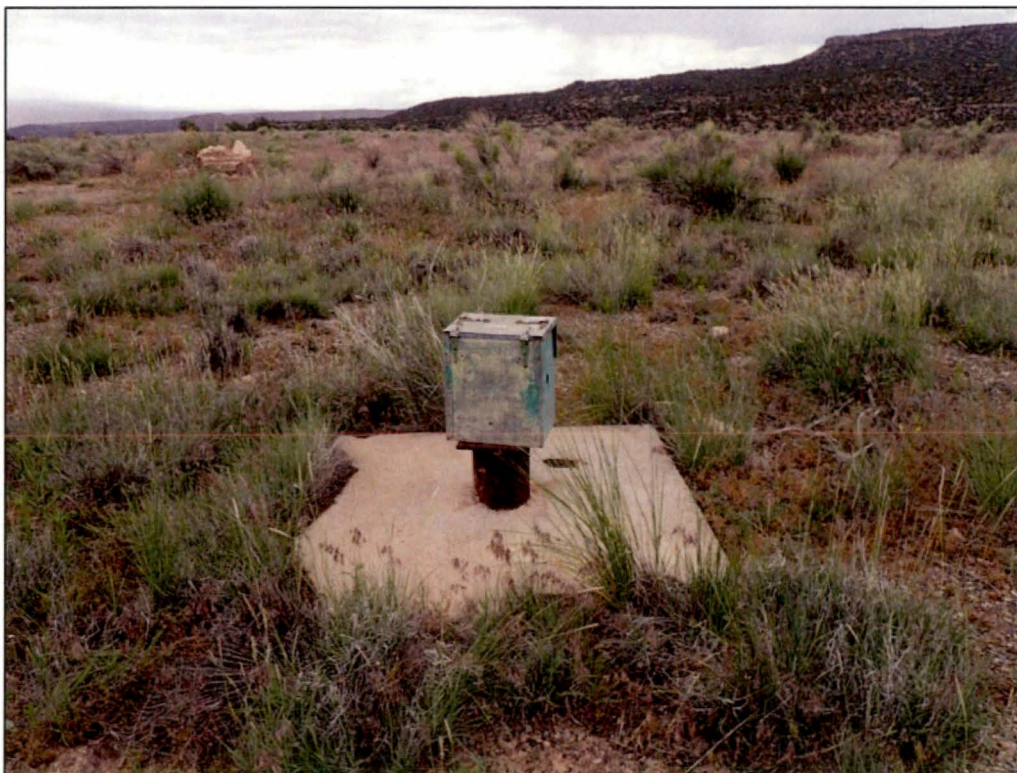
*PL-6. Monitoring Well CM93-2*

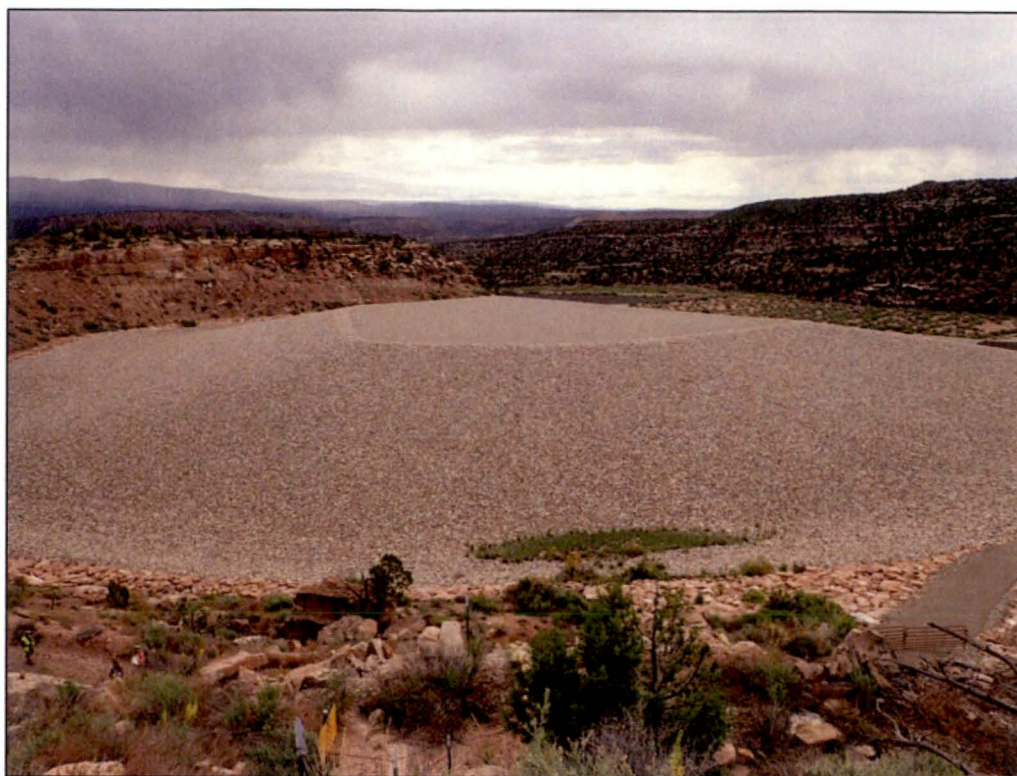
*PL-7. Disposal Cell*

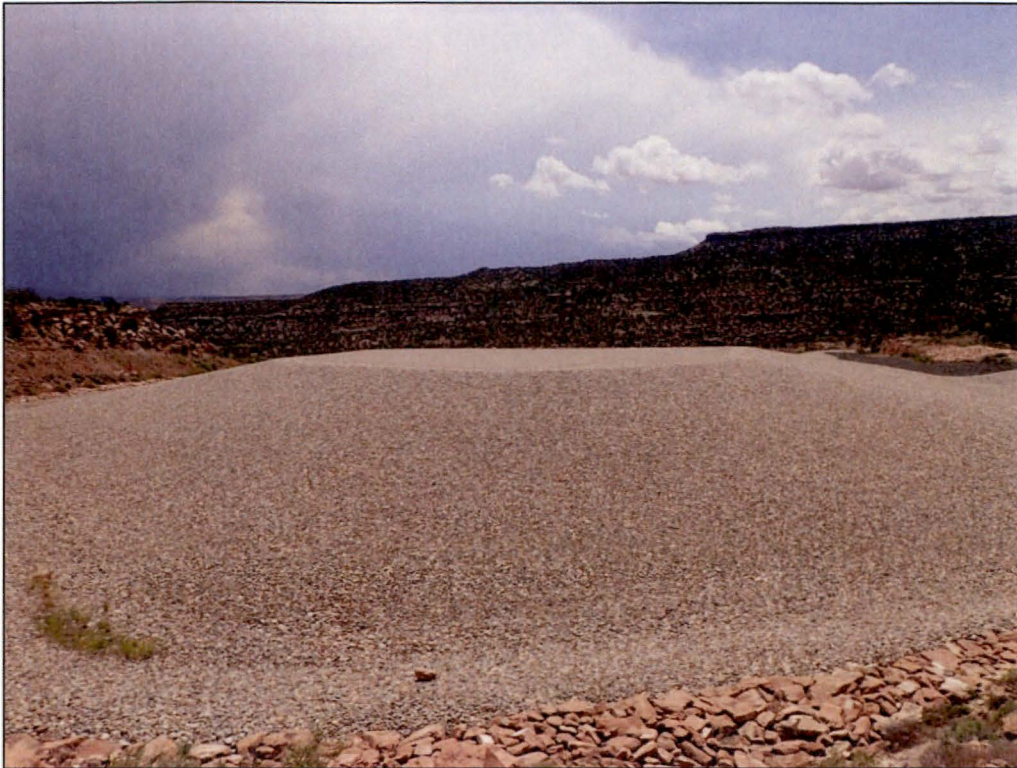
*PL-9. Boulder on Disposal Cell Apron*

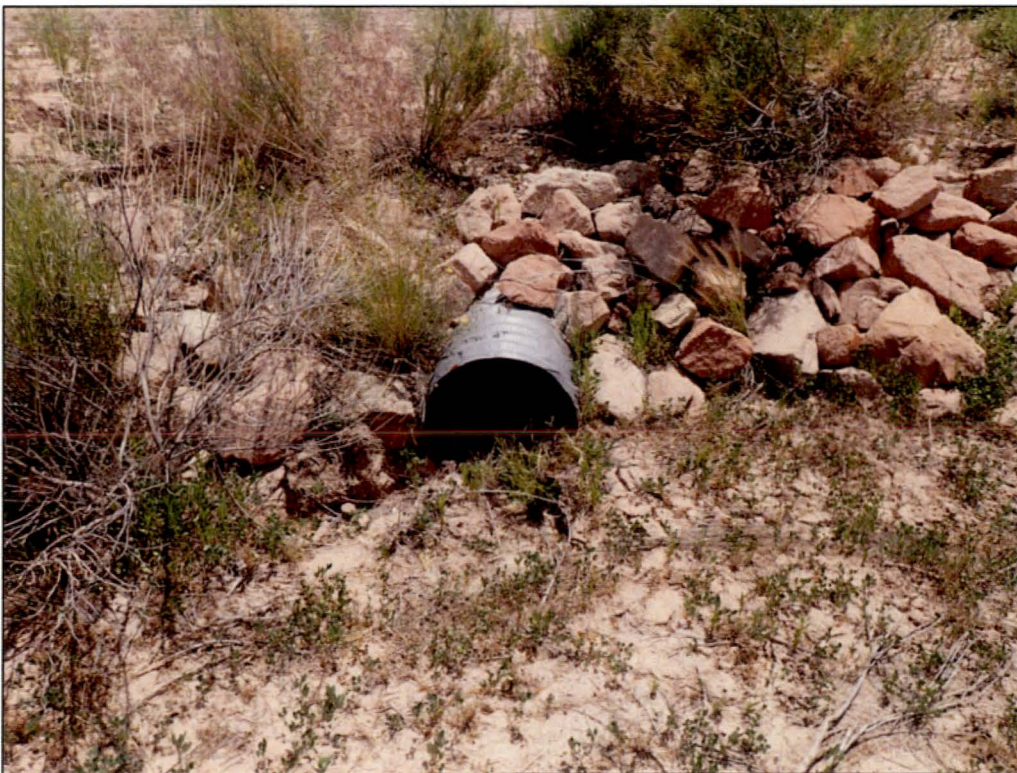
*PL-10. Culvert Inlet Partially Blocked by Sediment*

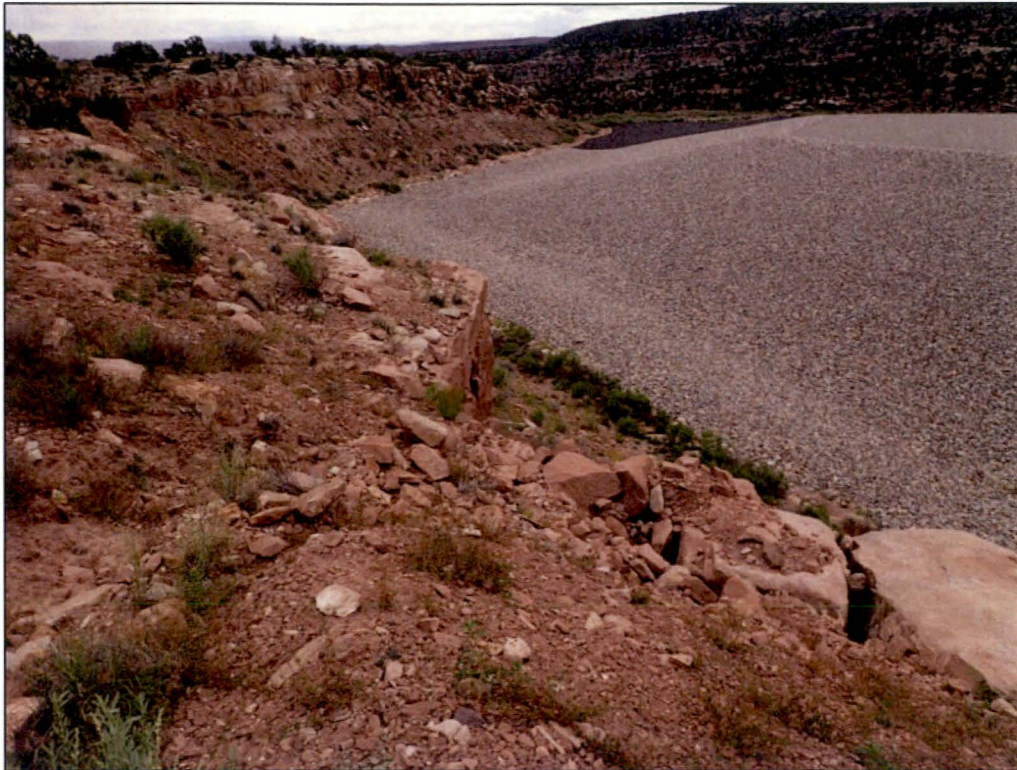
*PL-11. Erosion Along Cliff Edge Above Disposal Cell*

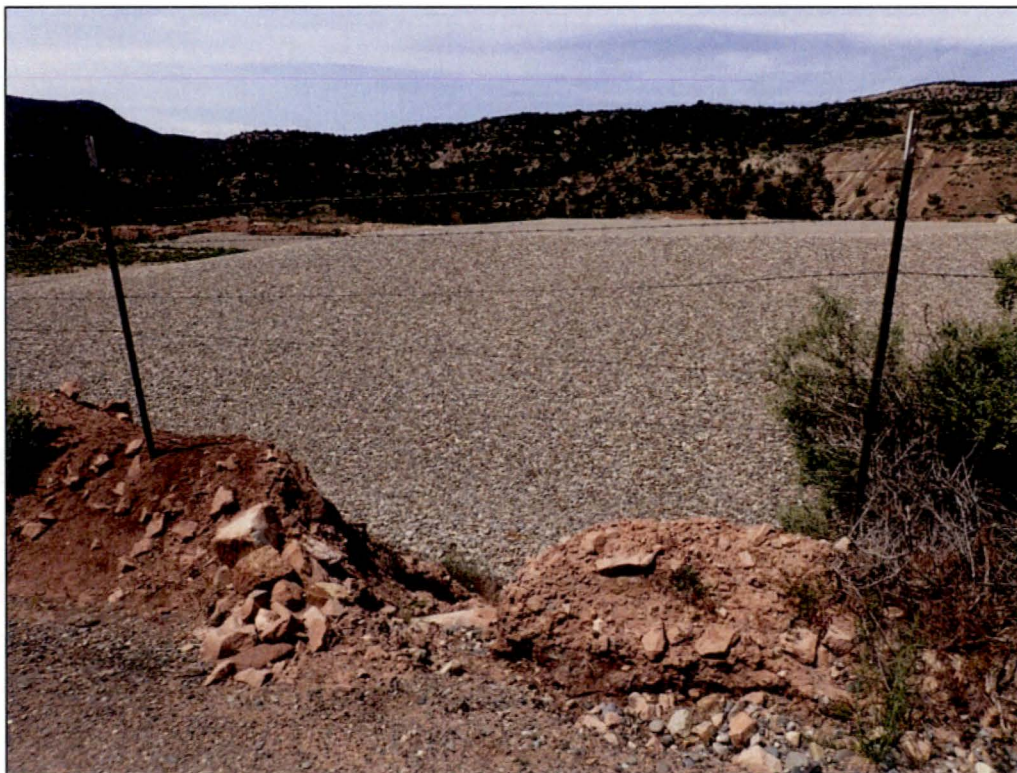
*PL-12. Berm Cut off County Road EE22 (Repaired Following Inspection)*

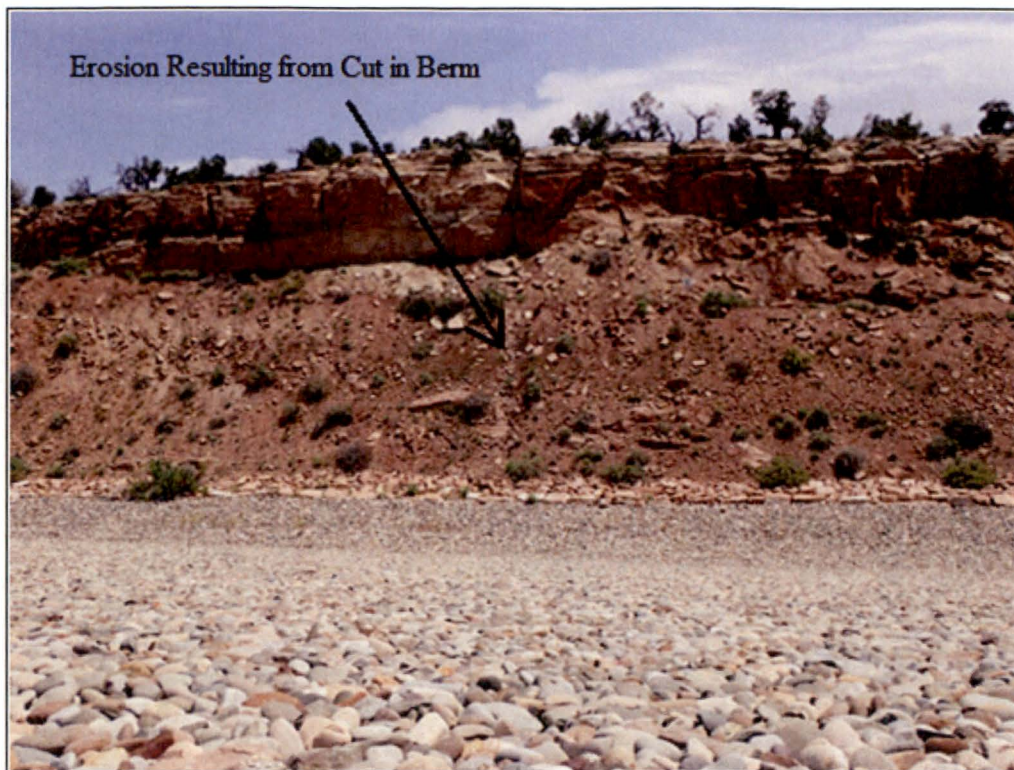
*PL-13. Erosion Along Cliff from Cut in County Road EE22 Berm*

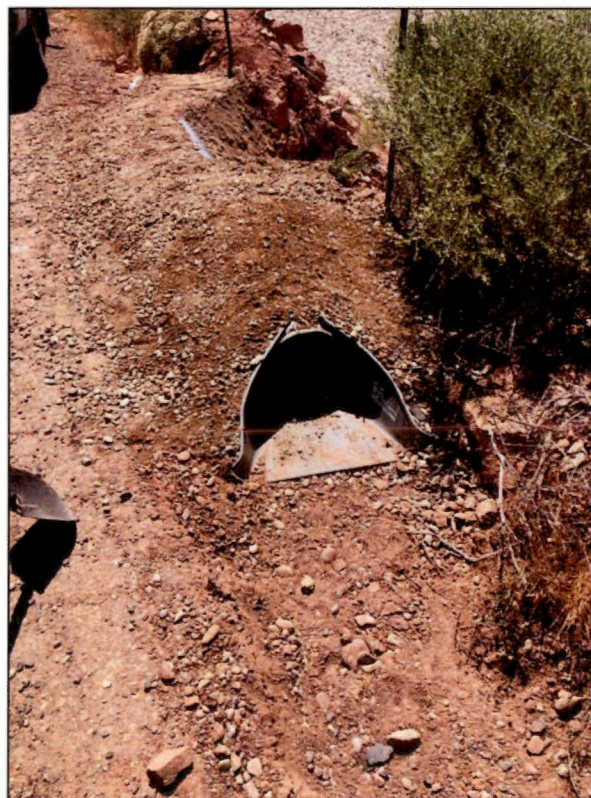
*PL-14. Berm Cut Repaired by Montrose County*

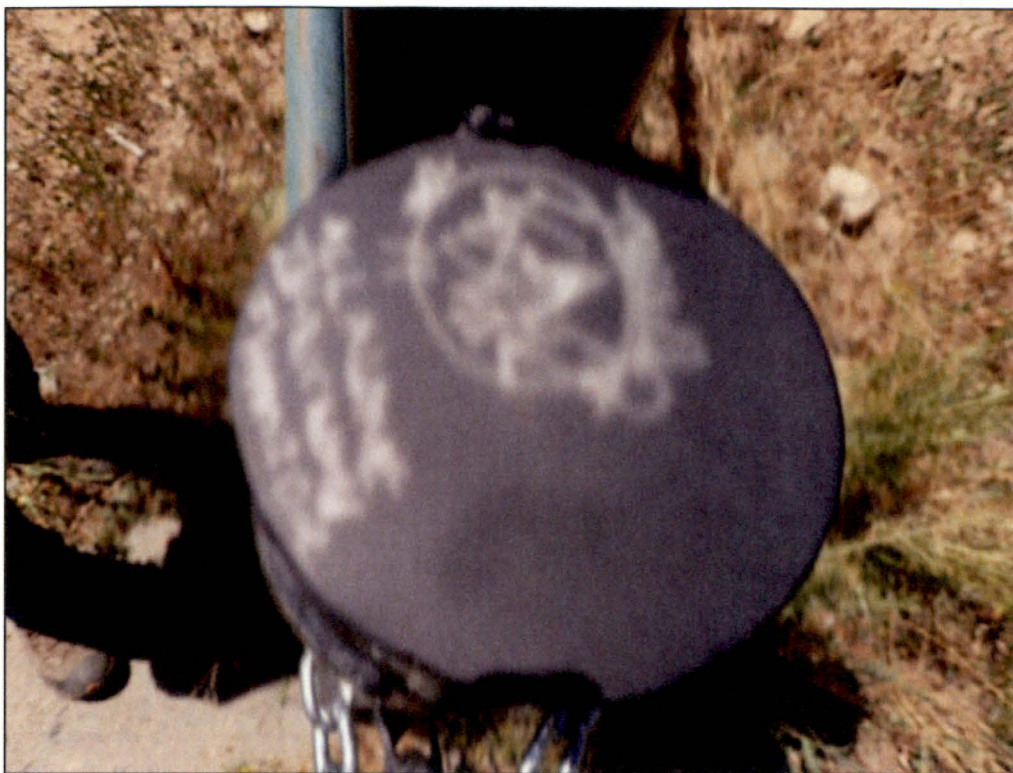
*PL-1. Recent Graffiti on Gate Cover at Outer Entrance Gate  
(Text Blurred Due to Nature of Content) (Removed)*

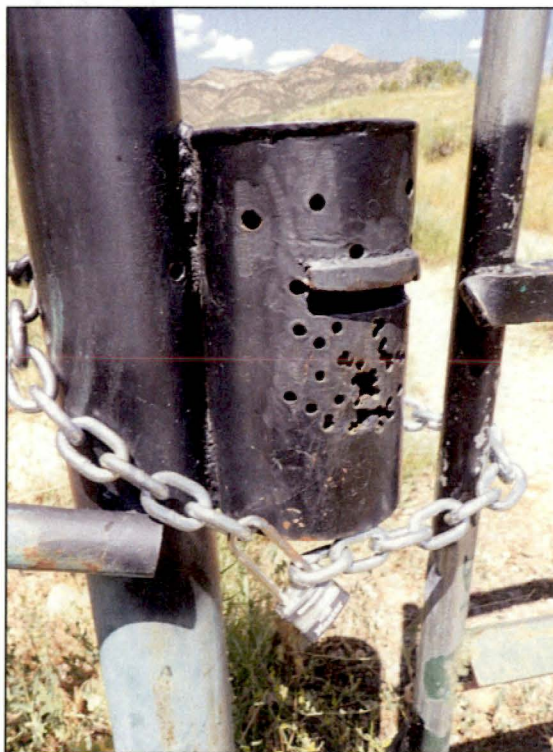
*PL-2. Bullet Holes in Gate Cover at Outer Entrance Gate*

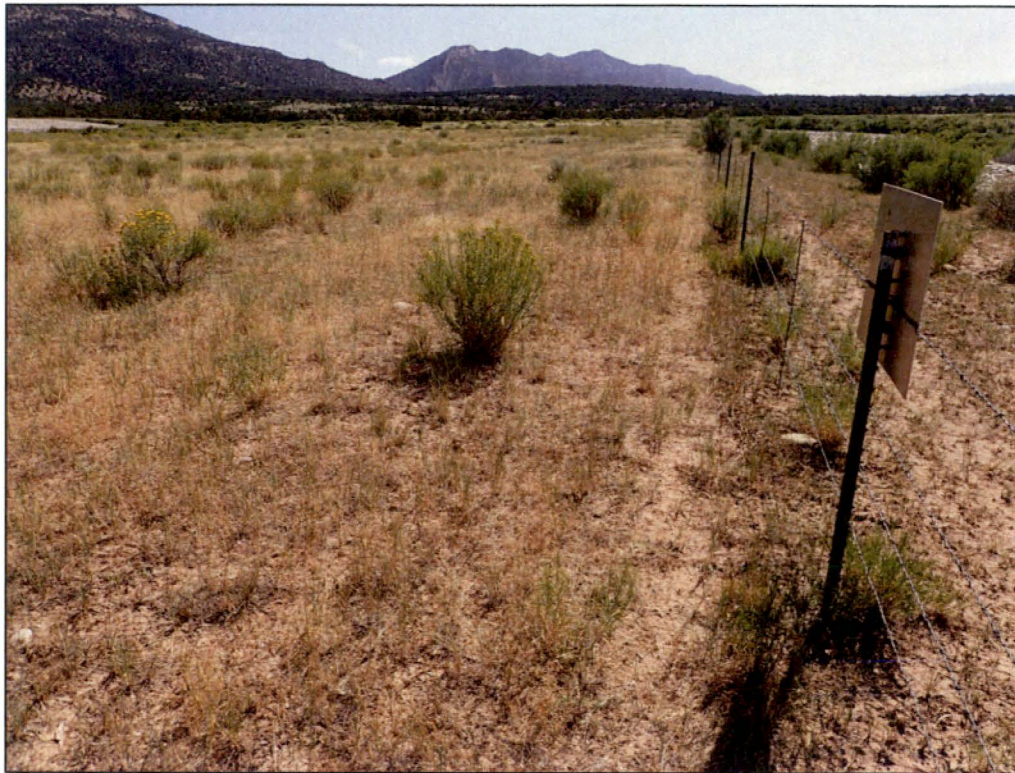
*PL-3. Regrowth on Last Year's Livestock Trails on Both Sides of Fence East of Reclaimed Area*

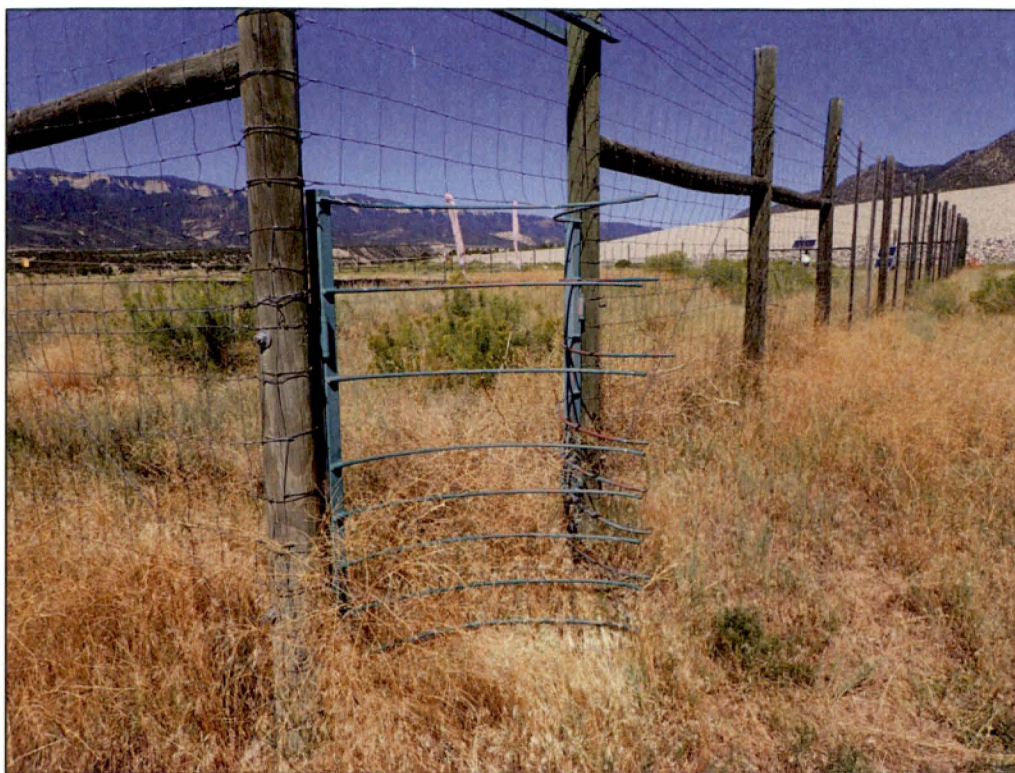
*PL-5. Tumbleweed Buildup in Wildlife Gates (Removed Following Inspection)*

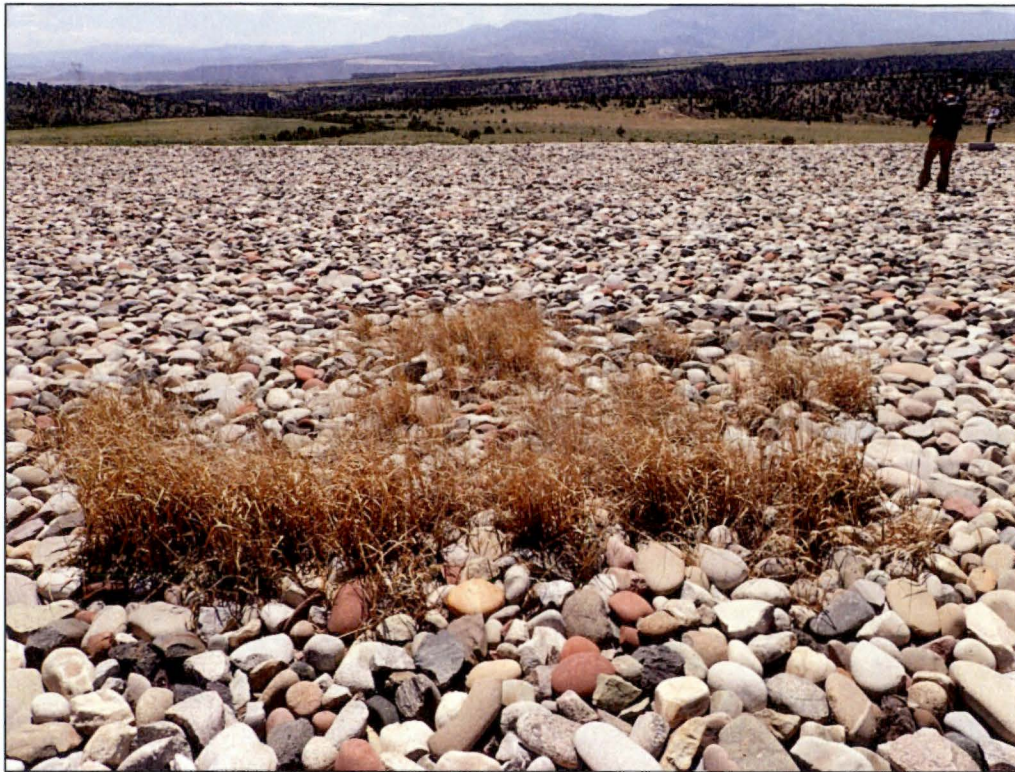
*PL-7. Treated Quackgrass, a State-Listed Noxious Weed*
