## 10.0 Lowman, Idaho, Disposal Site

The Lowman, Idaho, Uranium Mill Tailings Radiation Control Act (UMTRCA) Title I Disposal Site (site) was inspected on June 13, 2019. No changes were observed on the disposal cell or in the associated drainage features. Inspectors identified a minor maintenance need but found no cause for a follow-up inspection. Groundwater monitoring is not required and was discontinued in 2004.

Figure 10-1. 2019 Annual Inspection Drawing for the Lowman, Idaho, Disposal Site

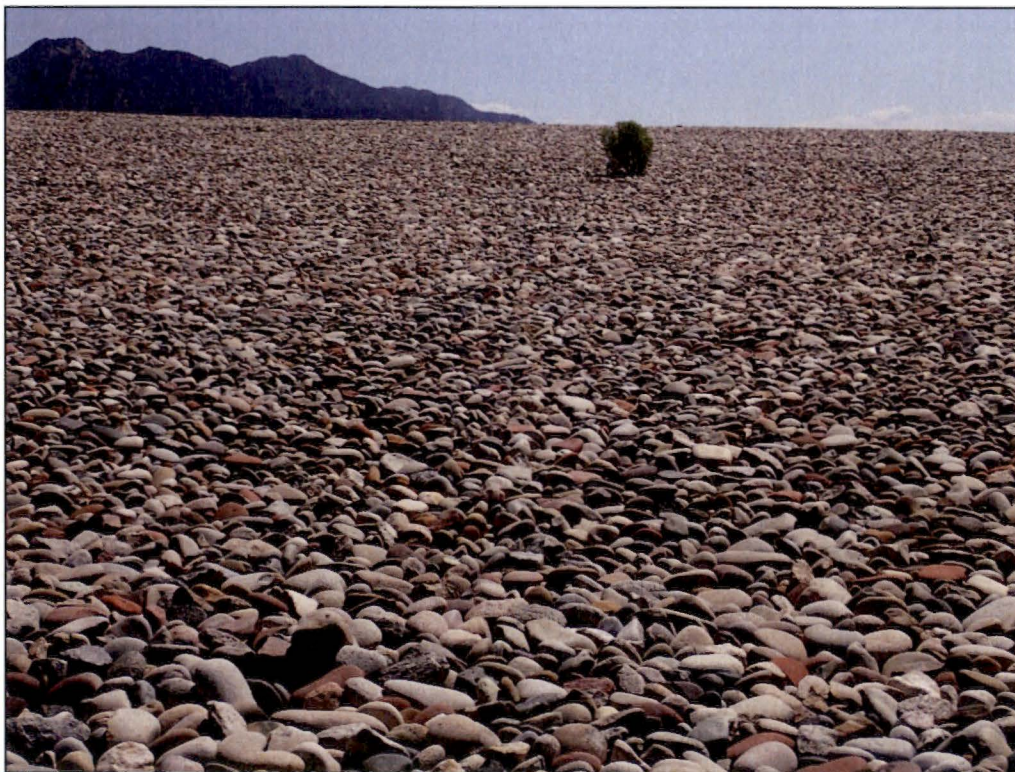
*PL-8. One Deep-Rooted Woody Plant—Rubber Rabbitbrush—on Disposal Cell Top Slope*

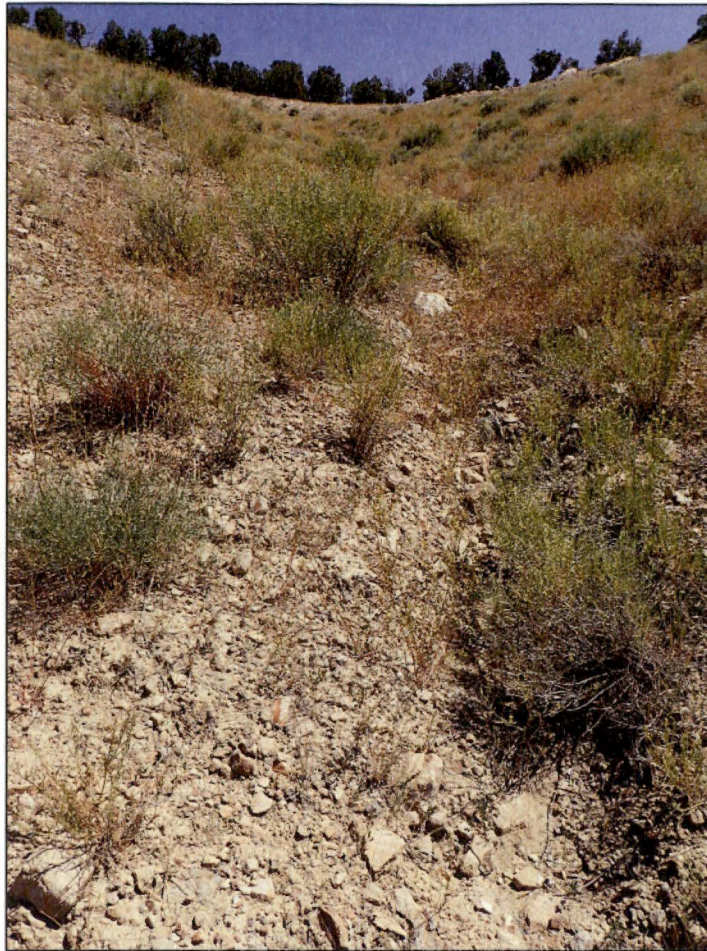
*PL-9. Upslope of Interceptor Trench Erosion*

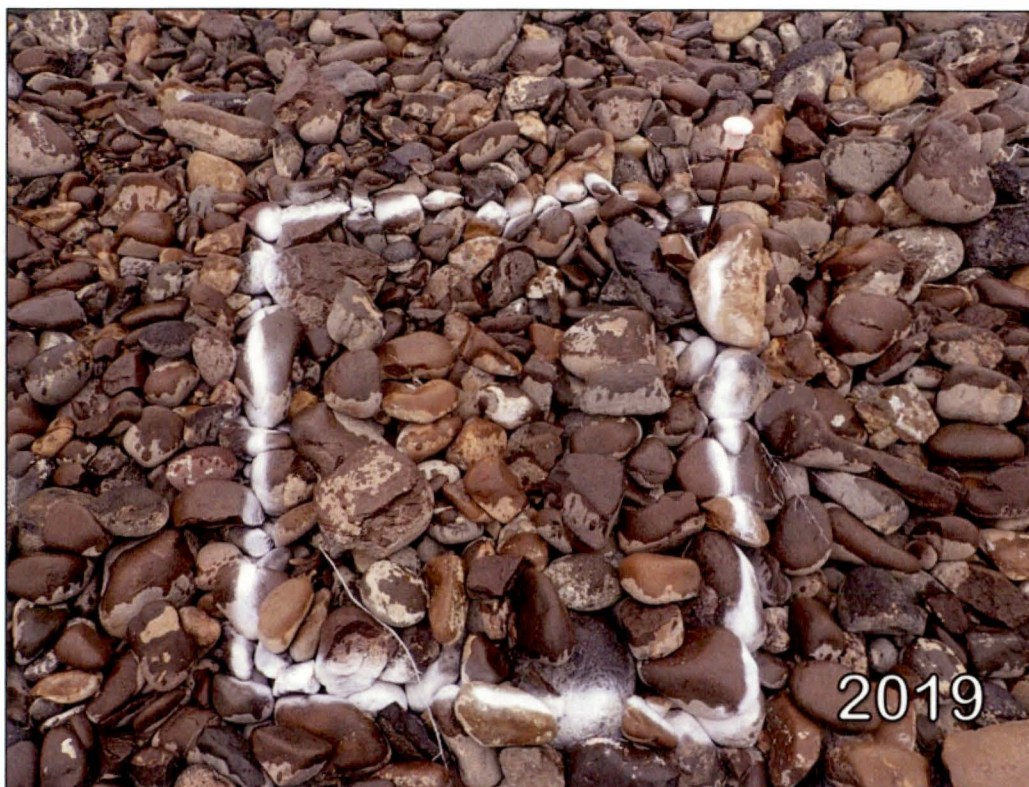
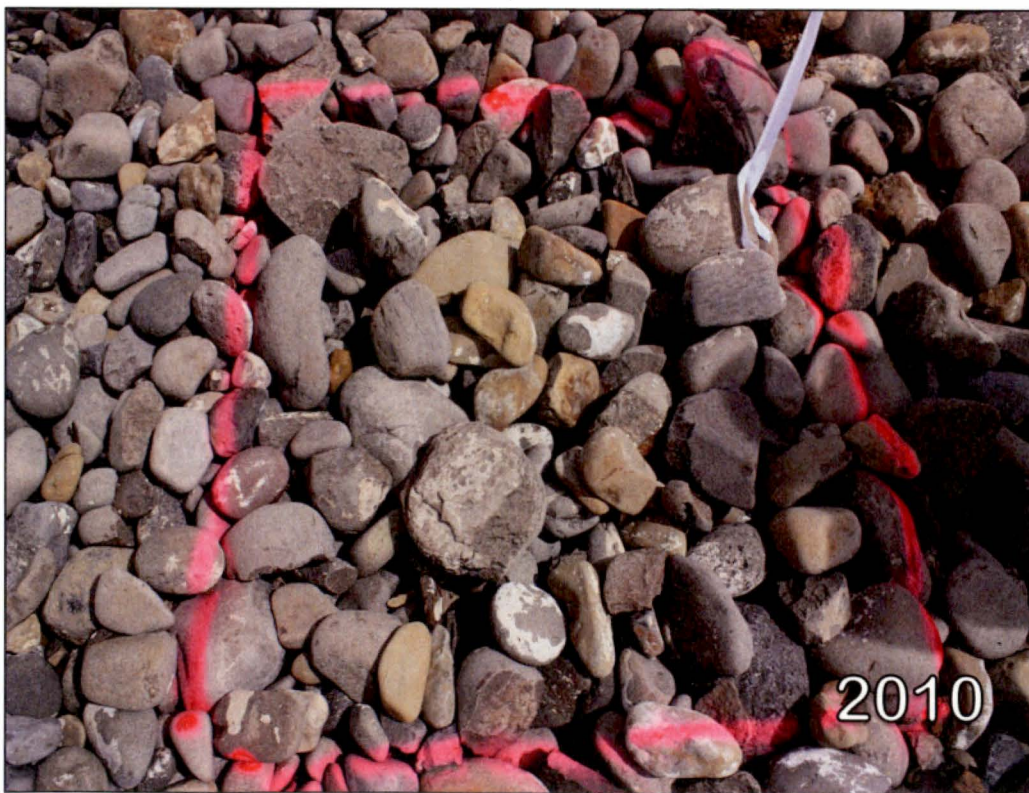
One of several types of rock used for the disposal cell erosion-protection riprap layer has exhibited minor degradation since the disposal cell was constructed. As a result, eight rock-quality monitoring plots, each measuring 1 square meter (indicated by Roman numerals I–VIII in Figure 15-1), were established in 2010 to monitor for continued rock degradation. The rock type exhibiting degradation constitutes approximately 1%–10% of the riprap material; degradation of this less competent rock is thought to result from freeze-thaw weathering. Rock-quality monitoring plots are visually monitored and documented annually with photographs.

PL-6. (a) Rock Quality Plot No. I—2019

PL-6. (b) Rock Quality Plot No. I—2010 Photo for Comparison

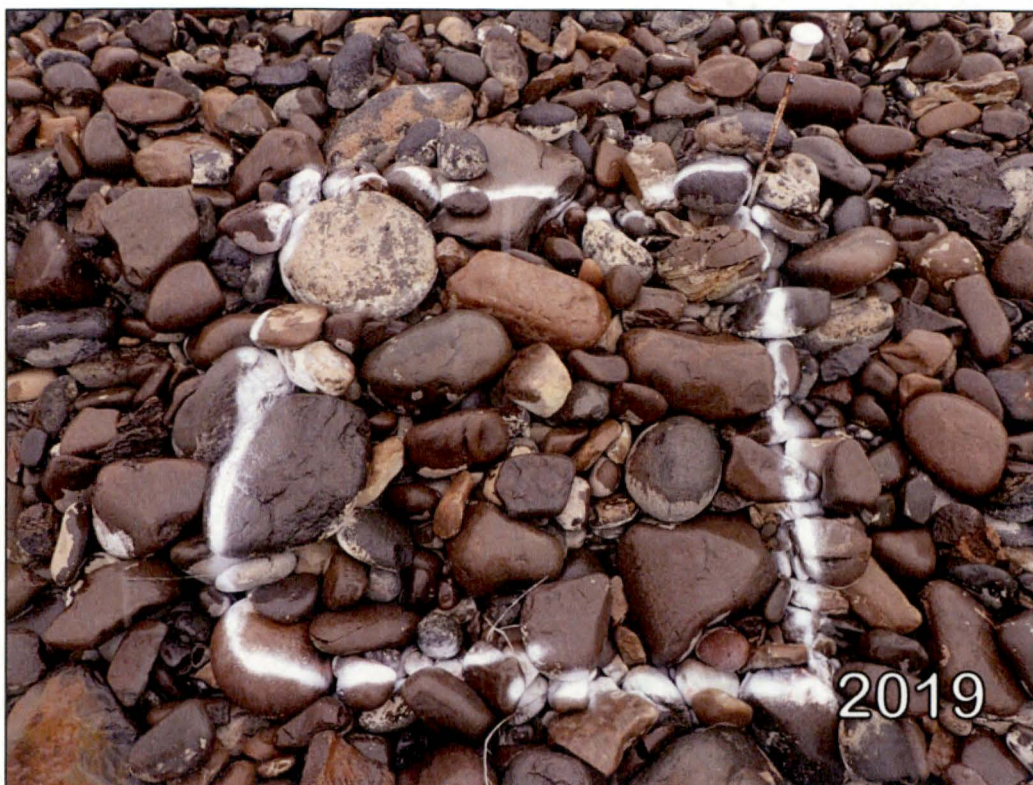
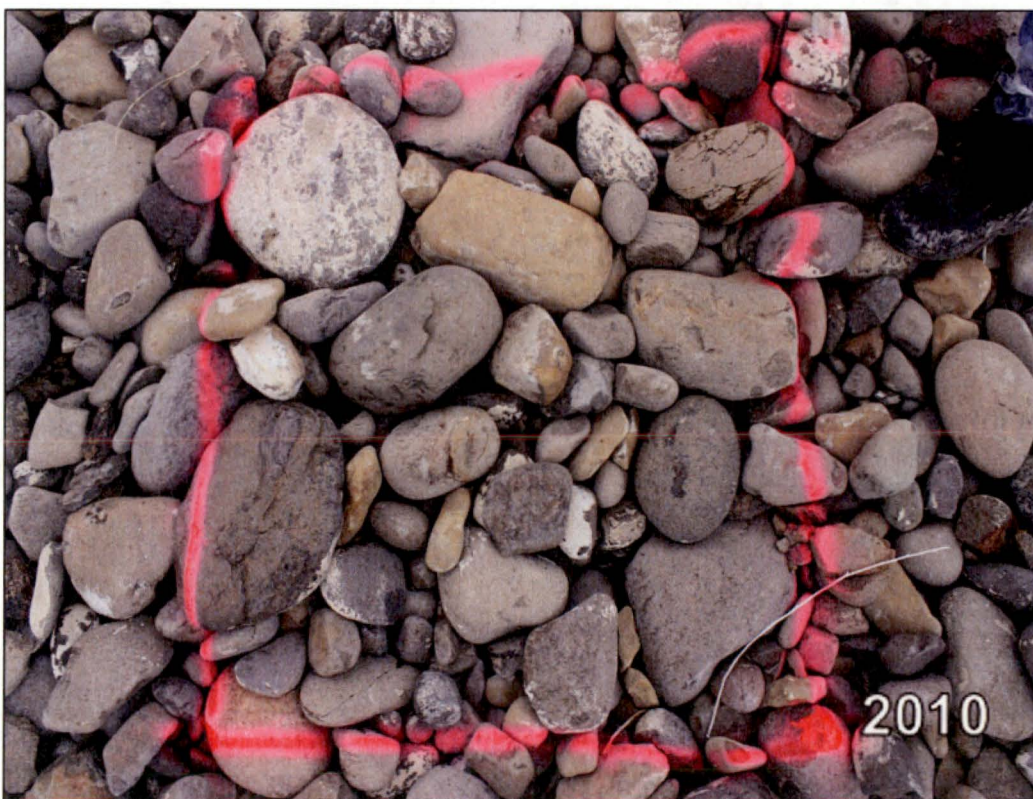
*PL-7. (a) Rock Quality Plot No. II—2019*

*PL-7. (b) Rock Quality Plot No. II—2010 Photo for Comparison*

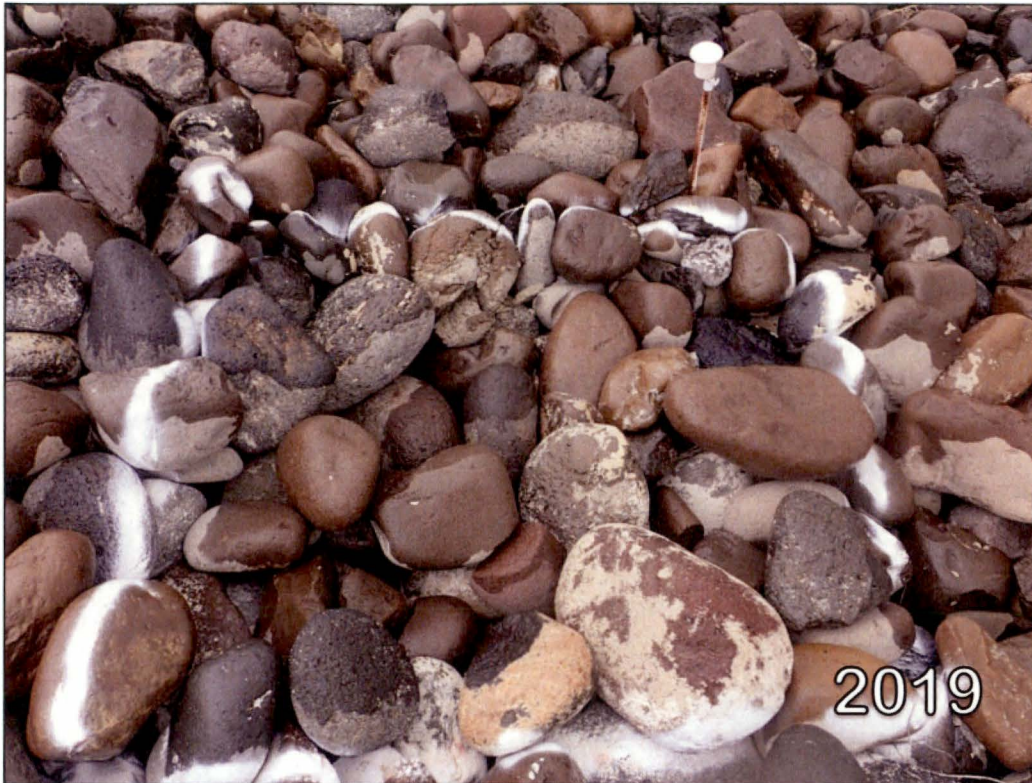
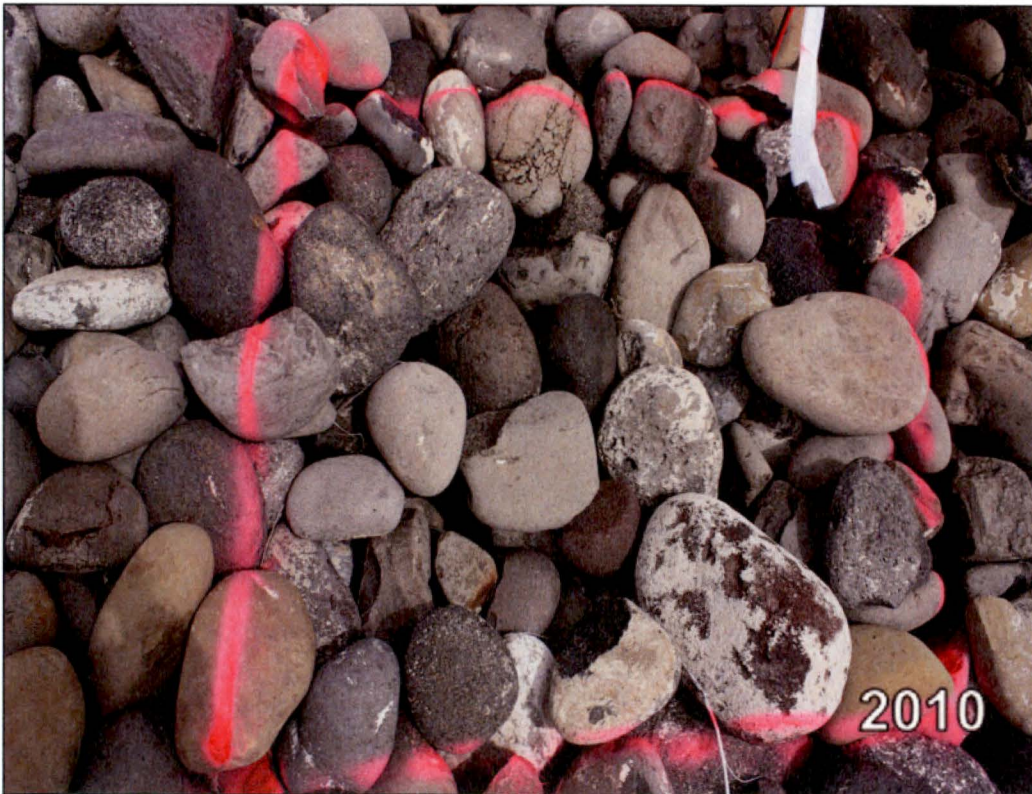
*PL-8. (a) Rock Quality Plot No. III—2019*

*PL-8. (b) Rock Quality Plot No. III—2010 Photo for Comparison*

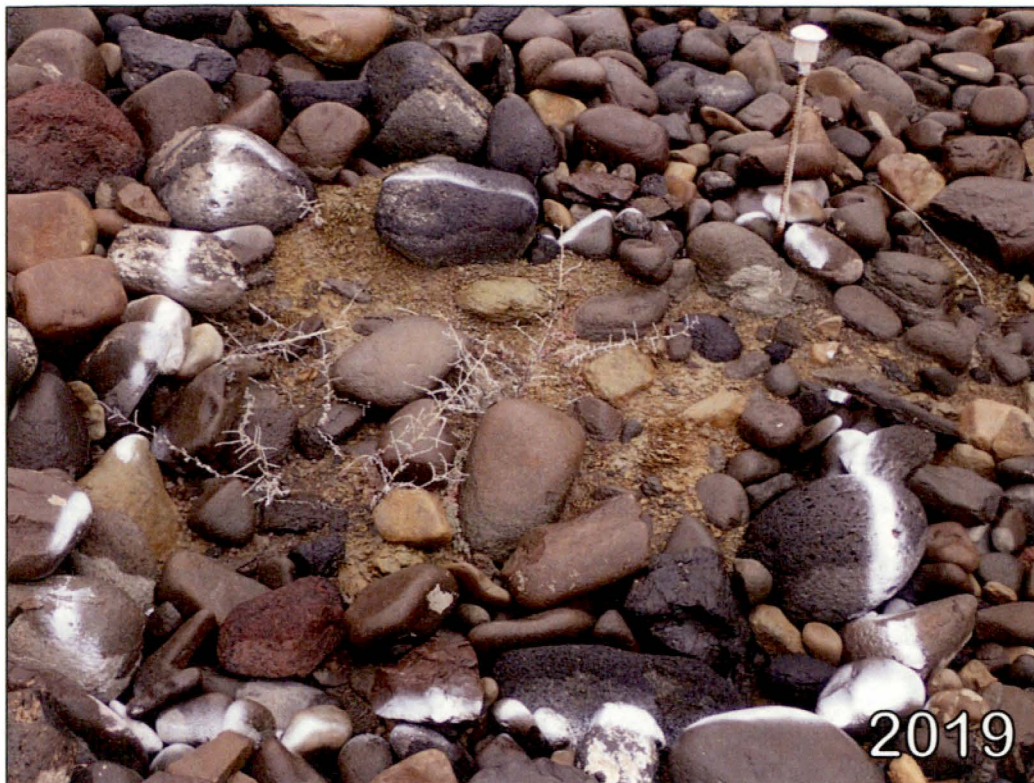
*PL-9. (a) Rock Quality Plot No. IV—2019*

*PL-9. (b) Rock Quality Plot No. IV—2010 Photo for Comparison*

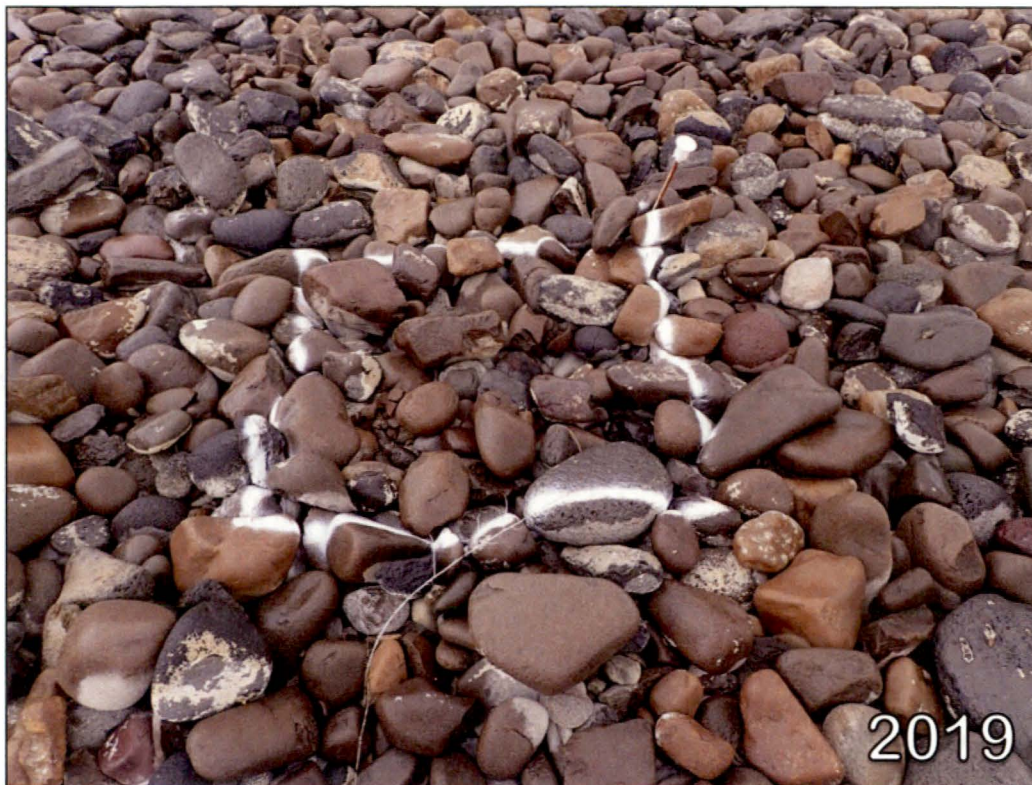
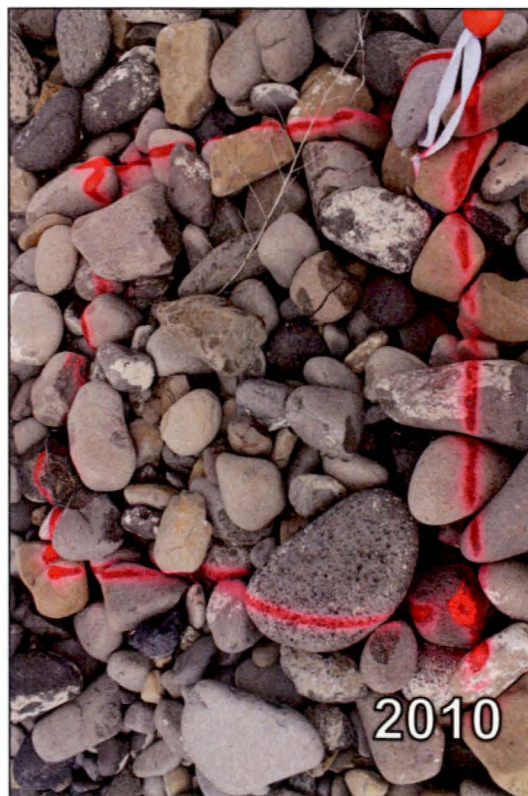
*PL-10. (a) Rock Quality Plot No. V—2019*

*PL-10. (b) Rock Quality Plot No. V—2010 Photo for Comparison*

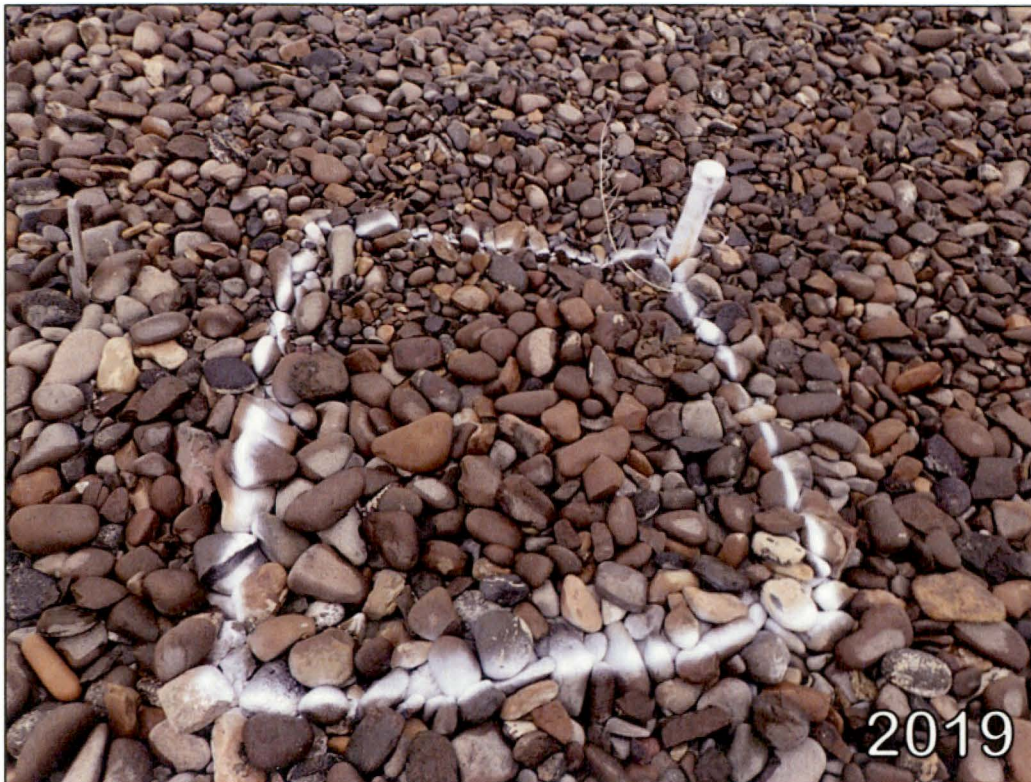
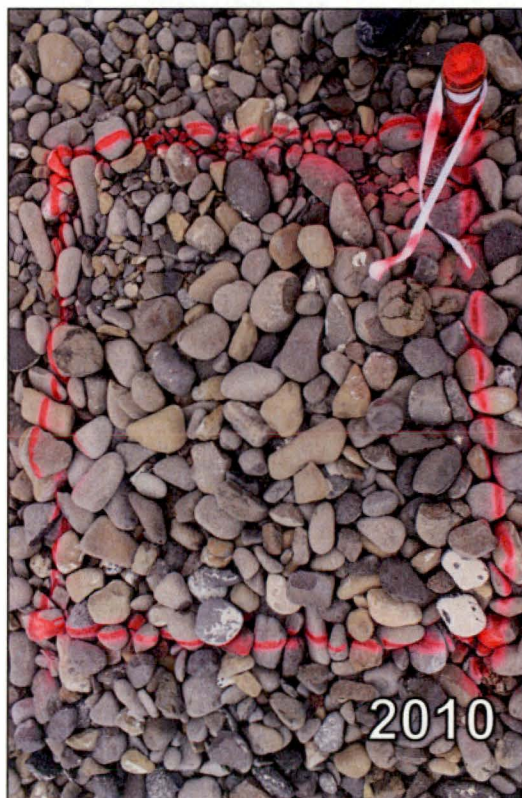
*PL-11. (a) Rock Quality Plot No. VI—2019*

*PL-11. (b) Rock Quality Plot No. VI—2010 Photo for Comparison*

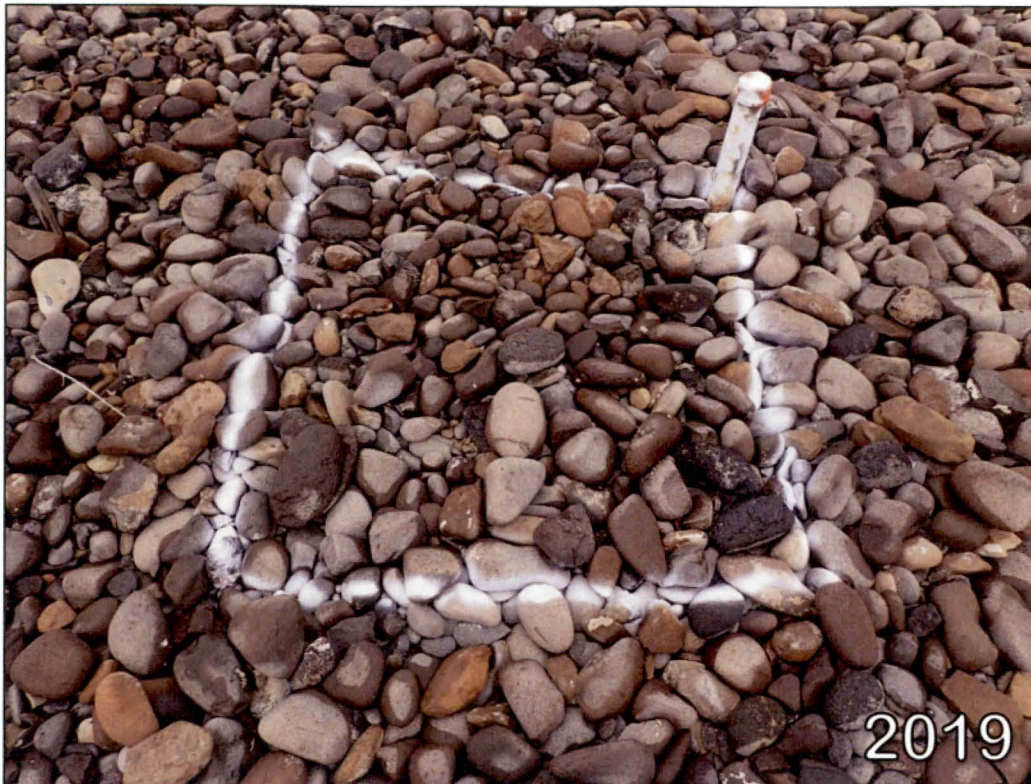
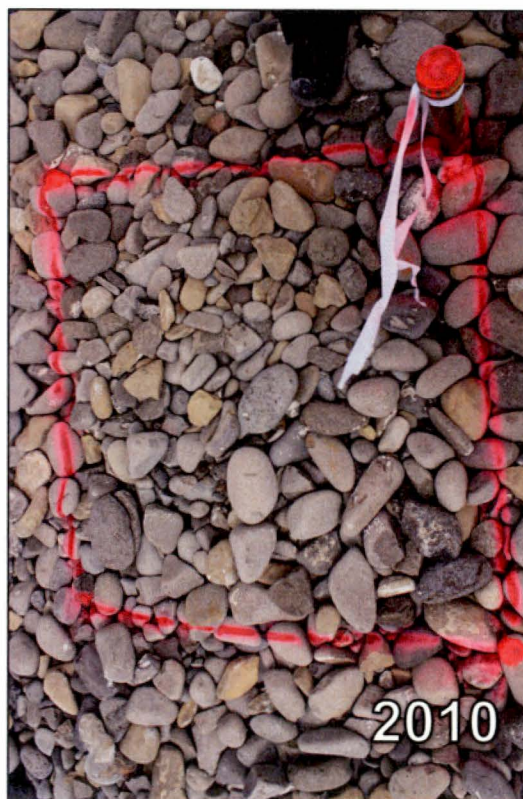
*PL-12. (a) Rock Quality Plot No. VII—2019*

*PL-12. (b) Rock Quality Plot No. VII—2010 Photo for Comparison*

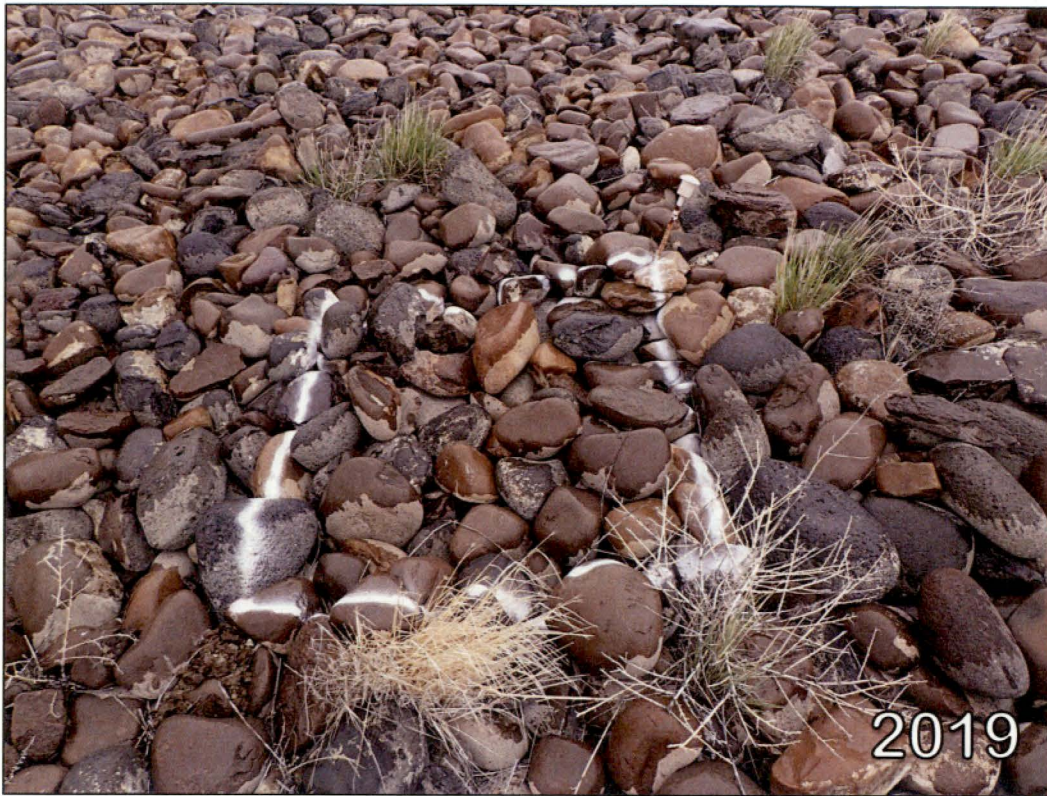
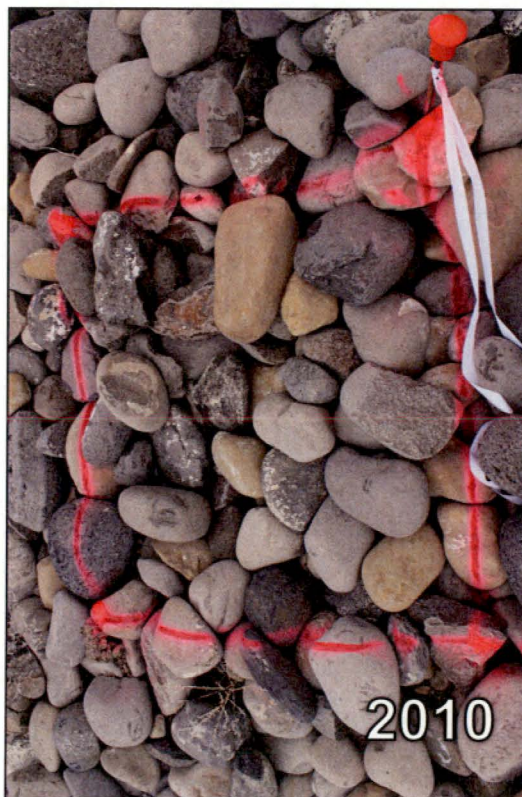
*PL-13. (a) Rock Quality Plot No. VIII—2019*

*PL-13. (b) Rock Quality Plot No. VIII—2010 Photo for Comparison*

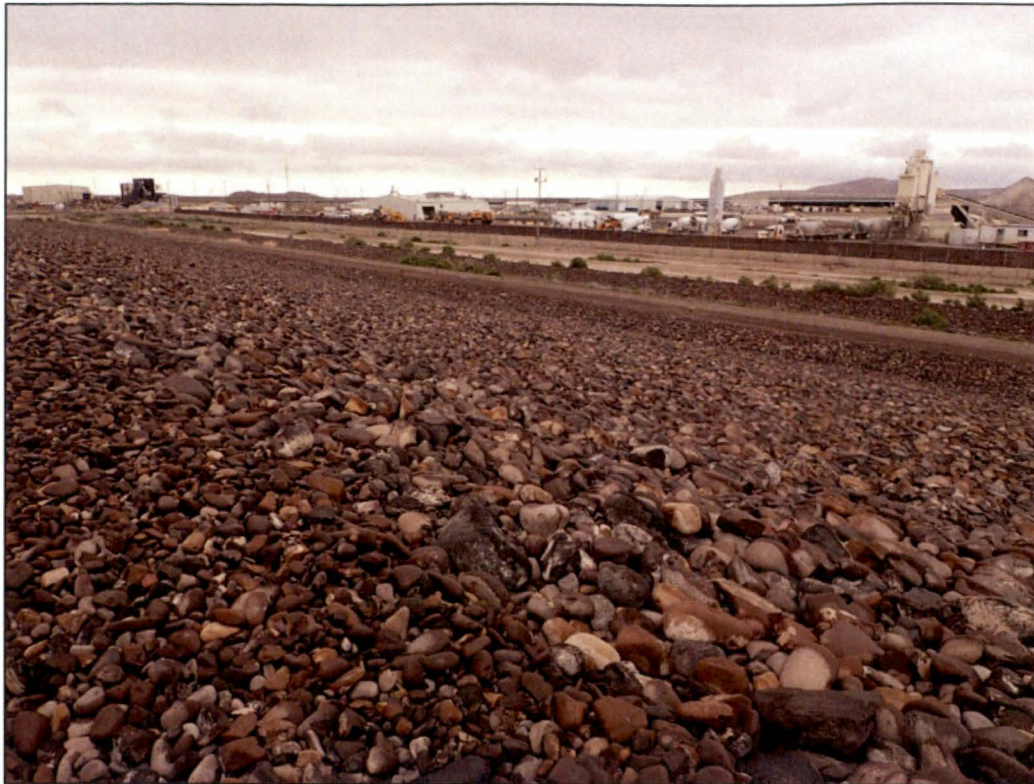
*PL-18. EnergySolutions Facility on North Side of Cell*

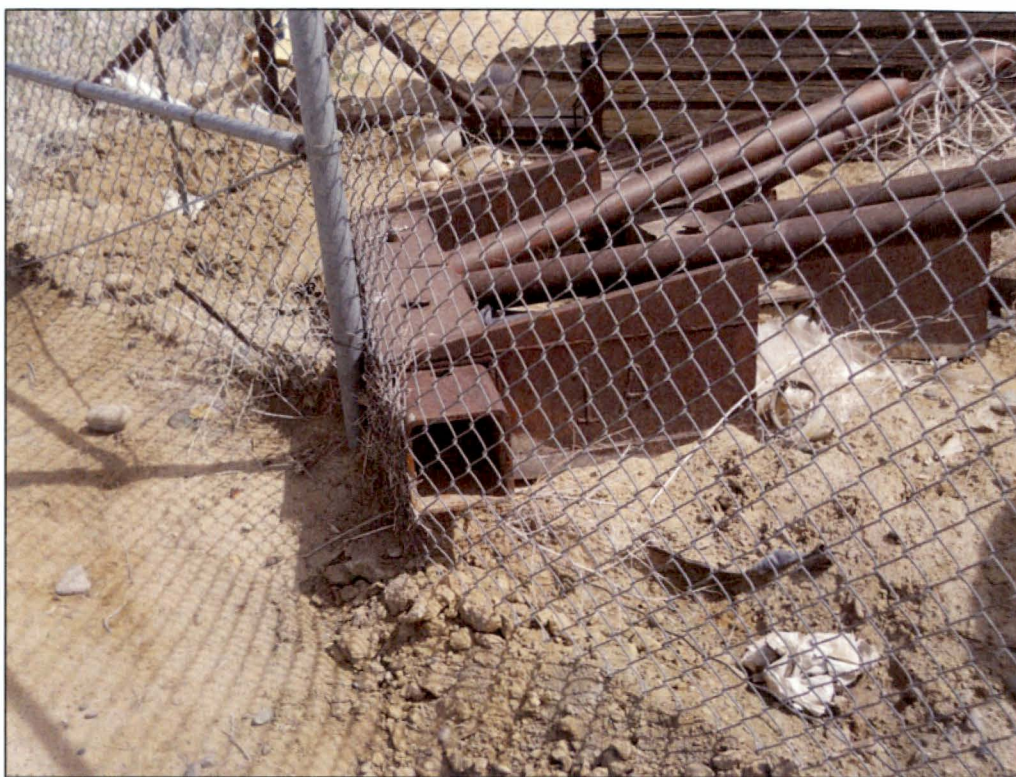
*PL-1. NECA Equipment Against Perimeter Fence Between Perimeter Signs P14 and P15*

- Replacing the faded pictorial sign next to the entrance sign
- Repairing a fence post and stanchion near perimeter sign P15
- Contacting NECA management to request removal of construction material leaning against the perimeter fence near perimeter sign P15, repair of the fence fabric between perimeter signs P11 and P12, and assistance in fence repairs along the common fence
- Removing accumulating tumbleweeds on the southeast side of the perimeter fence
- Replacing the pictorial signs next to the southwest entrance sign and perimeter signs P11 and P12
- Treating new woody vegetation on the disposal cell top and side slopes

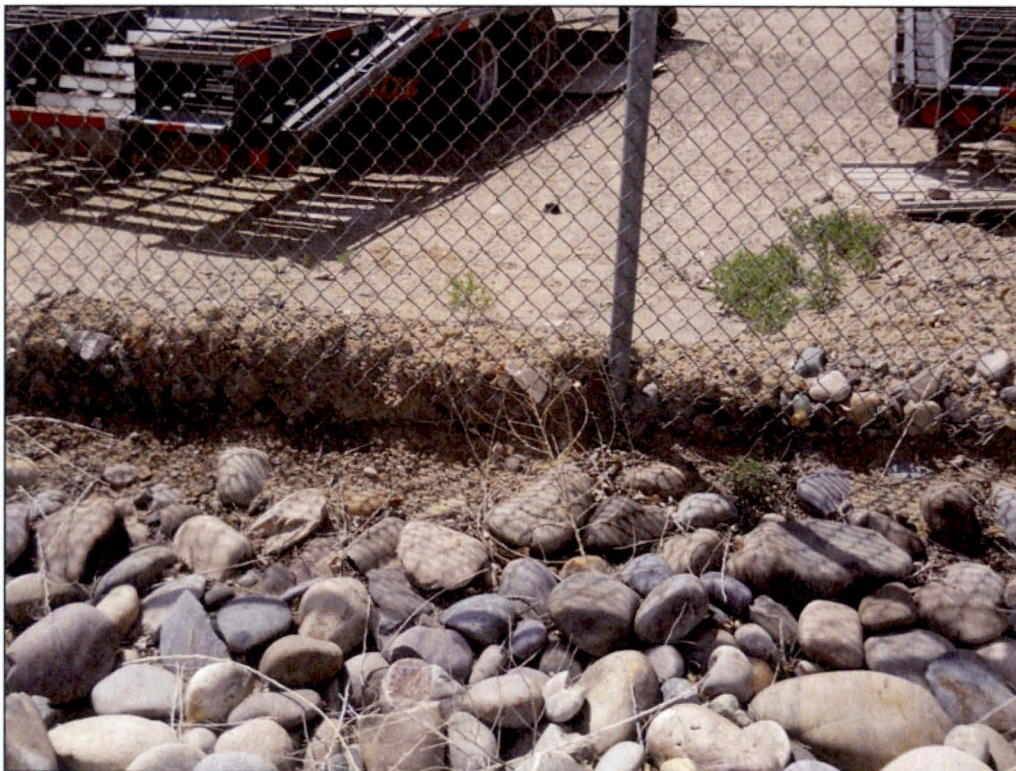
Dirt accumulation was also observed along the inside of the perimeter fence between perimeter signs P9 and P10. No maintenance is needed at this time. Inspectors will continue to monitor these areas. Regular maintenance continues to mitigate the accumulation of trash and tumbleweeds along the fence, although some minor tumbleweed accumulation was observed along the southeastern perimeter fence between perimeter signs P3 and P7. Maintenance to keep the perimeter fence lines free of debris will continue.

*PL-2. Dirt Accumulation Against Perimeter Fence Between Perimeter Signs P11 and P12*

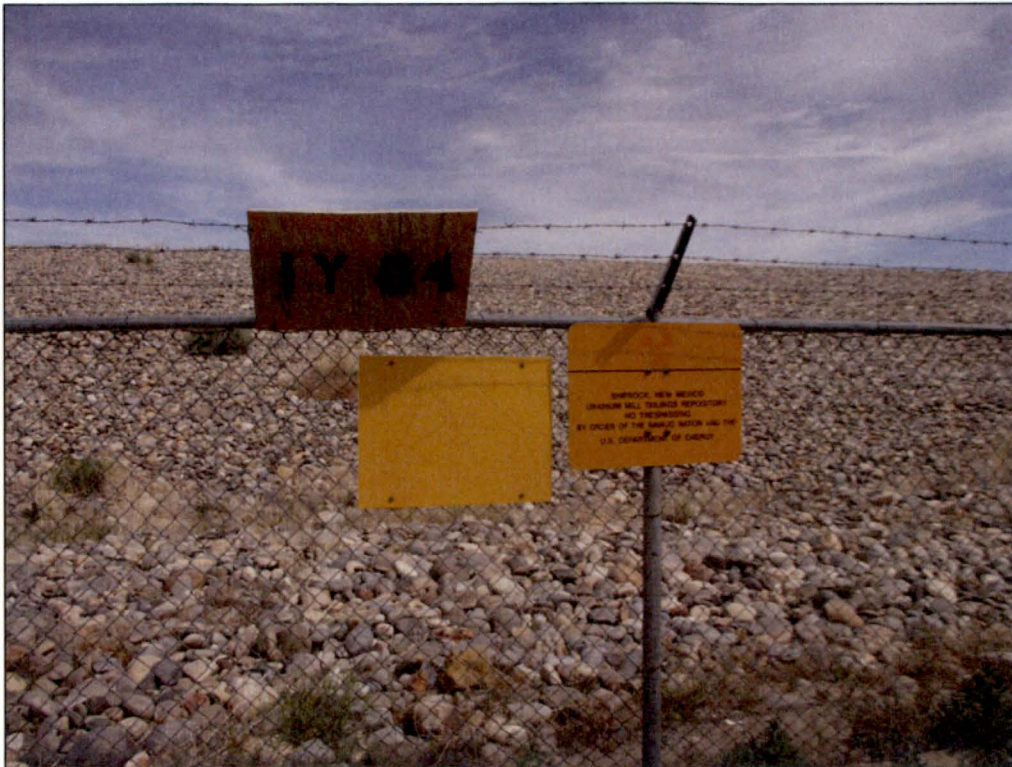
There are 17 pairs of perimeter signs, designated P1 through P17 (each pair consisting of one pictorial and one textual sign), positioned along the perimeter fence.<sup>1</sup> The pictorial signs near the southwestern entrance sign and perimeter signs P11, P12, and P17 were faded (PL-3) and were replaced following the inspection. The phone number on perimeter sign P8 was updated following the inspection. No other maintenance needs were identified.

PL-3. Faded Pictorial Perimeter Sign P11 at NECA Yard

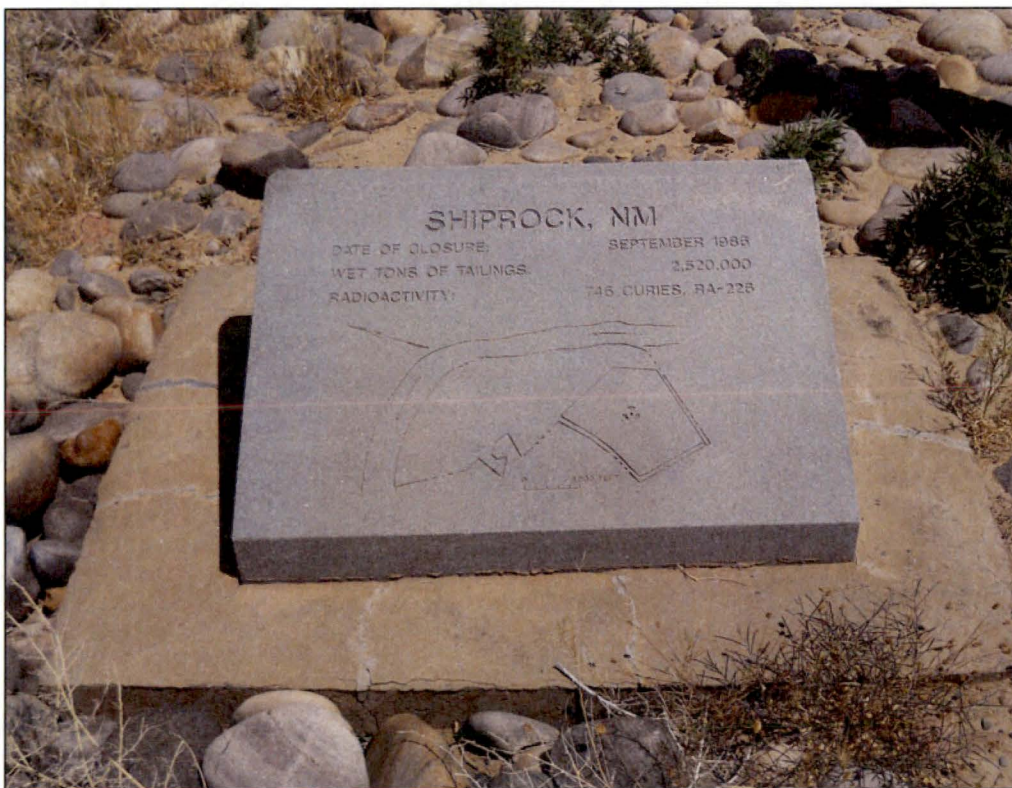
PL-4. Site Marker SMK-1

The site has two granite site markers. Site marker SMK-1 is just inside the west gate; minor cracks in its concrete base were resealed in 2018 (PL-4). Site marker SMK-2 is on the top slope of the disposal cell. No maintenance needs were identified.

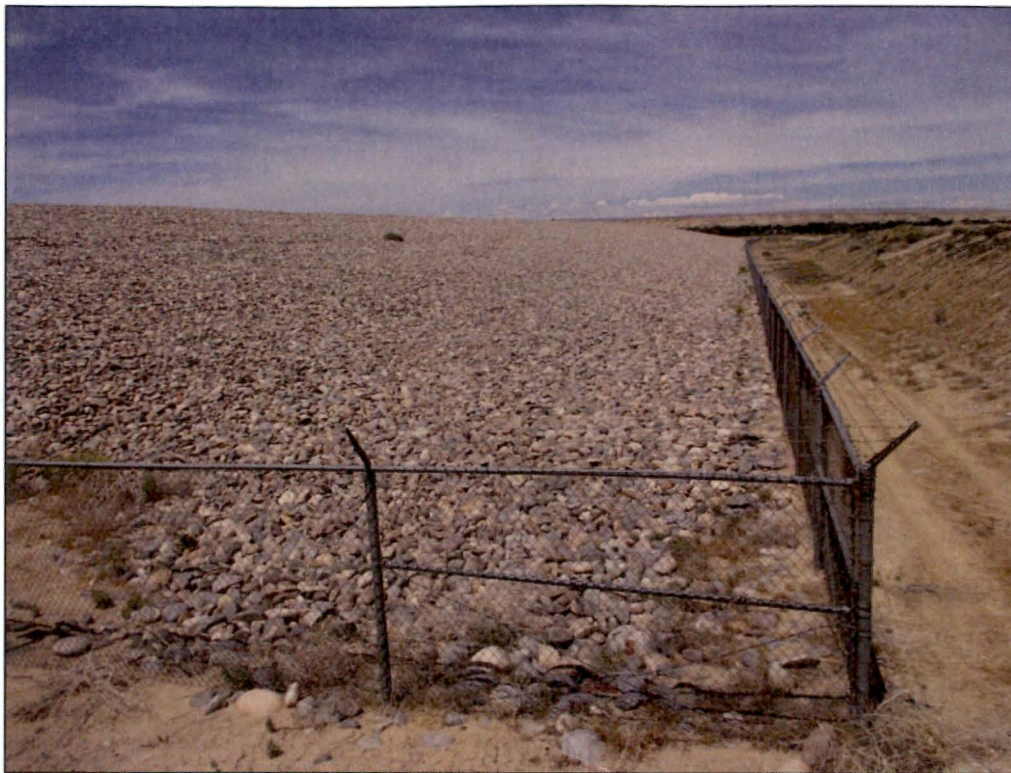
The disposal cell, completed in 1986, occupies 77 acres and is armored in riprap to control erosion and deter animal and human intrusion (PL-5). There was no evidence of erosion, settling, slumping, rock degradation, or other modifying processes that might affect the integrity of the disposal cell. Piezocones associated with a research project were installed on the disposal cell cover in the past and are no longer in use. Some of the filled piezocone pits have subsided slightly or were never completely backfilled, which resulted in shallow conical depressions in the cover. As reported in previous site inspection reports, the surface of the disposal cell contains numerous ruts associated with past vehicle traffic. An area where smaller riprap has been exposed was identified along the northern ridge of the disposal cell (PL-6). This area will be monitored for further changes that might indicate erosion or degradation of the cover. The condition of other depressions and vehicle ruts is monitored annually and has not changed significantly since the 2014 inspection.

*PL-5. Perimeter Fence and Southern Corner of Disposal Cell*

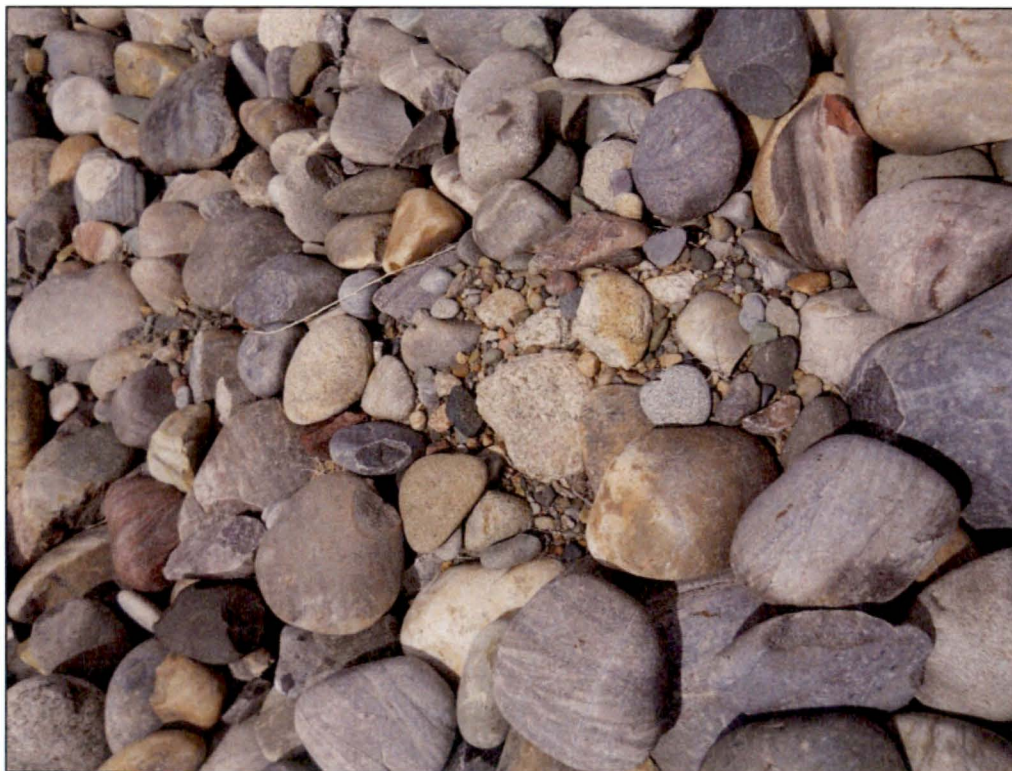
*PL-6. Exposure of Smaller Cobbles and Gravels Along Ridge of Disposal Cell*

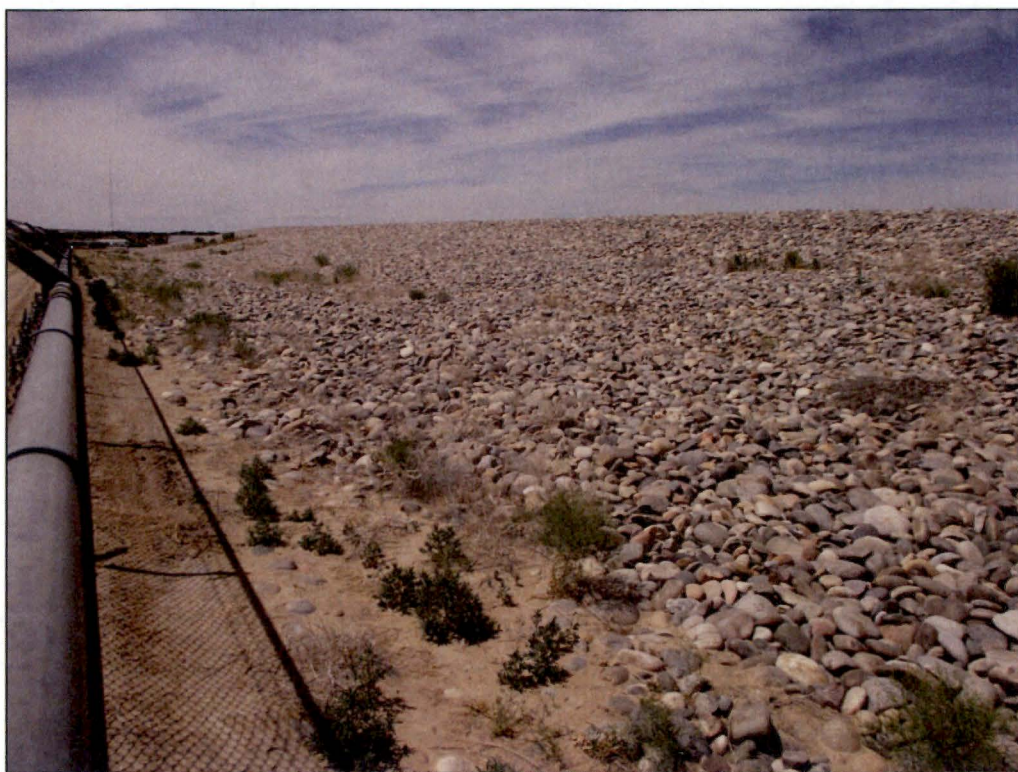
*PL-7. Sediment Accumulation in Diversion Channel Along Southwest Slope of Disposal Cell*

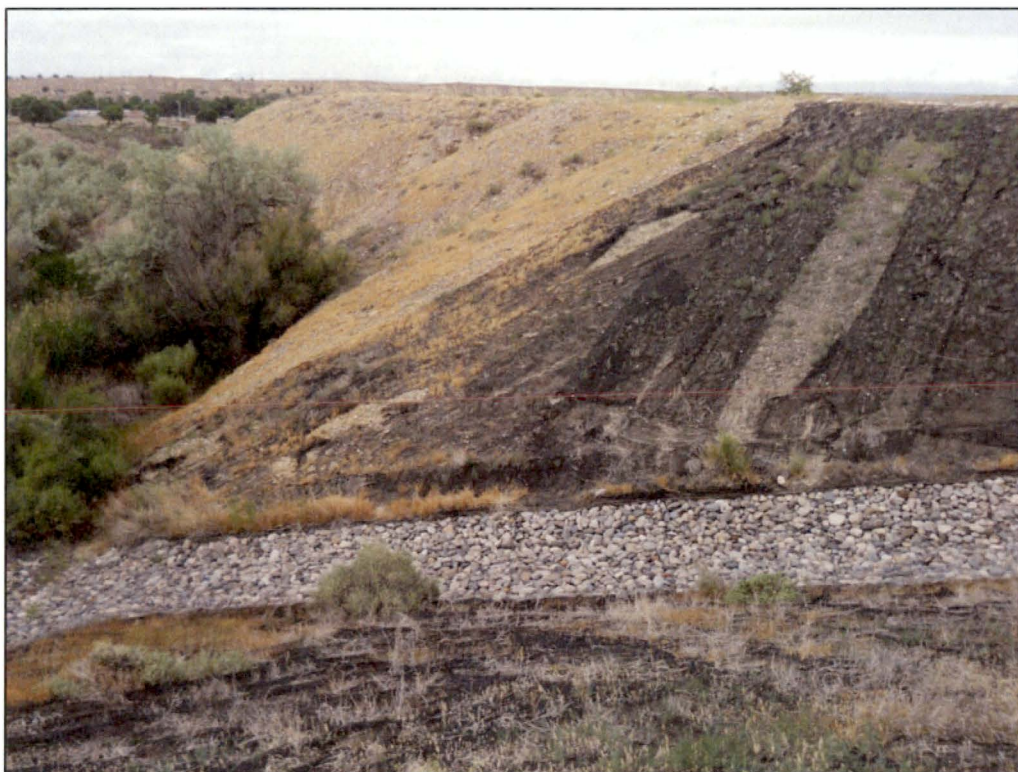
In 2002, LM constructed an 11-acre lined evaporation pond near the disposal cell as part of the groundwater compliance strategy. The pond, surrounded by a chainlink security fence, is maintained under the groundwater compliance strategy. Both the security fence and pond were intact and functional at the time of the inspection. Inspectors noted that the offsite portion of the outflow channel was functional and clear of debris. The degraded portion of the erosion control fabric on the south-facing bank of the energy dissipation basin identified during the 2018 inspection has been repaired and is functioning as intended (PL-8).

*PL-8. Revegetated Slopes at Energy Dissipation Basin*

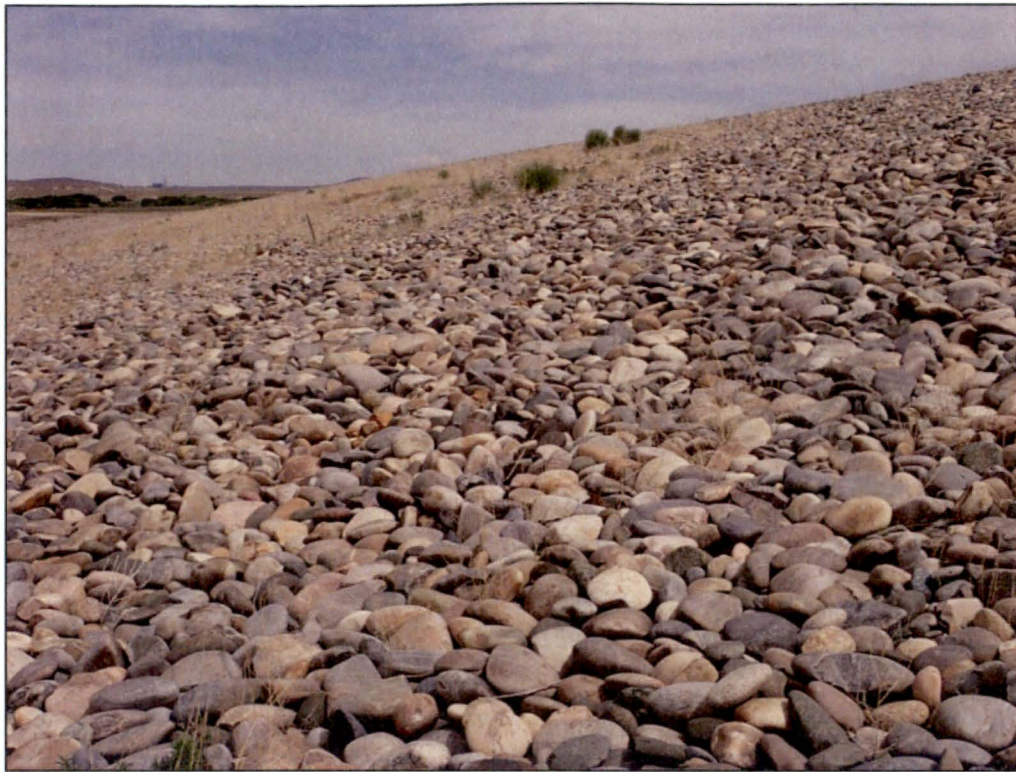
In a 1999 letter to the Navajo AML Reclamation/Uraniun Mill Tailings Remedial Action Department (Bergman-Tabbert 1999), LM committed to spraying annual weeds on the disposal cell top slope. During the inspection, annual weeds were observed growing on less than 1% of the top slope. After discussion among LM, Navajo AML, and LMS ecologists, LM recommended that it cease treatment of nonnoxious weeds on the cell and allow natural plant succession to progress. LM wrote a new letter to Navajo AML outlining its proposed vegetation management plan. Under the plan, LM would continue to treat State of New Mexico- and Navajo Nation-listed noxious weeds (primarily *Halogeton glomeratus*) in accordance with applicable laws and deep-rooted woody species in accordance with the LTSP (Kautsky 2019). Vegetation will continue to be monitored to inform future management decisions (PL-9).

*PL-9. Vegetation on Northeast Side Slope of Disposal Cell (Treated)*

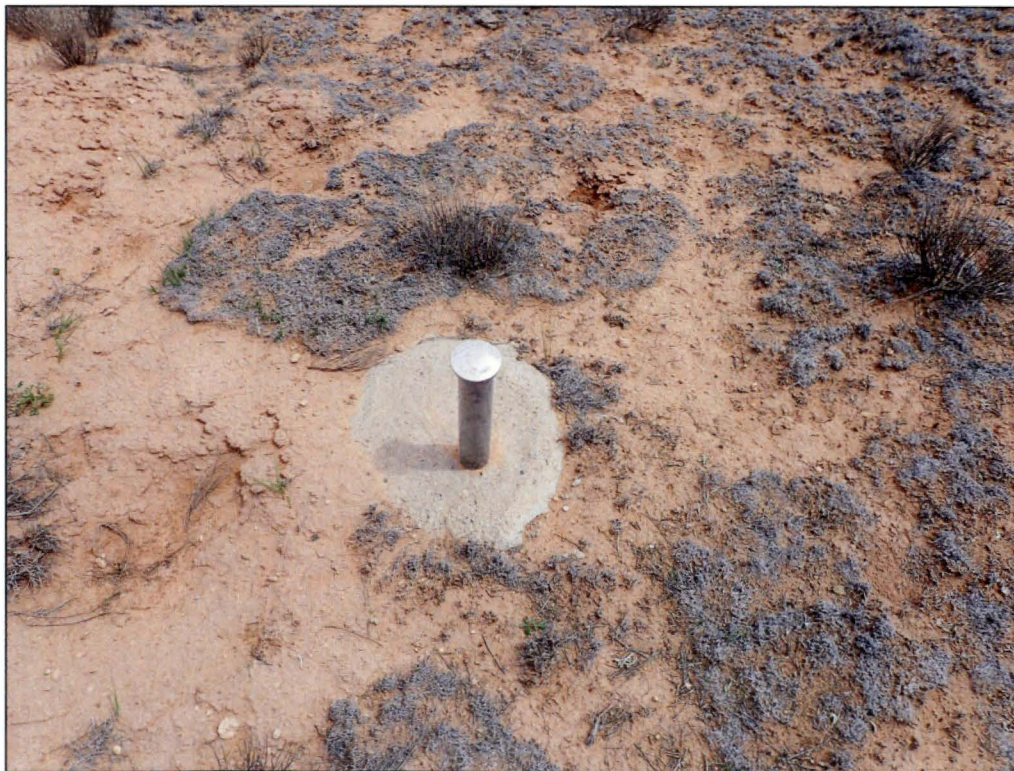
*PL-2. Boundary Monument BM-5*

The site has three survey monuments. Survey monument SM-2 was set in a low area and is frequently covered by several inches of soil. A T-post and rocks have been placed next to the monument to assist in locating this feature. Six boundary monuments delineate the corners of the site boundary (PL-2). No maintenance needs were identified.
