## 10.0 Lowman, Idaho, Disposal Site

The Lowman, Idaho, Uranium Mill Tailings Radiation Control Act (UMTRCA) Title I Disposal Site (site) was inspected on June 13, 2019. No changes were observed on the disposal cell or in the associated drainage features. Inspectors identified a minor maintenance need but found no cause for a follow-up inspection. Groundwater monitoring is not required and was discontinued in 2004.

Figure 10-1. 2019 Annual Inspection Drawing for the Lowman, Idaho, Disposal Site

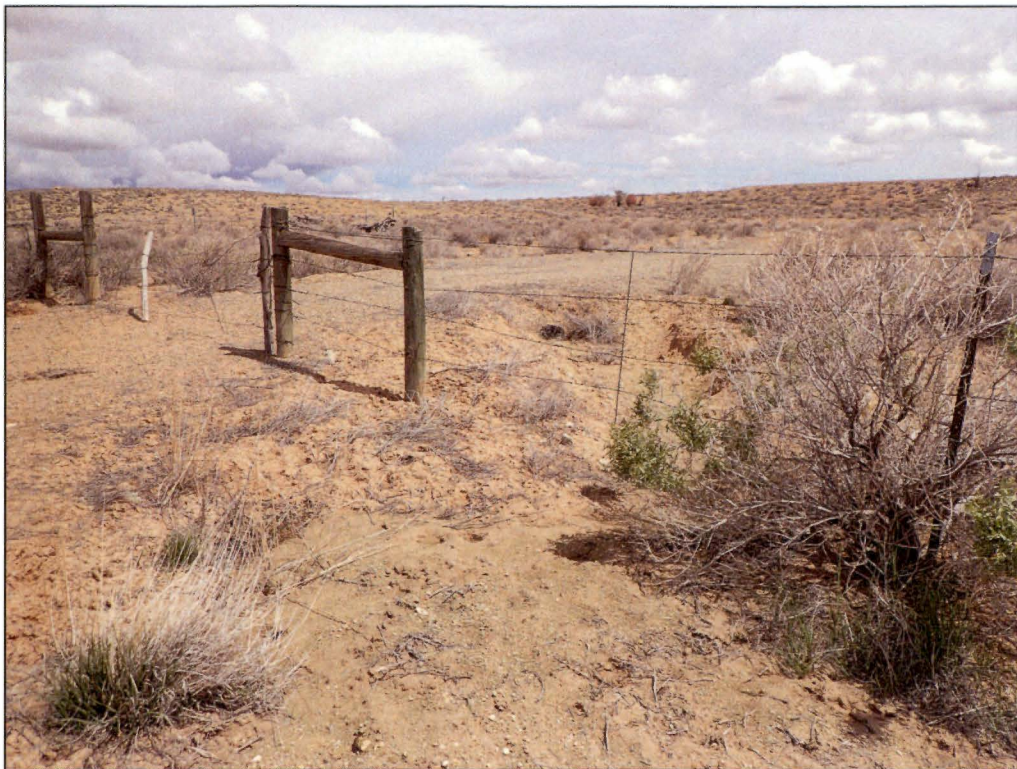
*PL-7. Woody Vegetation Next to Fence Post with Culvert at Gate Entrance*

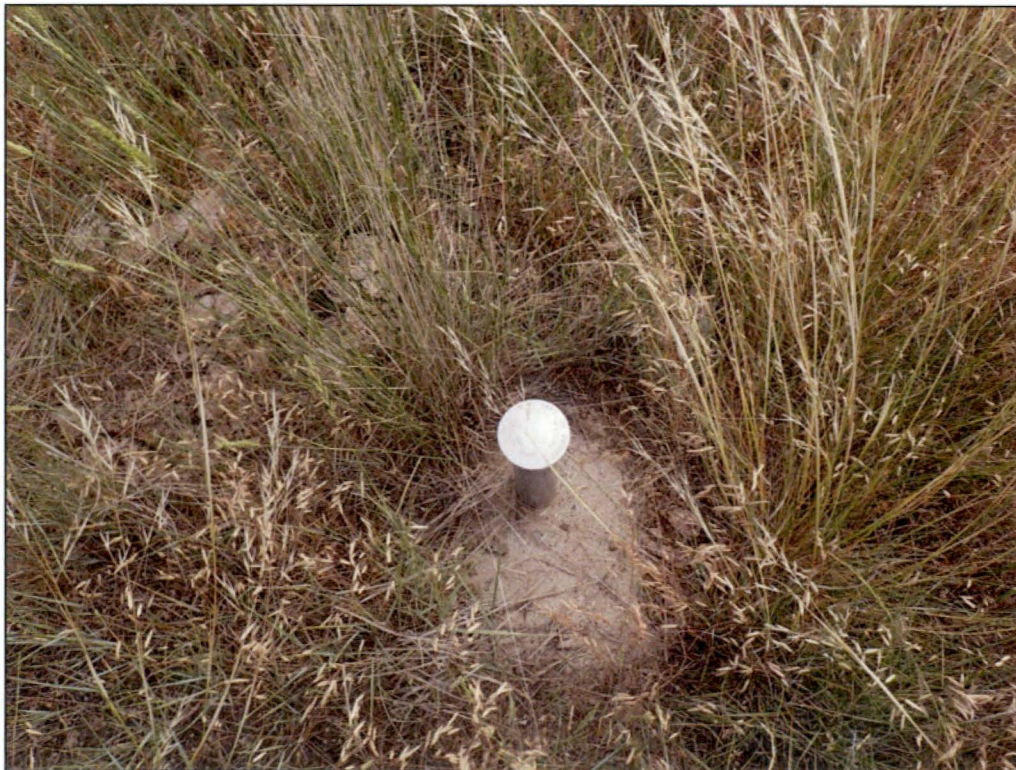
*PL-4. Boundary Monument BM-8*

The site has three survey monuments and eight boundary monuments (PL-4). Boundary monument BM-6 is bent but stable. The boundary monuments and a survey monument, as well as the perimeter signs, are outside the property boundary. The owner of the surrounding property (Hornbuckle ranch) is aware they are on his property but is not concerned. Therefore, the survey and boundary monuments and perimeter signs will remain at their current locations.

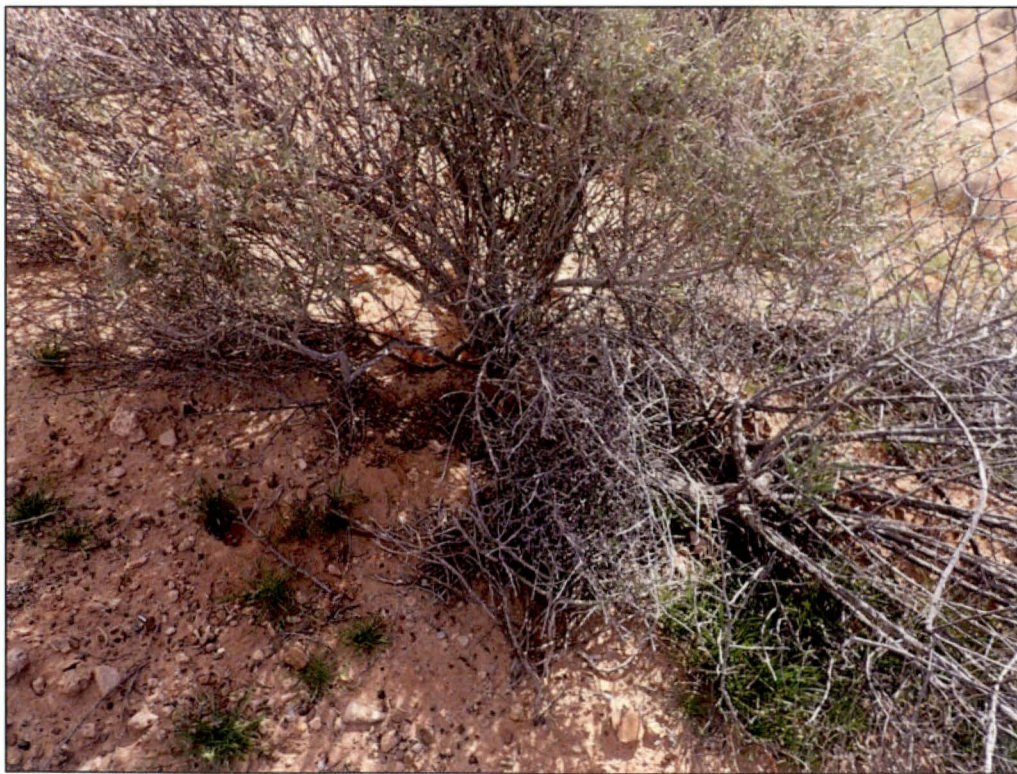
*PL-8. Shrubs Growing in Perimeter Fence Fabric (Removed Following Inspection)*

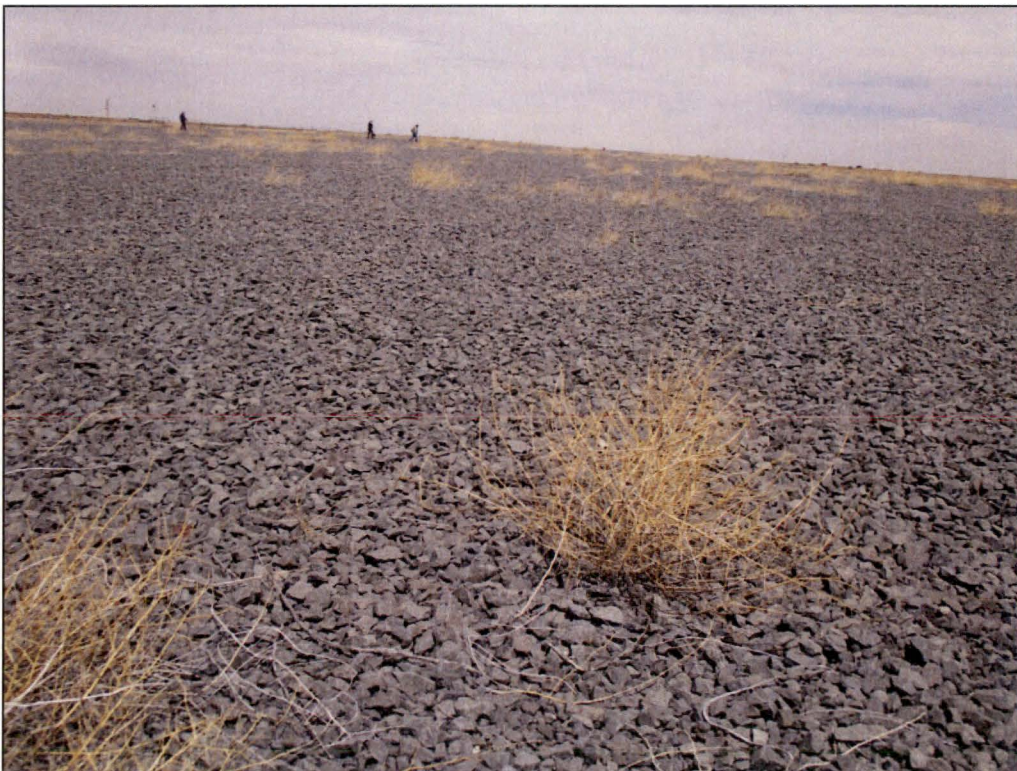
*PL-14. Annual Weeds on Disposal Cell Cover*

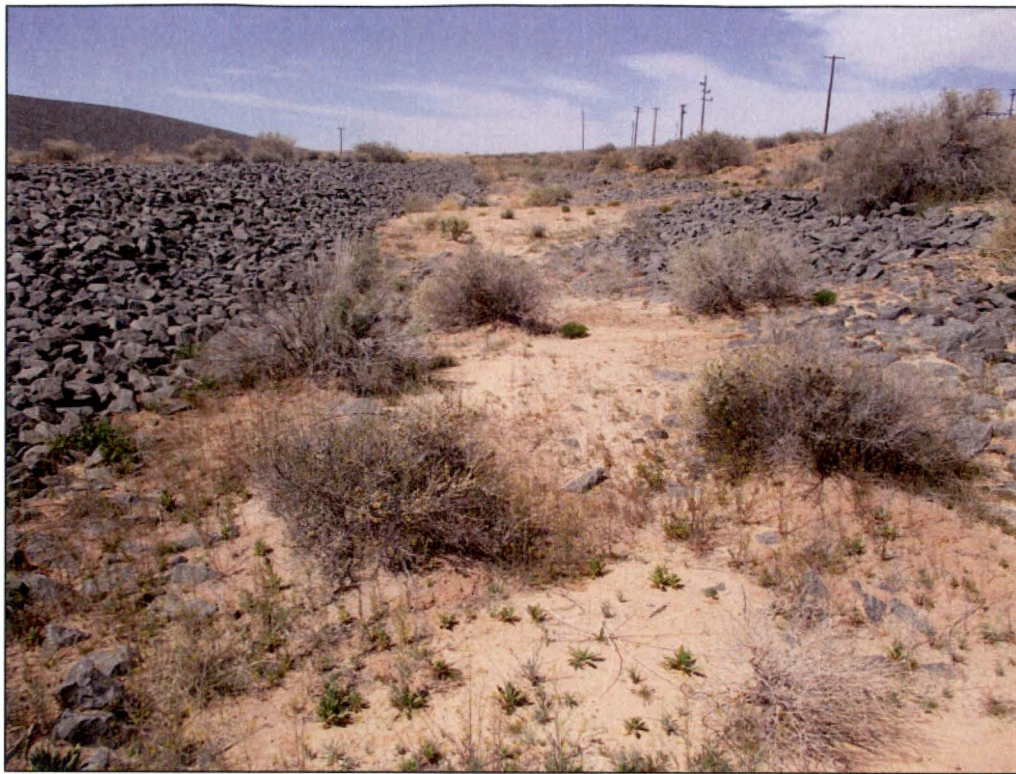
*PL-15. Sediment Accumulation and Vegetation in Diversion Channel*

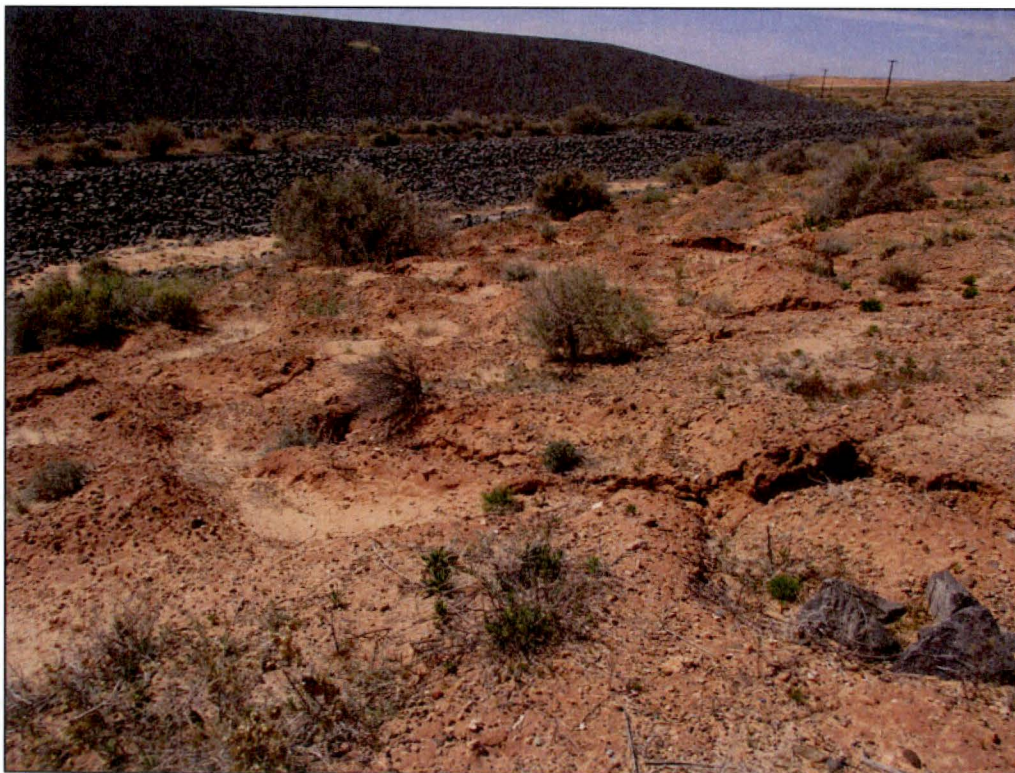
*PL-16. Soil Erosion in Reclaimed Area*
