ANALYSIS OF CHECK VALVE SWING ARMS

Task 1 Evaluation of Commercial Swing Arms FINAL REPORT

SwRI Project No. 06-3893-100

TU Electric Co.
Comanche Peak S.E.S.
P.O. Box 1002
Glen Rose, TX 76043

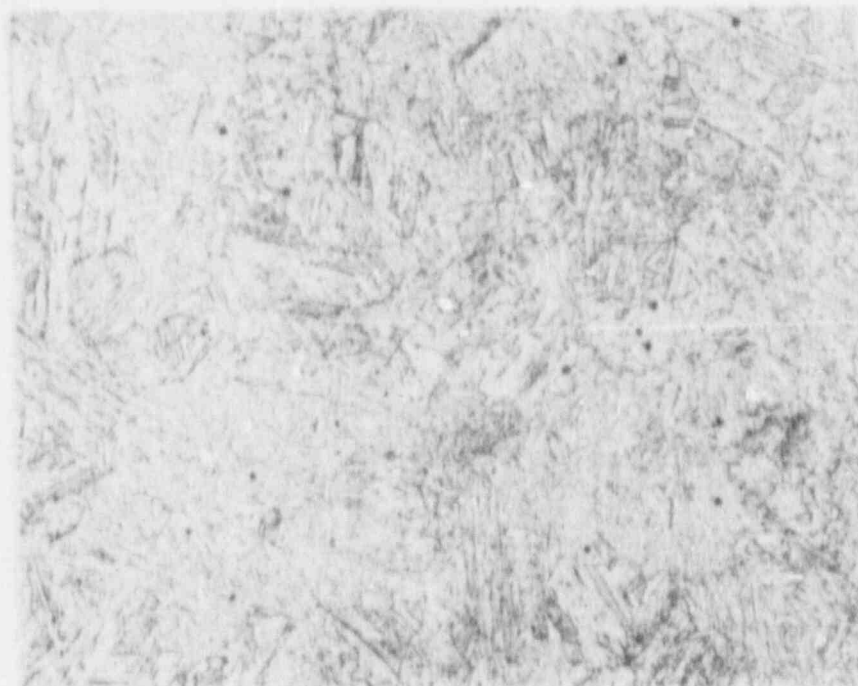
In certain cases, the ferrite content of the microstructure was found to be very low. Examples illustrating that situation are shown in Figure 4-5. The ferrite content in those photomicrographs is on the order of 1% or less. Three of the four 3-inch swing arms (Nos. 261, 262, 263) were characterized by a very low ferrite content.

(a) Section A-A, Sample No. 261 (3-in.).

(b) Section C-C, Sample No. 263 (3-in.).

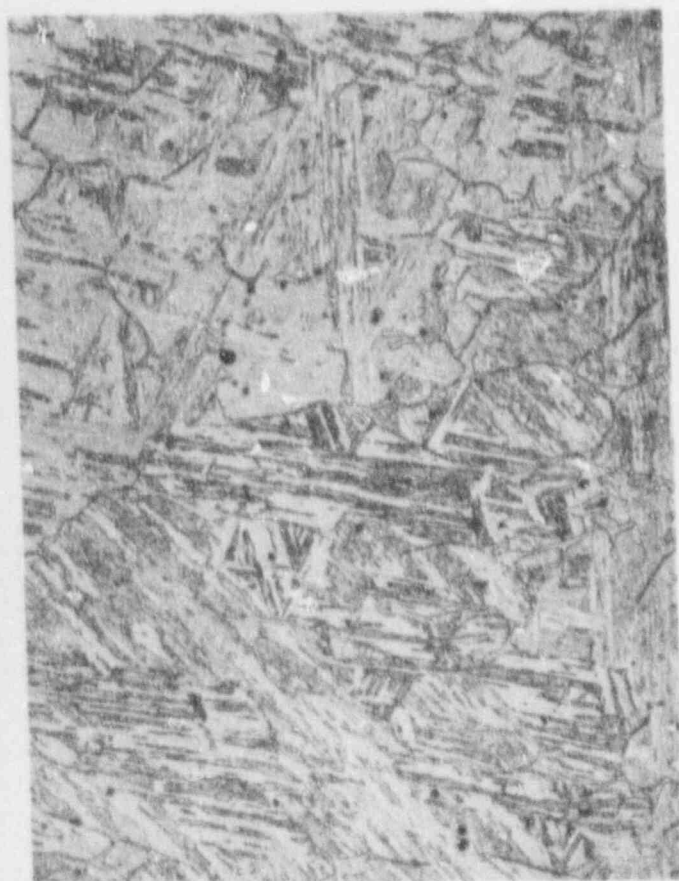
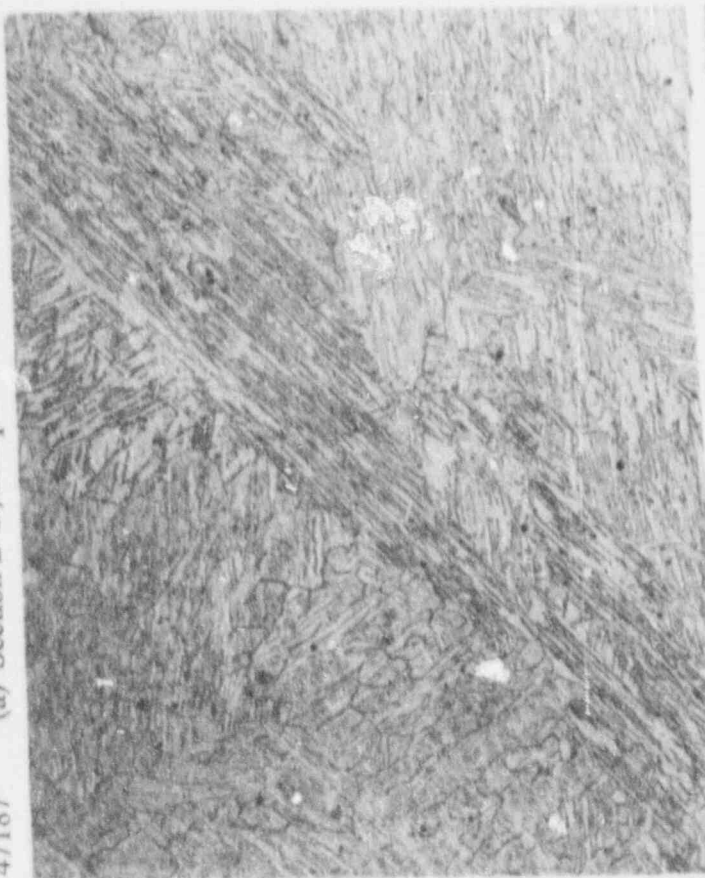
Three samples [Nos. 239 (16-in.), No. 242 (8-in.) and No. 257 (6-in.)] exhibited a matrix with distinctly different microstructural features from those described above. Examples of this type of microstructure are shown in Figures 4-6(a) and 4-6(b). These structures are also martensitic but are characterized by coarse martensite needles some of which are extremely long in particular grains. These features probably reflect some differences in thermal history from the group described earlier, but it should be noted that there were no consistent, notable differences in composition or hardness of these three samples as compared to the entire group. The hardness of two of the samples (Nos. 242 and 257) did tend toward the high side of the hardness range, however.

47187 (a) Section B-B, Sample No. 242 (8-in.) 200X

FIGURE 4-6. MICROSTRUCTURAL FEATURES OF
CAST 17-4PH SWING ARMS. Etchant:
Vilella's reagent

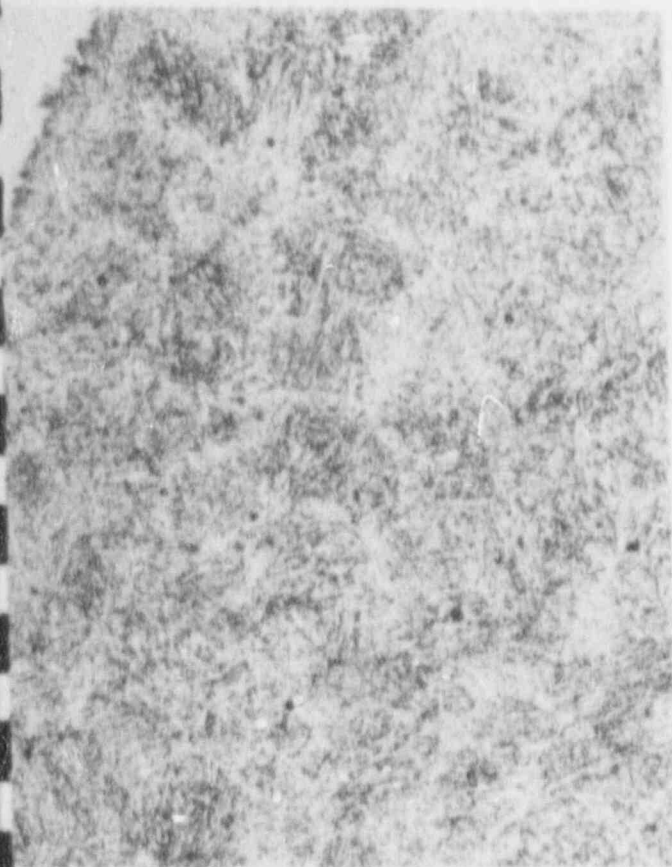
FIGURE 4-11. HAZ OF WELD REPAIR IN SAMPLE NO. 240 (16-in.). Section through disk attachment boss in plane normal to boss centerline. Etchant: Vilella's reagent

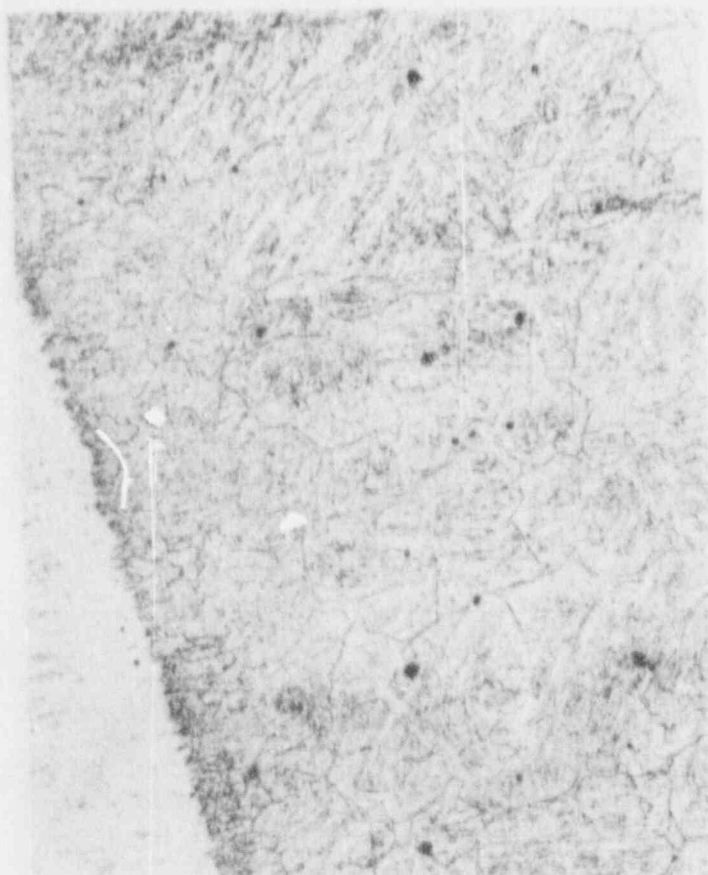
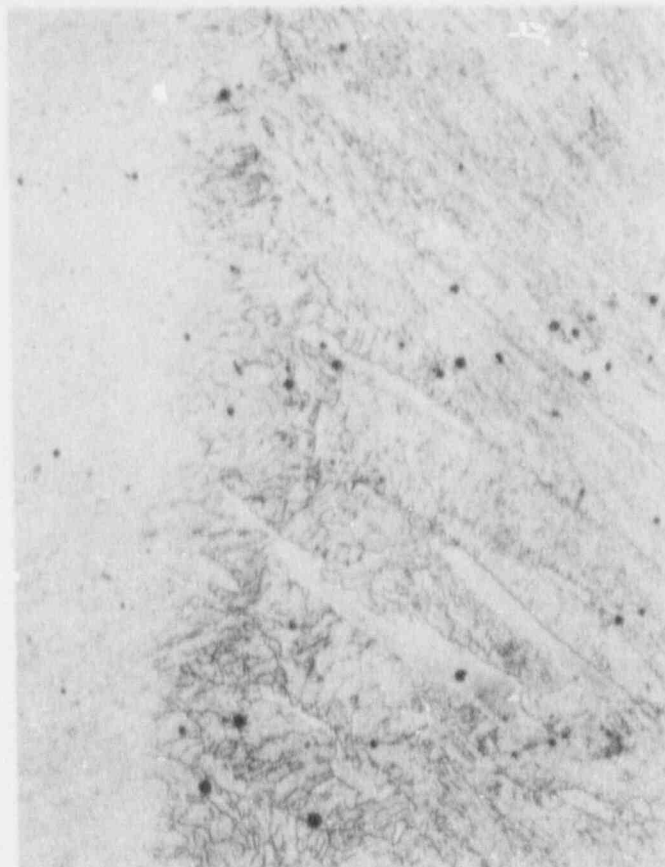
immediately adjacent to the fusion lines in Samples No. 256 (6-in.) and No. 245 (4-in.), see Figures 4-12(b) and 4-13. These microstructural features at the weld repairs indicate that these three samples (No. 243, 246 and 256) were properly heat treated after the weld repairs.

**FIGURE 4-12. MICROSTRUCTURES OF WELD REPAIRS
IN SAMPLES NO. 243 (8-in.) AND 256 (6-in.).**
Etchant: Vilella's reagent

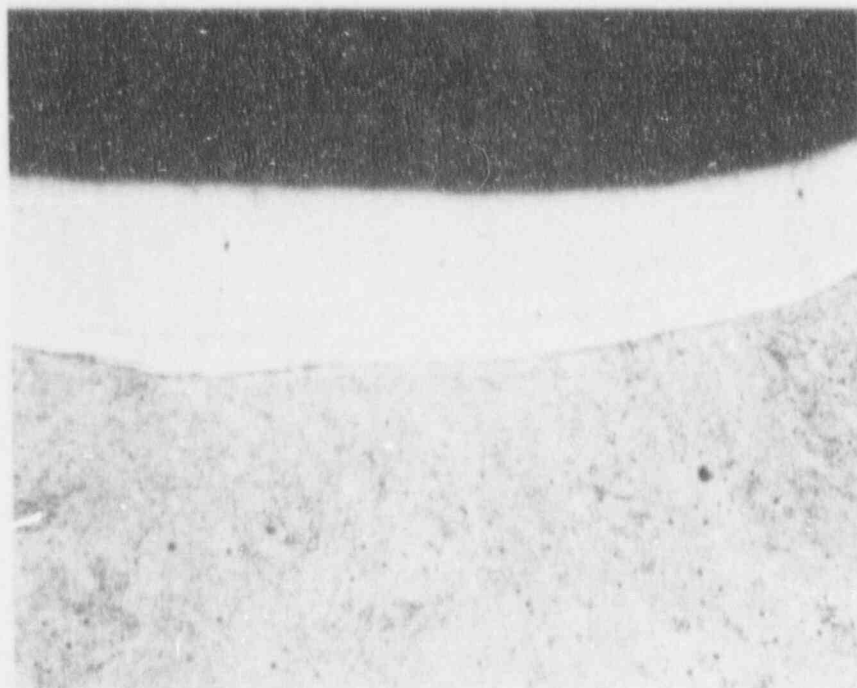
It should be noted that, even though the weld was made with an austenitic filler metal, no specific defects such as voids, lack-of-fusion or underbead cracking were observed in those weld repairs which were sectioned. Also, Figure 4-13 illustrates that the weld repair in that case was only 0.06-in. deep. Similar, relatively shallow penetration was also observed in other cases of repairs at locations outside of the disk attachment bosses.

FIGURE 4-13. MICROSTRUCTURE OF WELD REPAIR -
SAMPLE NO. 245 (4-in.). Section B-B.
 Etchant: Vilella's reagent

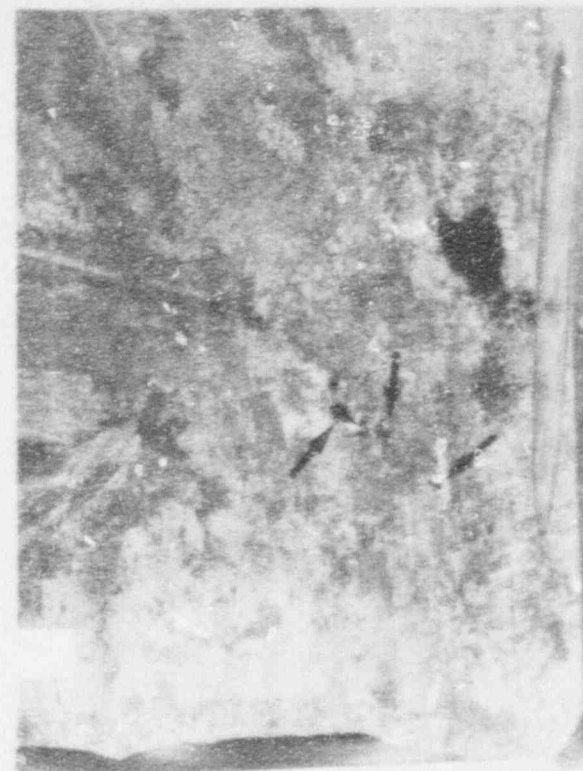
The second radiographic indication in Sample No. 240 was located within the curved portion of the arm near the hinge boss, see Figure 5-1. Section B₀-B₀ was cut to intersect the flaw indication. A cluster of voids was clearly evident on each side of this initial cut and sequential sections were examined in both directions from Section B₀-B₀. Photomicrographs from these sections are shown in Figures 5-5 and 5-6. In each of the three sections closest to the center of the indication, the void cluster consisted of one or more relatively large voids (largest dimension on the order of 0.05-inch) with several much smaller voids in the immediate vicinity [see Figures 5-5(b) and (c) and 5-6(a)]. Of the two outer sections, one exhibited a cluster of very small voids [Figure 5-6(b)] and the other contained a small fissure [Figure 5-5(a)]. These features indicate that the outermost sections were located at or near the extremities of the flaw and serve to establish the maximum dimension of the flawed zone. A diagram showing the extent of the flawed zone is shown in Figure 5-7. Since the metallographic sections identified the flaw as a cluster of voids rather than a single large void or a discrete crack-type feature, the flaw zone in Figure 5-7 is dimensioned to represent a volume which completely contains the void cluster. Note that the outlined areas in Figure 5-7 represent the projections of the volume on the top and side of the arm. The cross sections shown in Figures 5-5 and 5-6 must be considered to view the actual shape of the flawed zone. In this case, the flaw may be considered as a thin, irregular volume lying on a warped surface and containing a concentration of small voids. Considering the volume as a single, open void, the maximum cross-sectional void area would be only 0.01-in.² or less.

47963 (a) Section B_o-B_o - 0.34-in. As polished. 16X

47960 (c) Section B_o-B_o. Etched 4X

47959 (b) Section B_o-B_o - 0.06-in. Etched 4X

FIGURE 5-5. TRANSVERSE SECTIONS FROM SAMPLE NO. 240. Sec Figure 5-1 for locations. Arrows mark larger voids in (b) and (c).

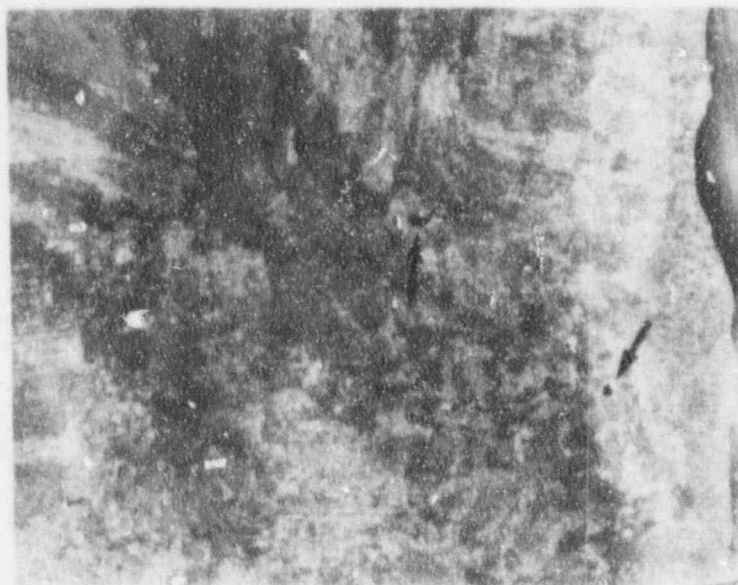
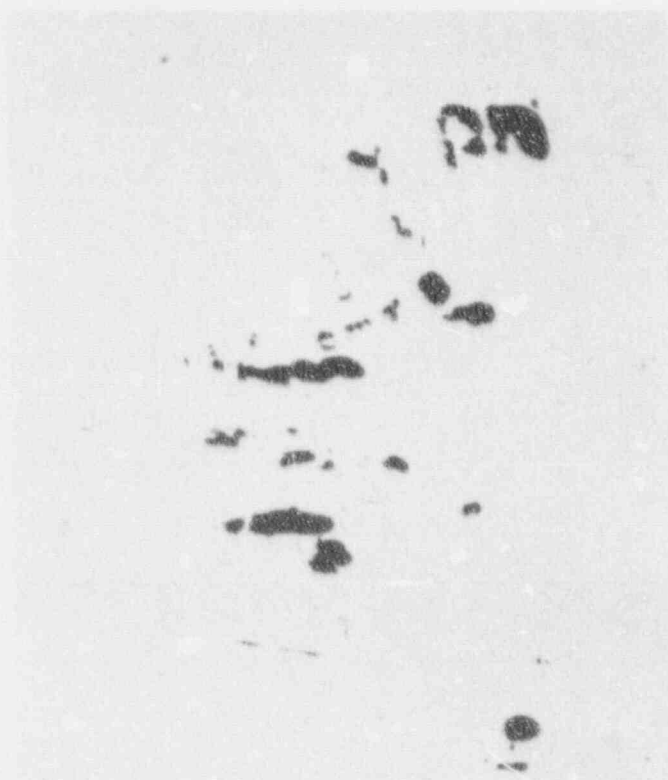
(a) Section $B_0-B_0 + 0.30$ -in. Etched.
Arrows mark larger voids.

(b) Section $B_0-B_0 + 0.36$ -in. As polished.

FIGURE 5-6. TRANSVERSE SECTIONS FROM SAMPLE NO. 240.
See Figures 5-1 and 5-7 for locations.

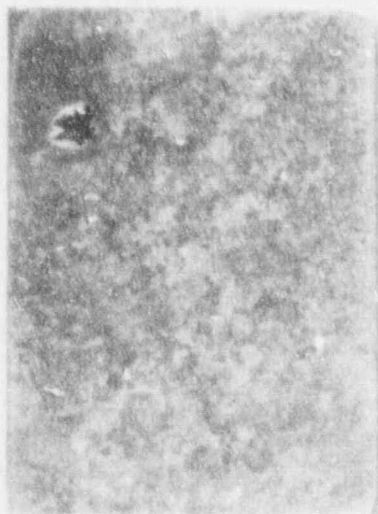
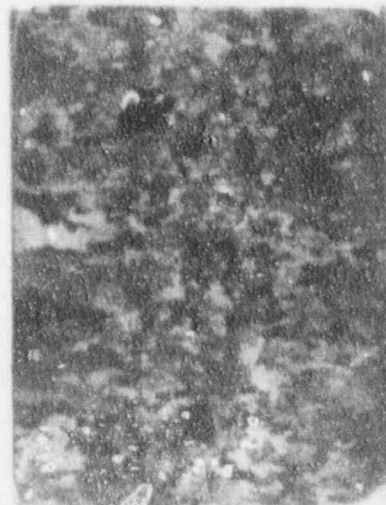
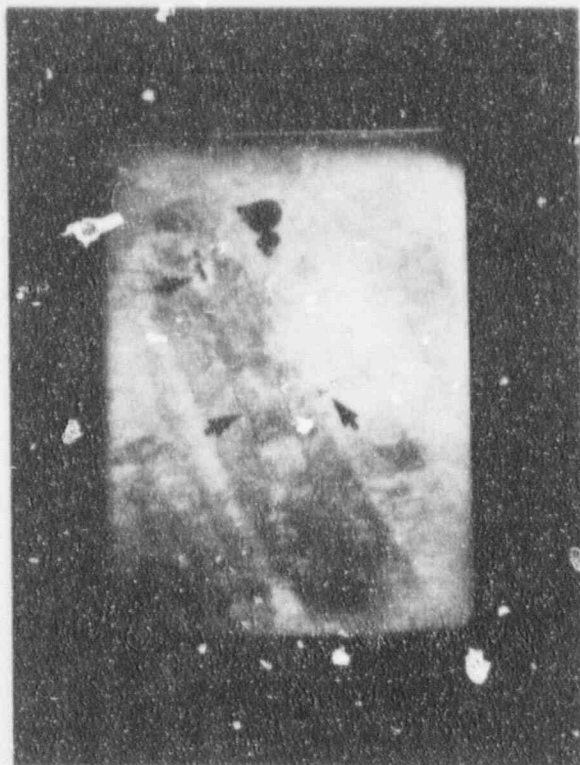
The longitudinal sections revealed a large, elongated void oriented essentially normal to the long axis of the arm. Photomicrographs from selected longitudinal sections are shown in Figure 5-8. In these sections, the void is roughly circular in cross section with a maximum dimension on the order of 0.16-inch. Near the centerline of the arm, the character of the flaw changed from a single large void to clusters of very small voids as shown in Figure 5-9. Further grinding eliminated the flaw.

(c) Section A₁-A₁ + 0.68-in. Note small voids at arrows.

FIGURE 5-8. LONGITUDINAL SECTIONS FROM SAMPLE NO. 255. See Figure 5-11.

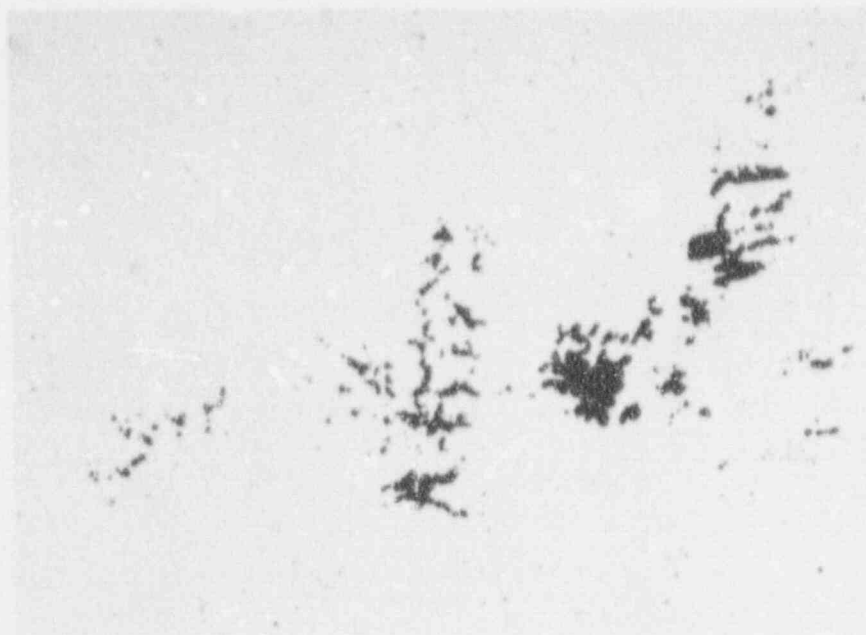
**FIGURE 5-9. LONGITUDINAL SECTION FROM
SAMPLE NO. 255 (10-in). See Figure 5-11.
Section $A_1-A_1 + 0.88$ -in. As polished.**

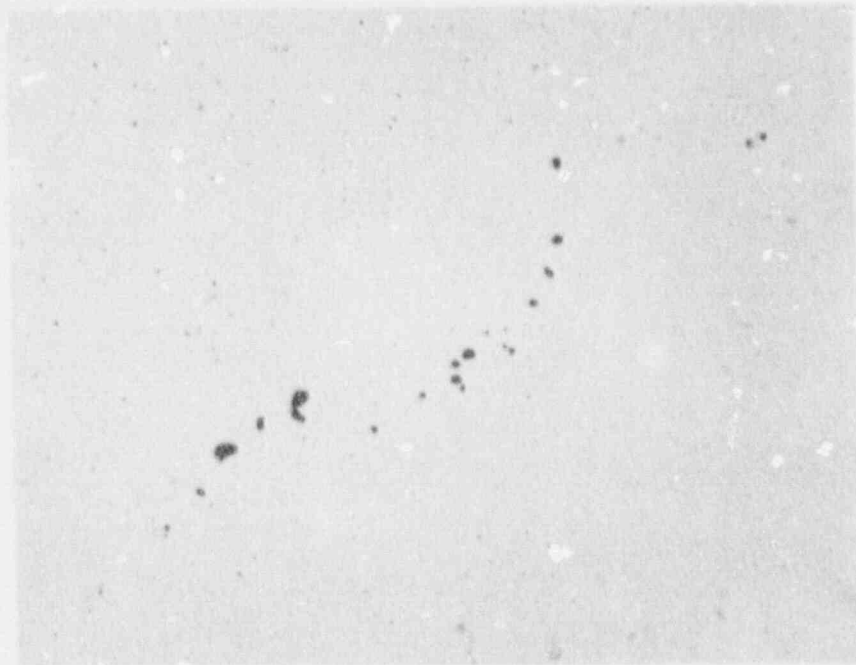
Sample No. 242, one of the two 8-in. swing arms, exhibited a single, Level 2 radiographic indication similar to those recorded for Samples 239 and 240. This indication was located in the straight portion of the arm approximately 2 inches from the centerline of the valve disk boss. Multiple transverse sections through the zone of the indications were examined and representative photomicrographs are shown in Figures 5-12 through 5-15. In each cross section, the flaw appeared as a cluster of small voids with the most severe condition shown in Figure 5-15. It should be noted that in Figures 5-14 and 5-15 some of the voids are aligned in the vertical direction, an orientation that would contribute to a strong radiographic indication in a through-thickness radiograph.

FIGURE 5-12. TRANSVERSE SECTIONS FROM SAMPLE NO. 242 (8-in.).
See Figure 5-16 for locations. As polished.

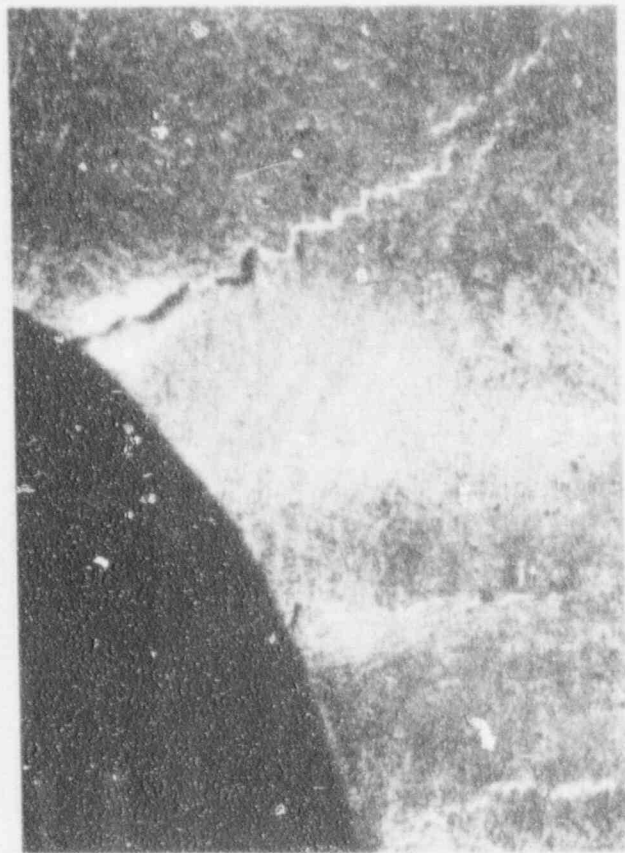
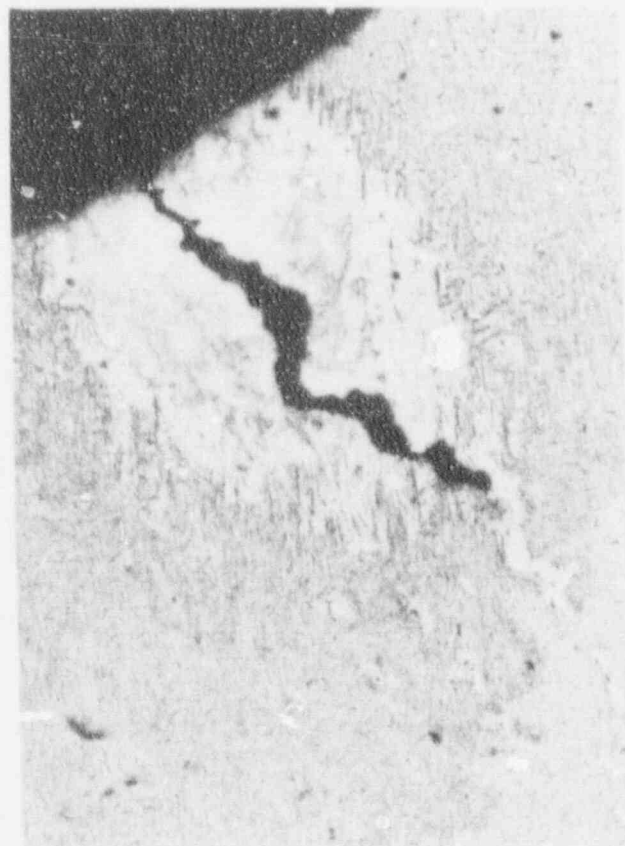
A distinct, surface connected shrinkage crack (hot crack) was present at the valve disk boss of Sample No. 255 (10-in.), see Figure 5-17. The crack was located in the radius at the boss and was oriented transverse to the long axis of the arm. In this case, a light etching zone was present around the crack indicating a localized variation in composition. The light etching zone extended beyond the crack tip along an intergranular path. Sequential sectioning established that the crack extended almost half-way across the arm with a maximum length on the top surface of 0.93-inch. The maximum depth measured in the several sections was 0.07-inch [Figure 5-17(a)].

FIGURE 5-17. SURFACE CONNECTED FLAW IN SAMPLE NO. 255 (10-in.). Note different magnifications. Section designations correspond to Figure 4-1. Etchant: Vilella's reagent

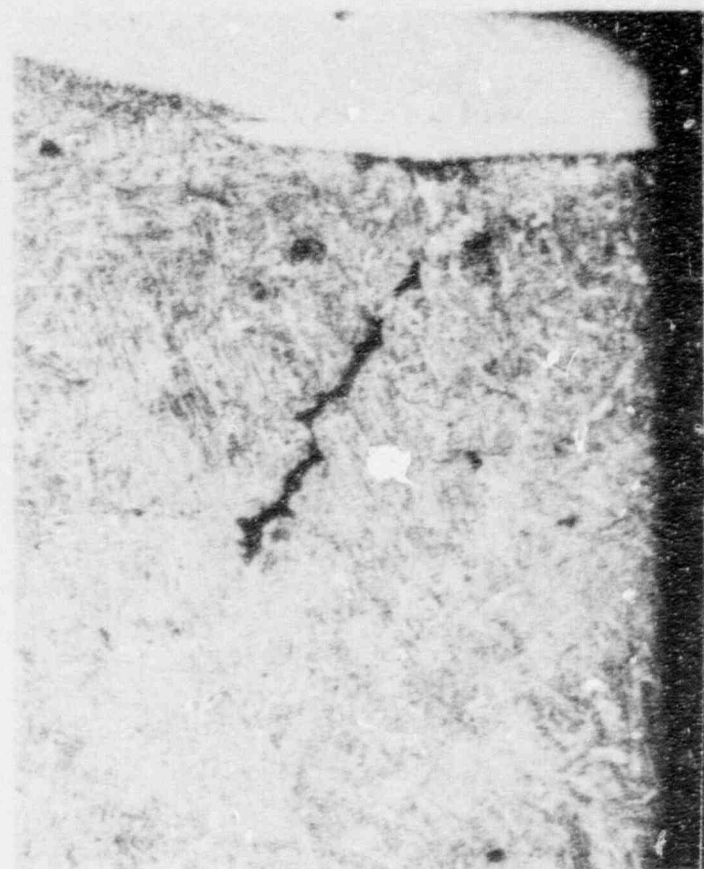
- (a) Sample No. 245 (4-in.).
Section B-B, Figure 4-1.
Right-hand edge is bore of
valve disk boss. Repair
weld is at top of boss.

FIGURE 5-19. MICROFISSURES IN 4-in. AND 3-in. SWING ARMS. Etchant: Vilella's reagent

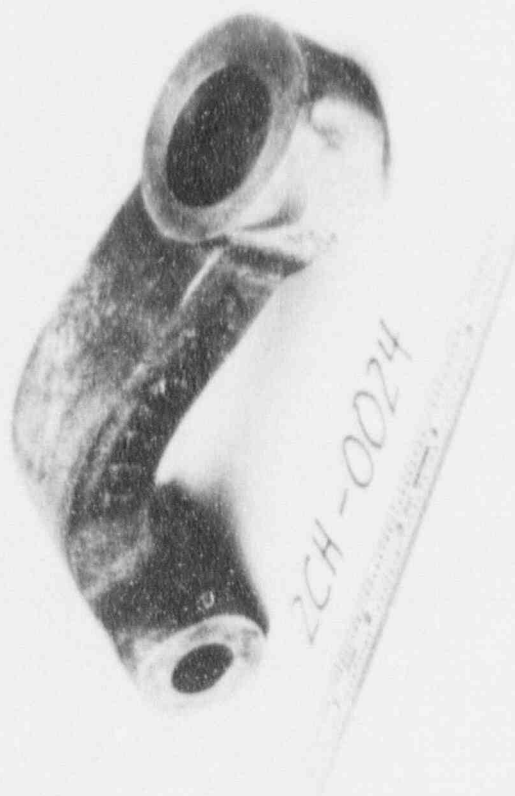
FIGURE A-8. SAMPLE NO. 257, 6-INCH CHECK VALVE. Dimensions in inches. Diagram is schematic.

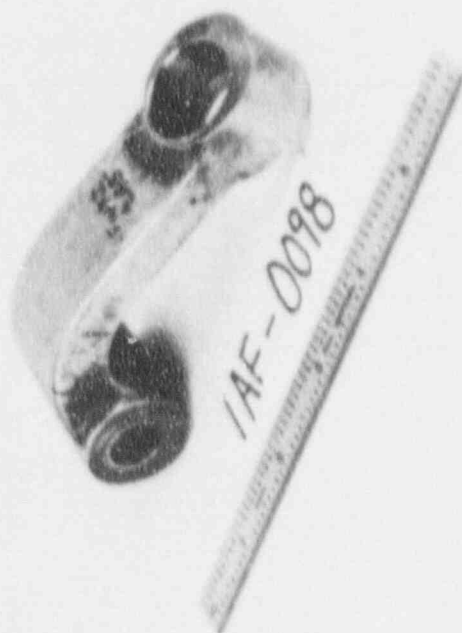
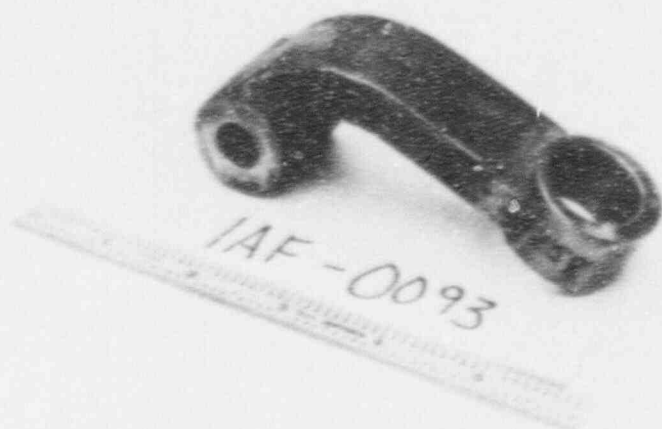
FIGURE A-9. SAMPLE NO. 245, 4-INCH CHECK VALVE. Dimensions in inches. Diagram is schematic.

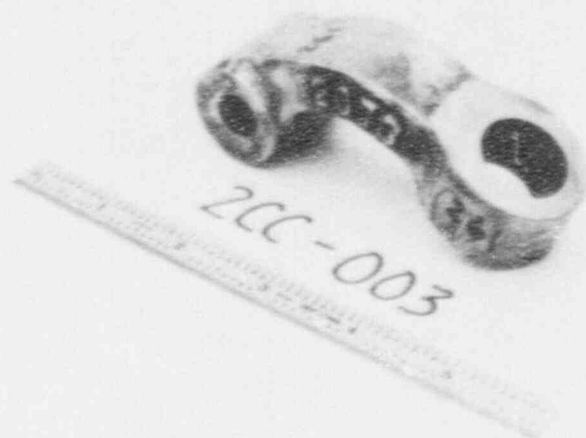
FIGURE A-13. SAMPLE NO. 746, 3-INCH CHECK VALVE. Dimensions in inches. Diagram is schematic.

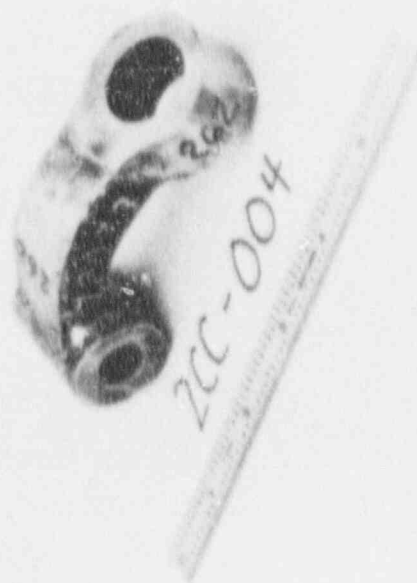
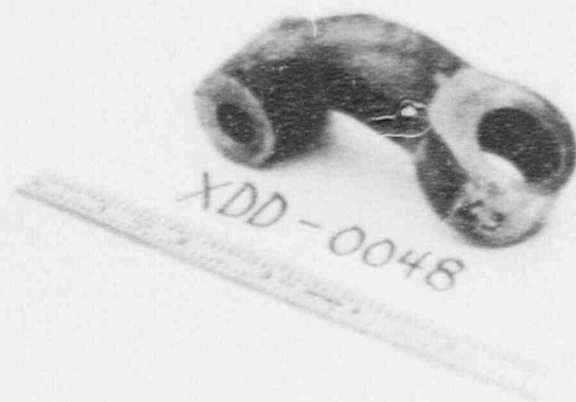
FIGURE A-15. SAMPLE NO. 262, 3-INCH CHECK VALVE. Dimensions in inches. Diagram is schematic.

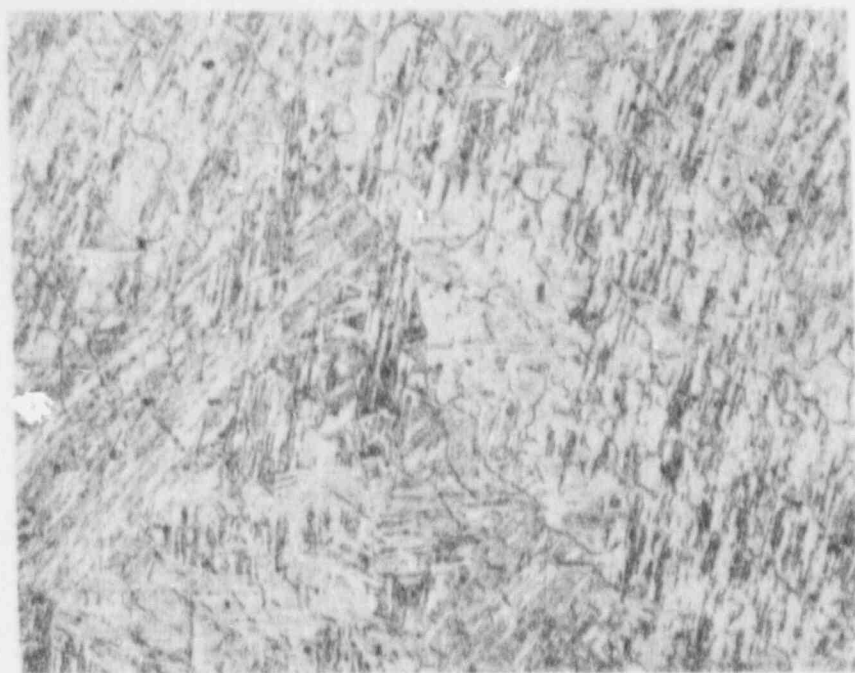
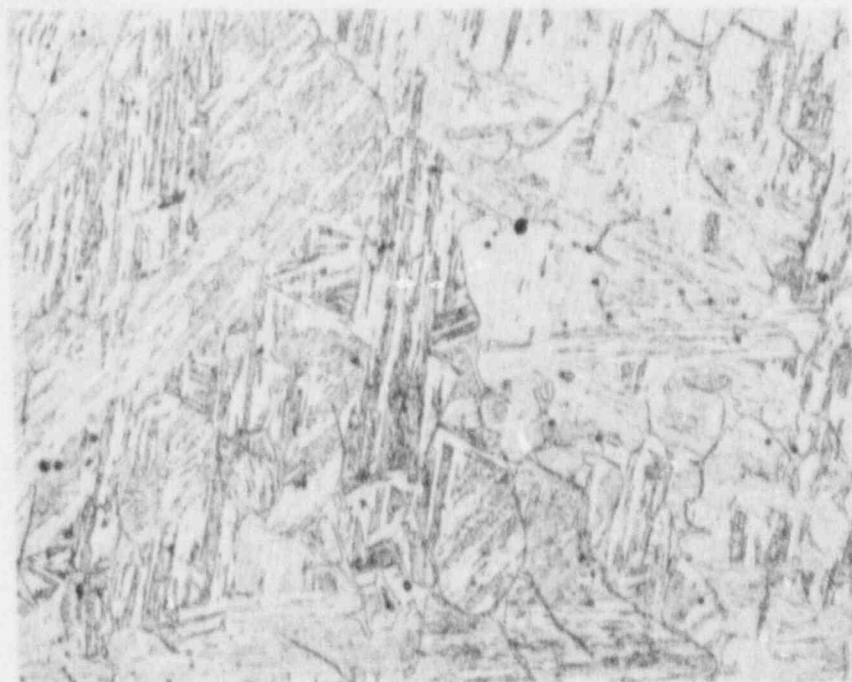
FIGURE B-4. TYPICAL MICROSTRUCTURE OF SAMPLE NO. 242 (8-in.). Section B-B. (See Figure B-5). Etchant: Vilella's reagent

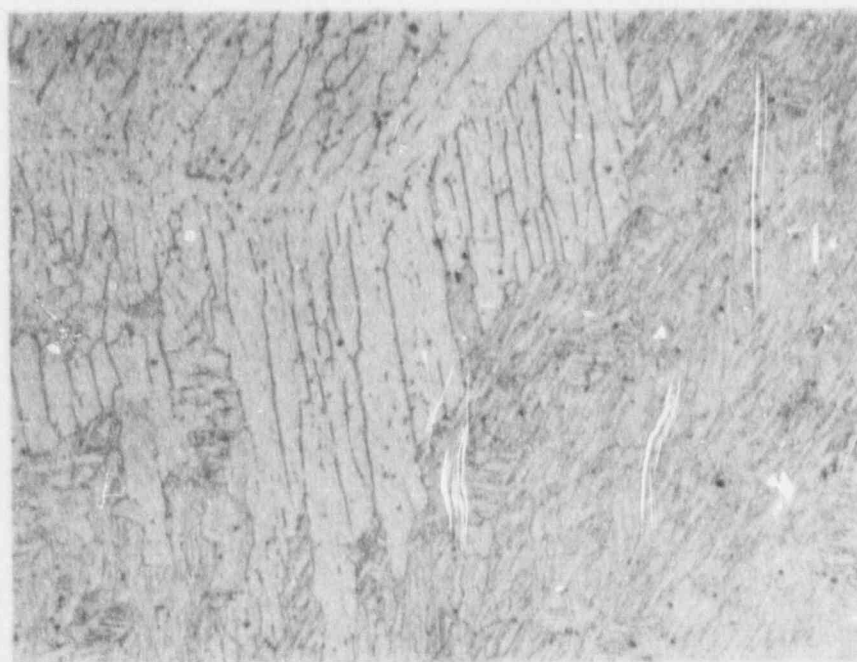
FIGURE B-5. MICROSTRUCTURE OF SAMPLE NO. 242 (8-in.).
See Figure B-4. Etchant: Vilella's reagent

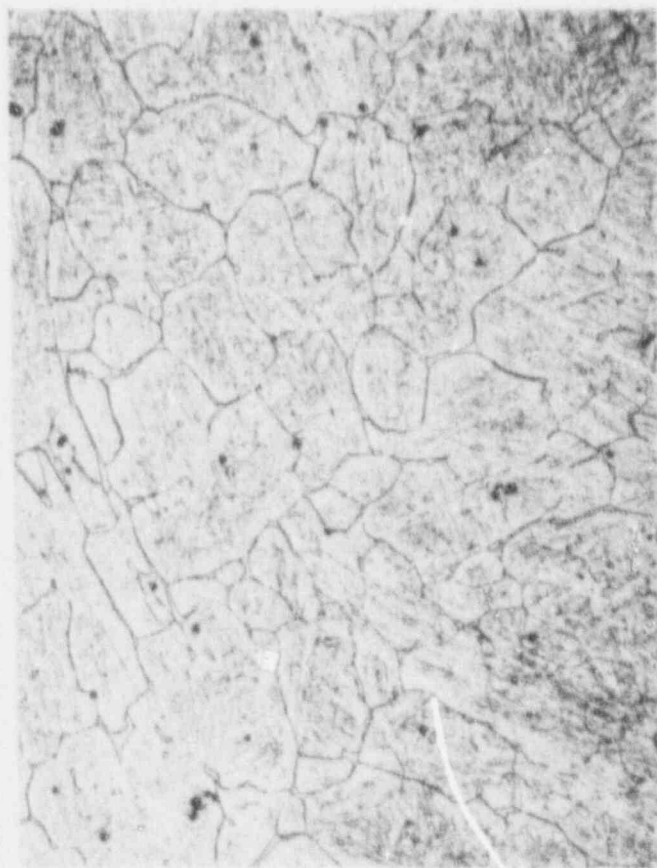
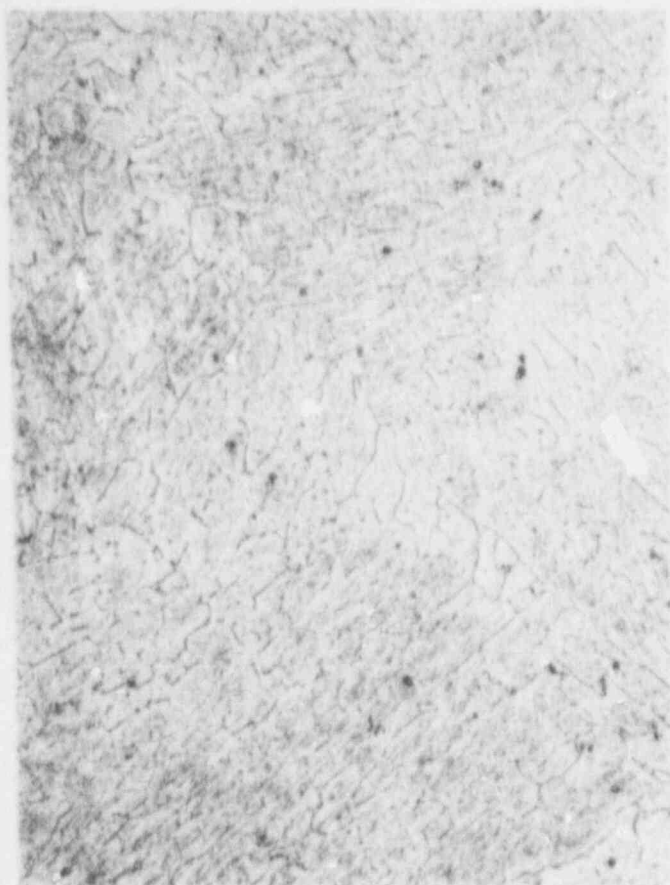
(a) Typical structure.

(b) Localized directional features.

FIGURE B-6. MICROSTRUCTURE OF SAMPLE NO. 243 (8-in.). Etchant: Vilella's reagent

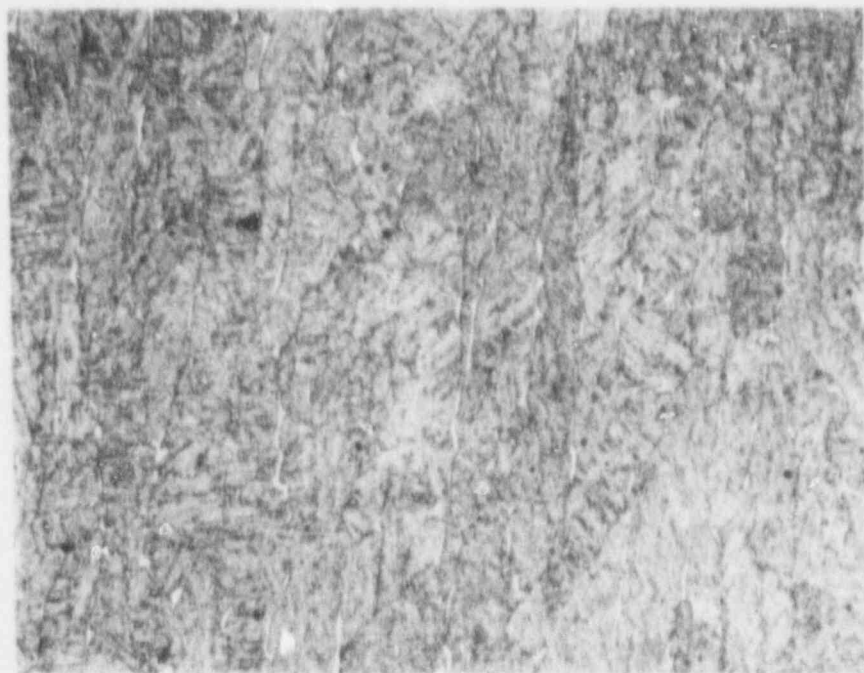
FIGURE B-7. TYPICAL MICROSTRUCTURE OF SAMPLE NO. 244 (6-in.). See Figure B-8. Etchant: Vilella's reagent

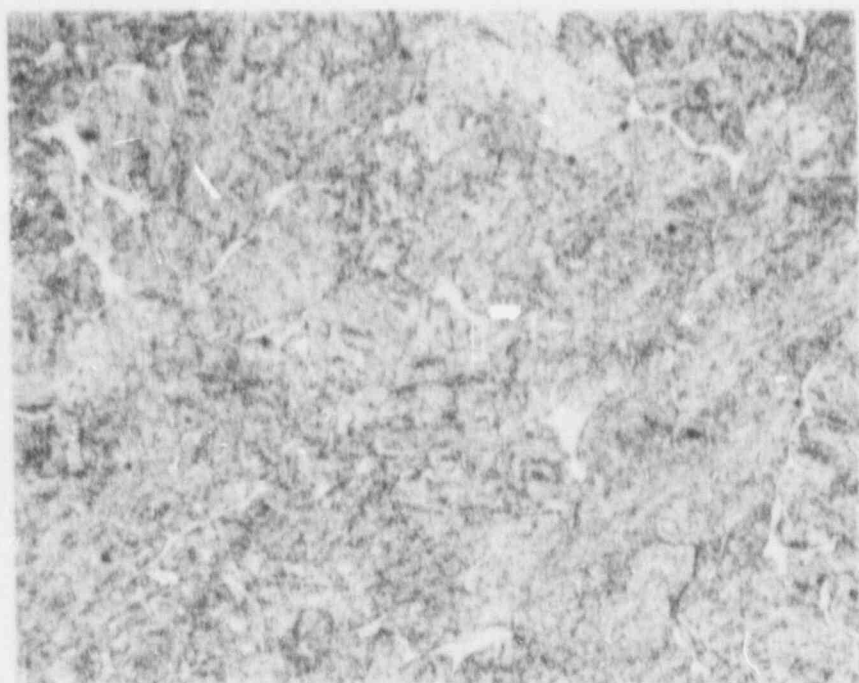
FIGURE B-8. MICROSTRUCTURE OF SAMPLE NO. 244 (6-in.).
See Figure B-7. Etchant: Vilella's reagent

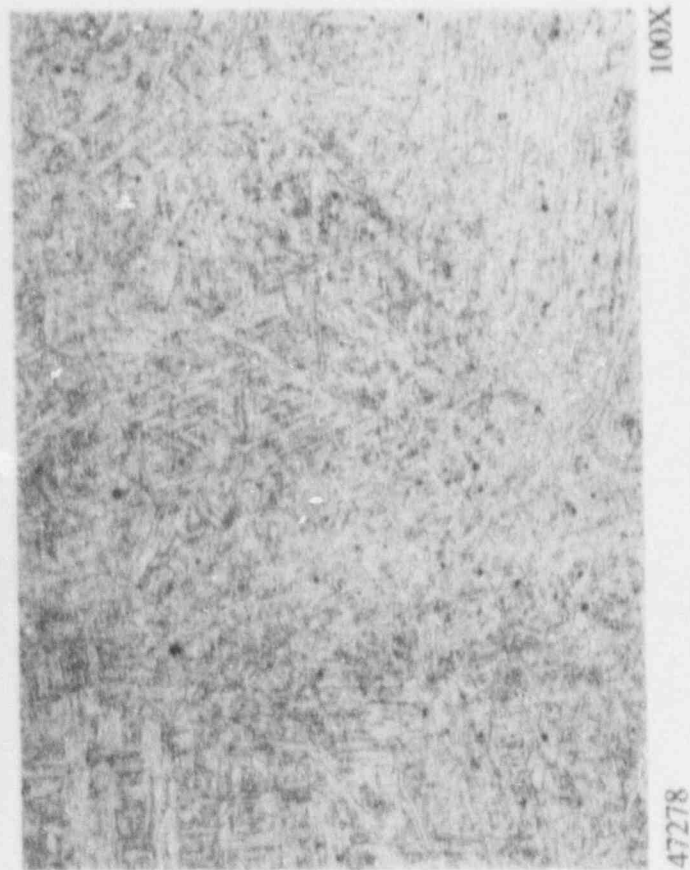
(a) Typical structure.

FIGURE B-9. MICROSTRUCTURE OF SAMPLE NO. 256
(6-in.). Etchant: Vilella's reagent

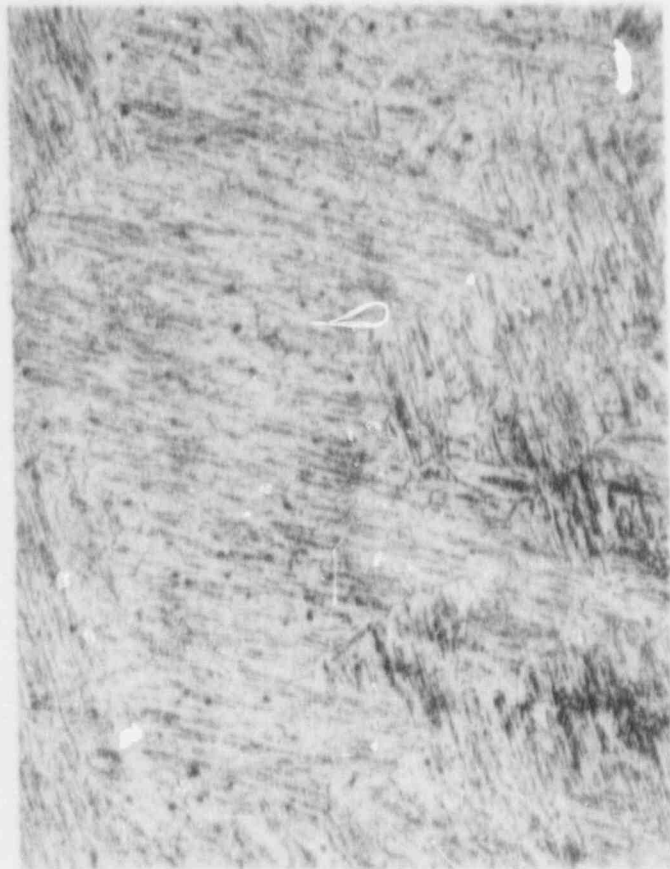
(a) Typical structure.

FIGURE B-10. MICROSTRUCTURE OF SAMPLE NO. 257
(6-in.). Etchant: Vilella's reagent

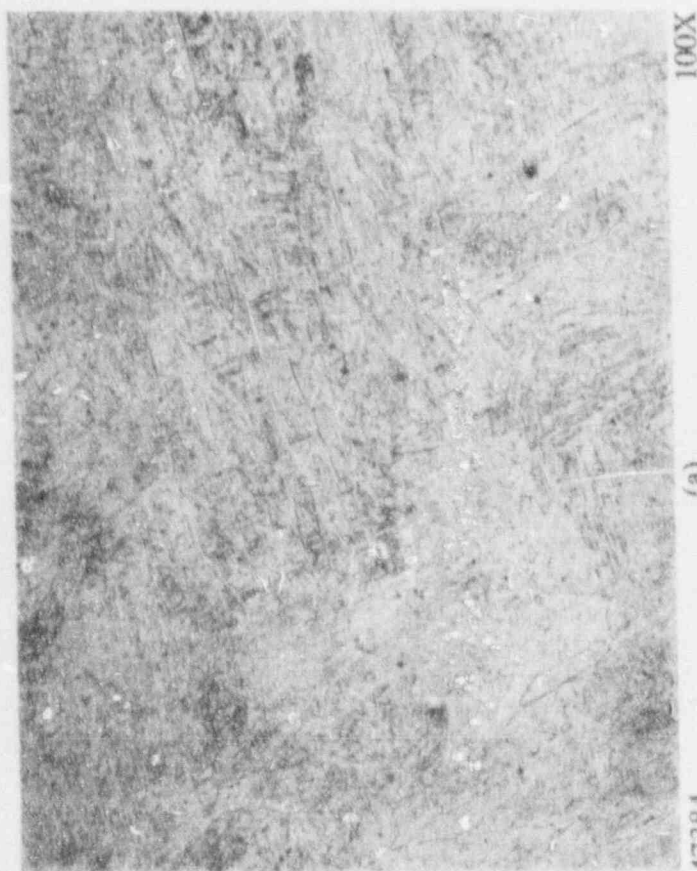
FIGURE B-12. MICROSTRUCTURE OF SAMPLE NO. 258
(4-in.). Etchant: Vilella's reagent

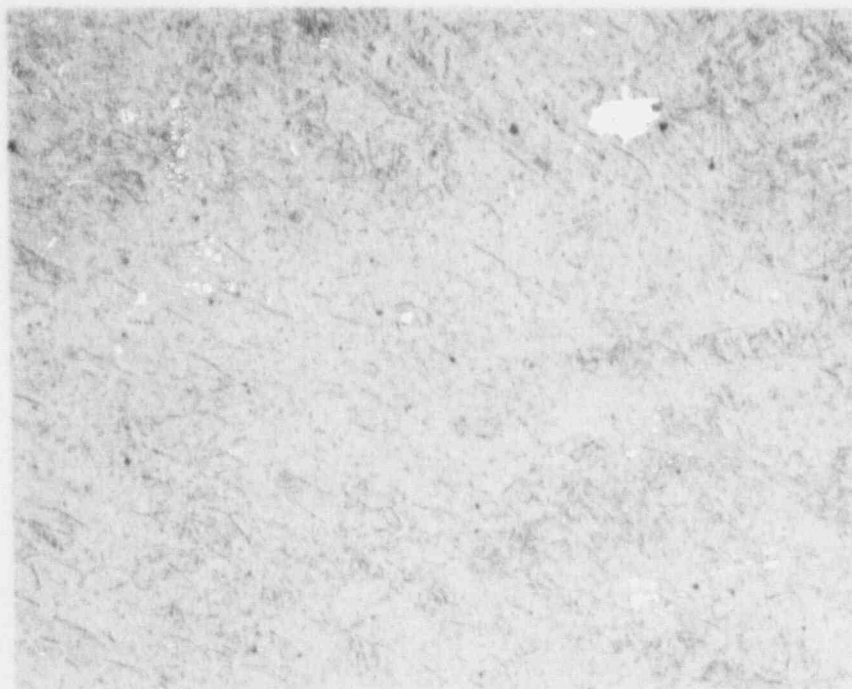
FIGURE B-13. TYPICAL MICROSTRUCTURE OF SAMPLE NO. 259
(4-in.). Etchant: Vilella's reagent

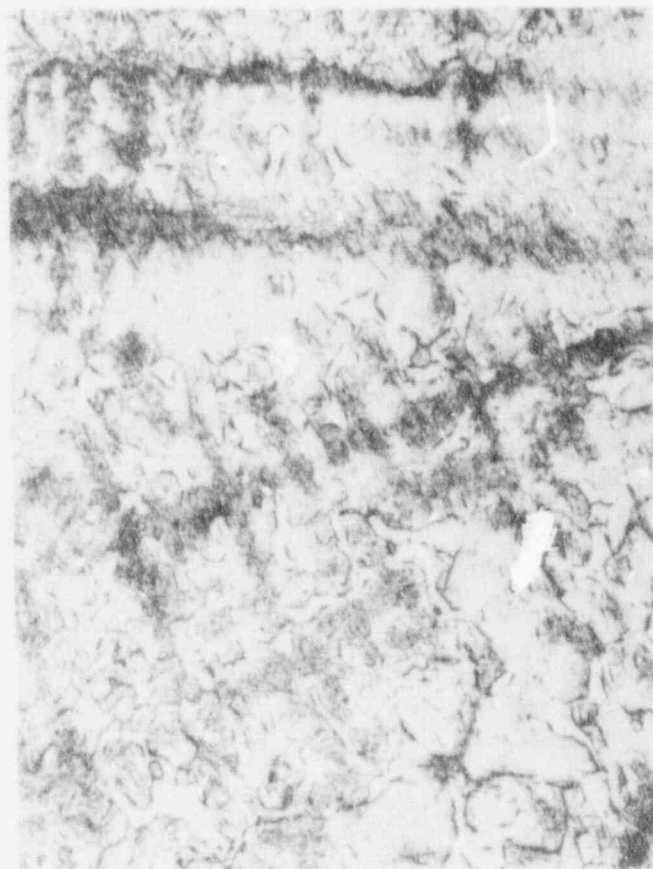
FIGURE B-14. MICROSTRUCTURE OF SAMPLE NO. 260 (4-in.). Etchant: Vilella's reagent

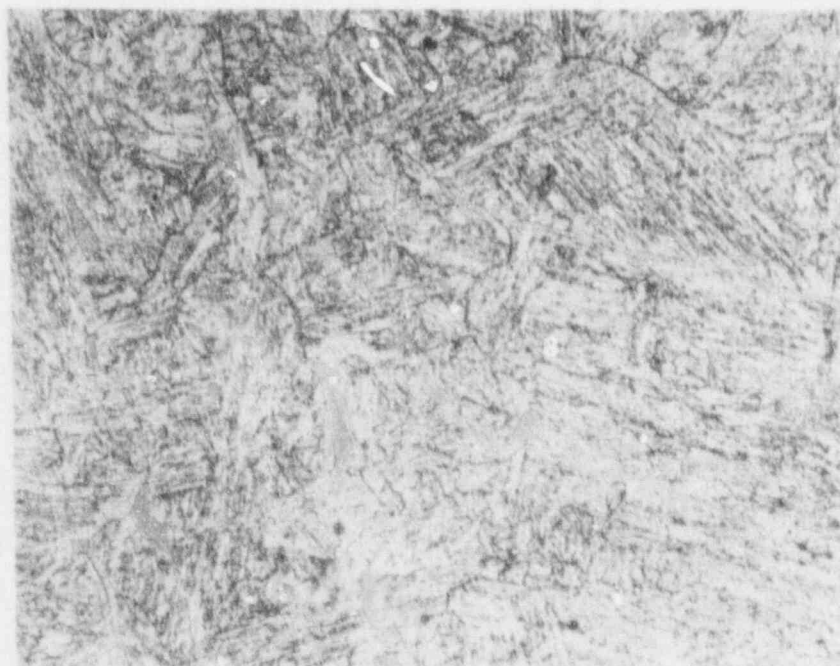
FIGURE B-15. TYPICAL MICROSTRUCTURE OF SAMPLE NO. 246 (3-in.). Etchant: Vilella's reagent

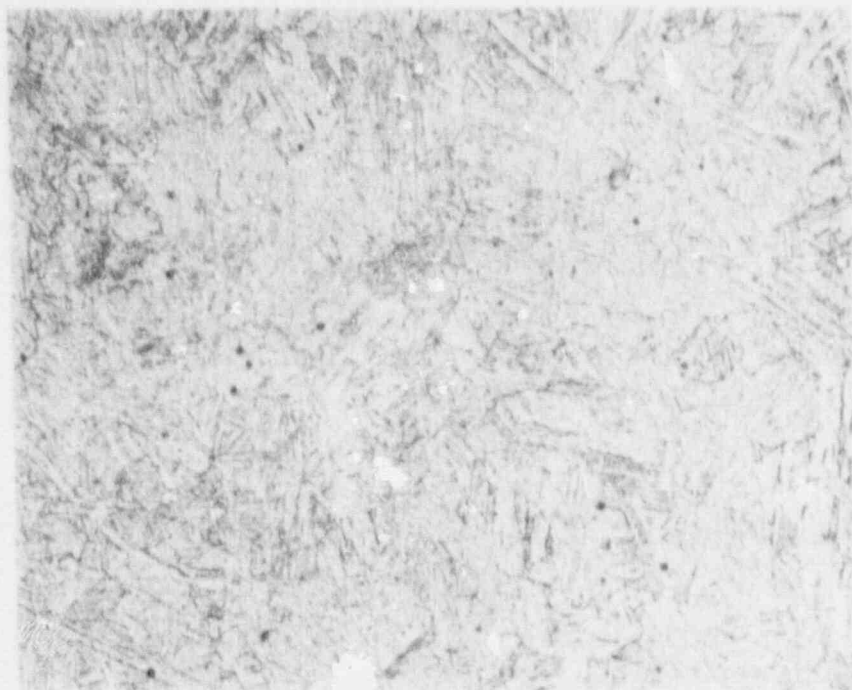
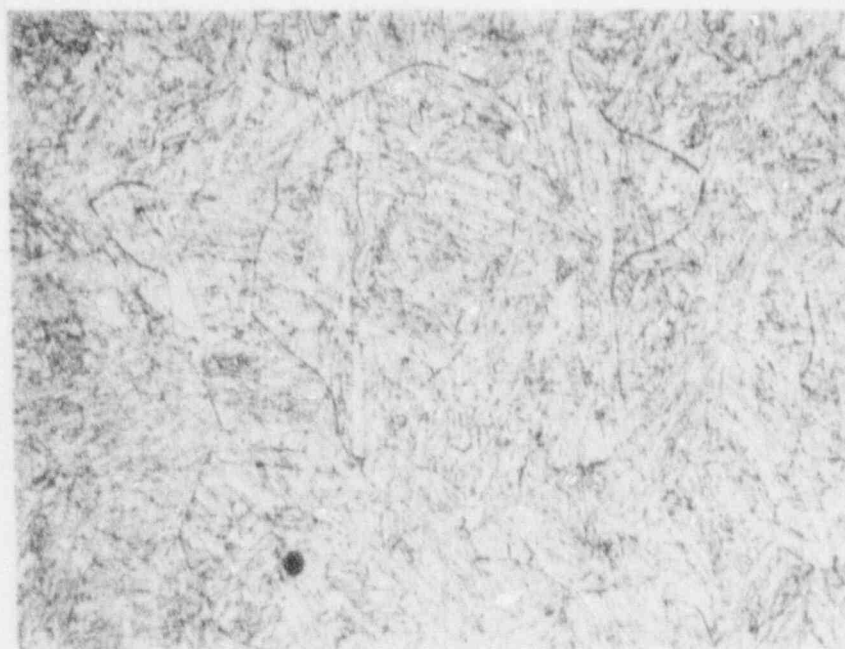
FIGURE B-16. TYPICAL MICROSTRUCTURE OF SAMPLE NO. 261 (3-in.). Etchant: Vilella's reagent

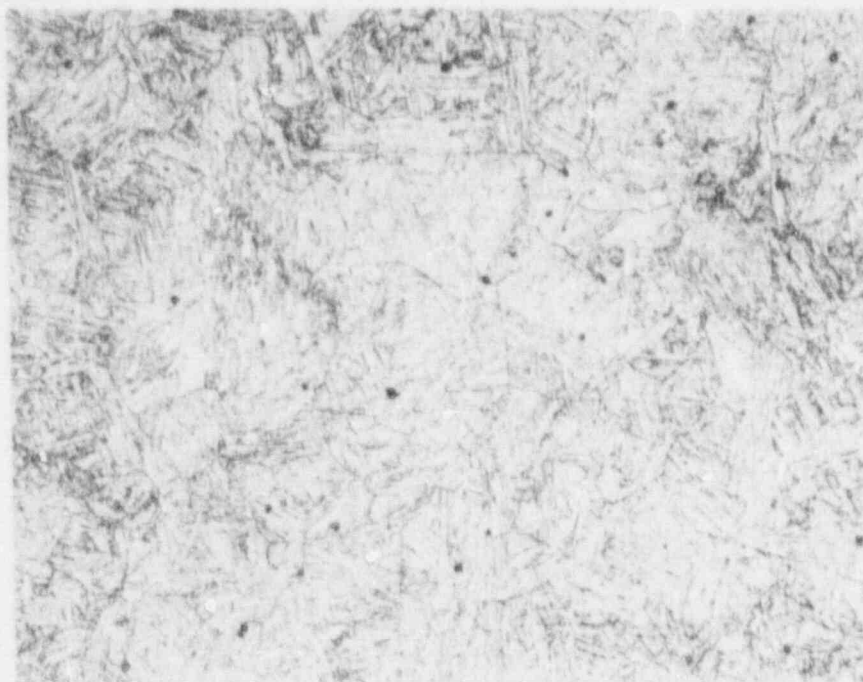
FIGURE B-17. TYPICAL MICROSTRUCTURE OF SAMPLE NO. 262
(3-in.). Etchant: Vilella's reagent
