**Babcock & Wilcox**

RDD:85:5104-02:03

EXAMINATION OF CRDM LEAFSPRING AND FOREIGN DEBRIS  
SAMPLES REMOVED FROM DAVIS BESSE-1

MAY 13, 1985

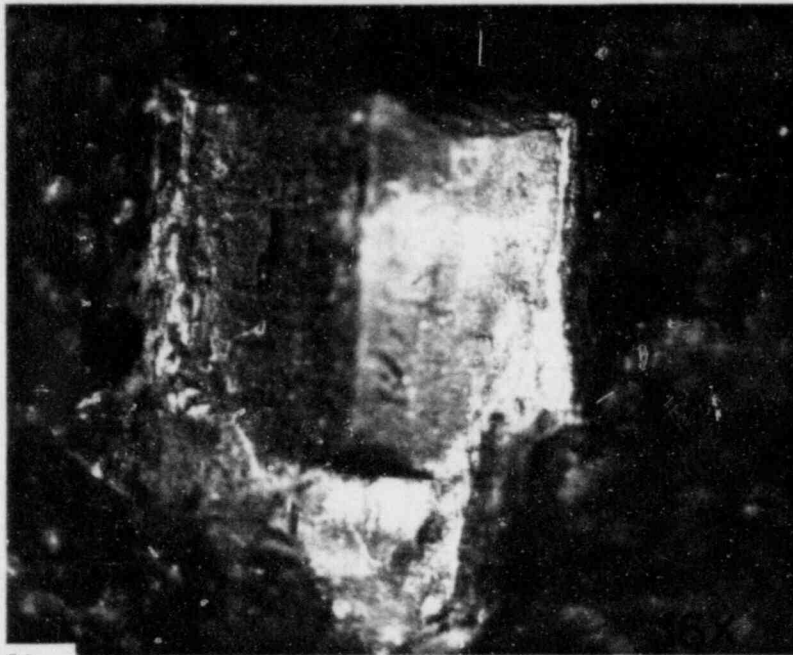
F85-21

Figure 9 - Photomicrograph Showing the Bottom Particle DB-3.

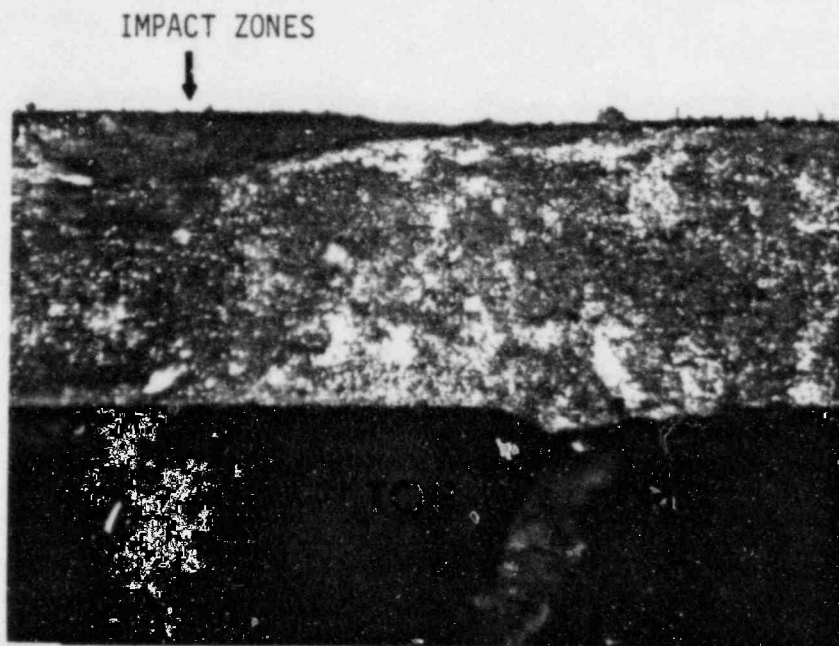
F85-32

Figure 13 - Fractograph of the Center of the Figure 12. 23X.

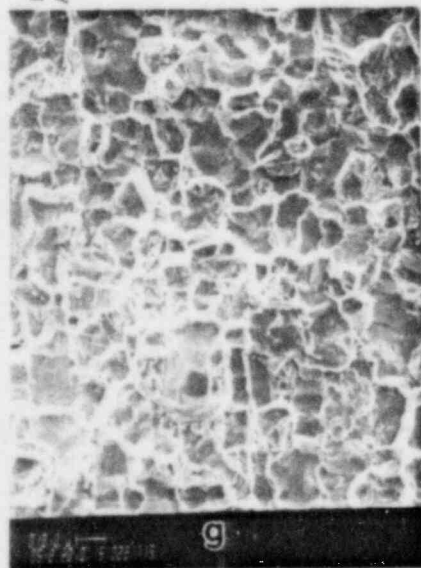
Figure 27 - Comparison of Service and Laboratory Fracture Morphologies of Spring DB-5 and 10.

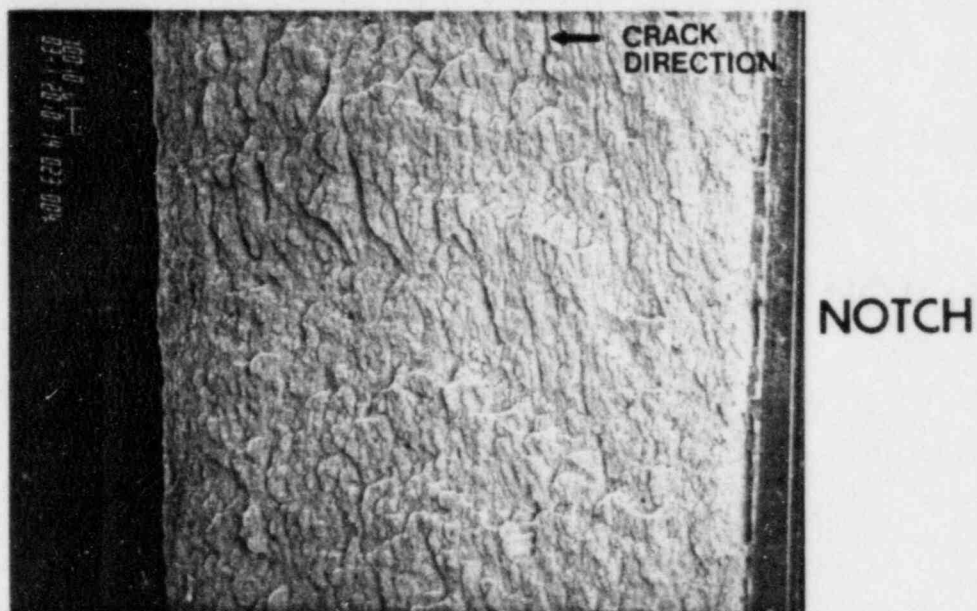
Figure 28 - SEM Fractograph of Three Point Bend Laboratory Fracture in Spring DB-11 from Heat 610073 Showing Quasi-Cleavage and Microvoid Coalescence.

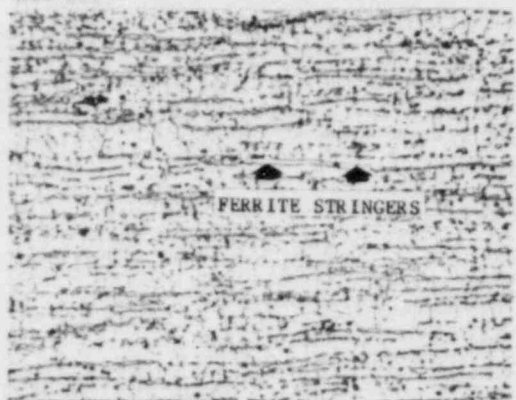
M85-301

TOP VIEW 500X  
SPRING AXIS
