DOCKET NO. 50-301
REPORT OF STEAM GENERATOR TUBE INSPECTION
POINT BEACH NUCLEAR PLANT, UNIT NO. 2

EXAMINATION OF POINT BEACH UNIT #2

STEAM GENERATOR TUBE SAMPLE

POINT BEACH UNIT 2 (WIS)
ANALYSIS OF APRIL, 1981
EDDY CURRENT INSPECTION RESULTS

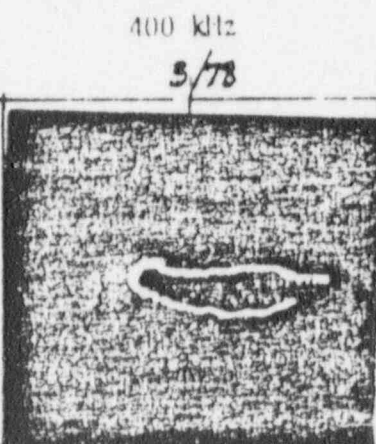
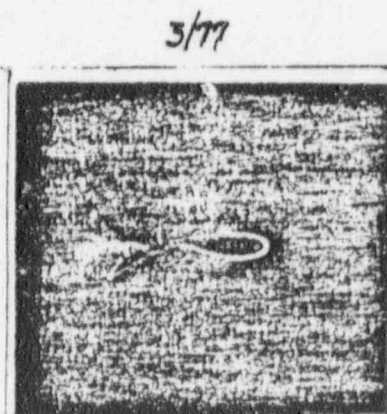
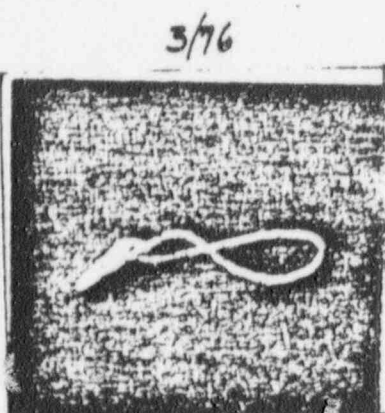
R21C46

POINT BEACH UNIT 2 (WFO)
STEAM GENERATOR A INLET

400 100 MIX
36 %

400 100 MIX
37 %
