U.S. DEPARTMENT OF
ENERGY

2020 Annual Site Inspection and Monitoring Report for Uranium Mill Tailings Radiation Control Act Title I Disposal Sites

March 2021

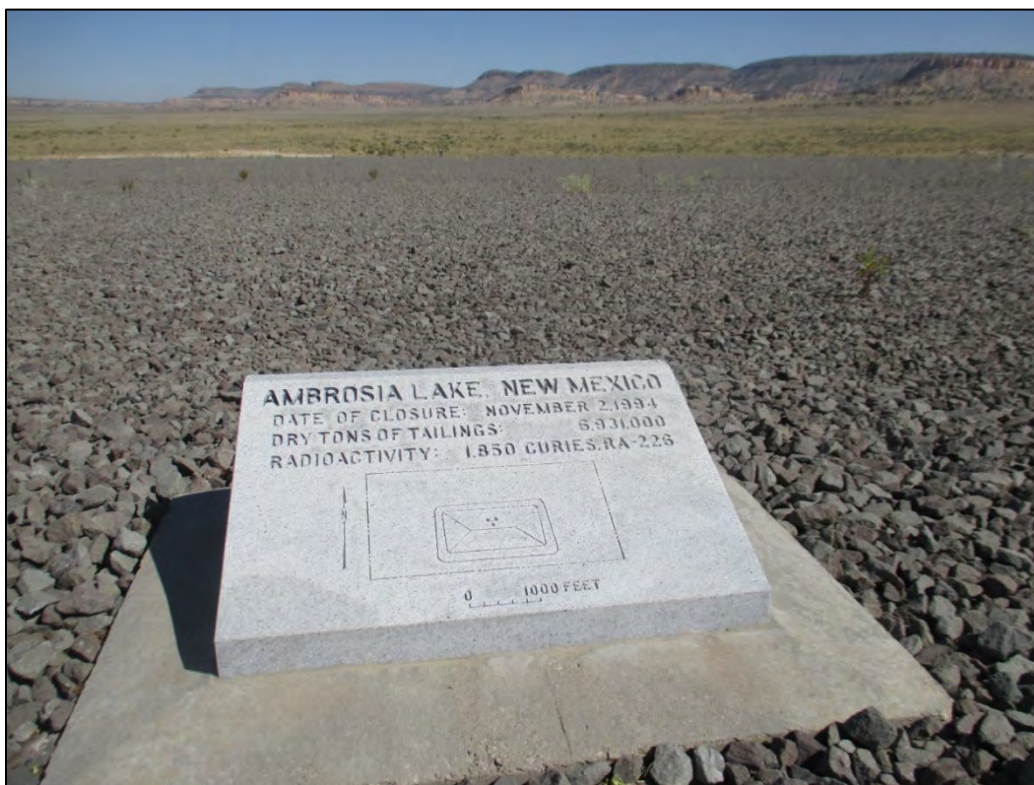
The site has two granite site markers. Site marker SMK-1 is just inside the site entrance, and site marker SMK-2 is on the top slope of the disposal cell (PL-3). No maintenance needs were identified.

PL-3. Site Marker SMK-2

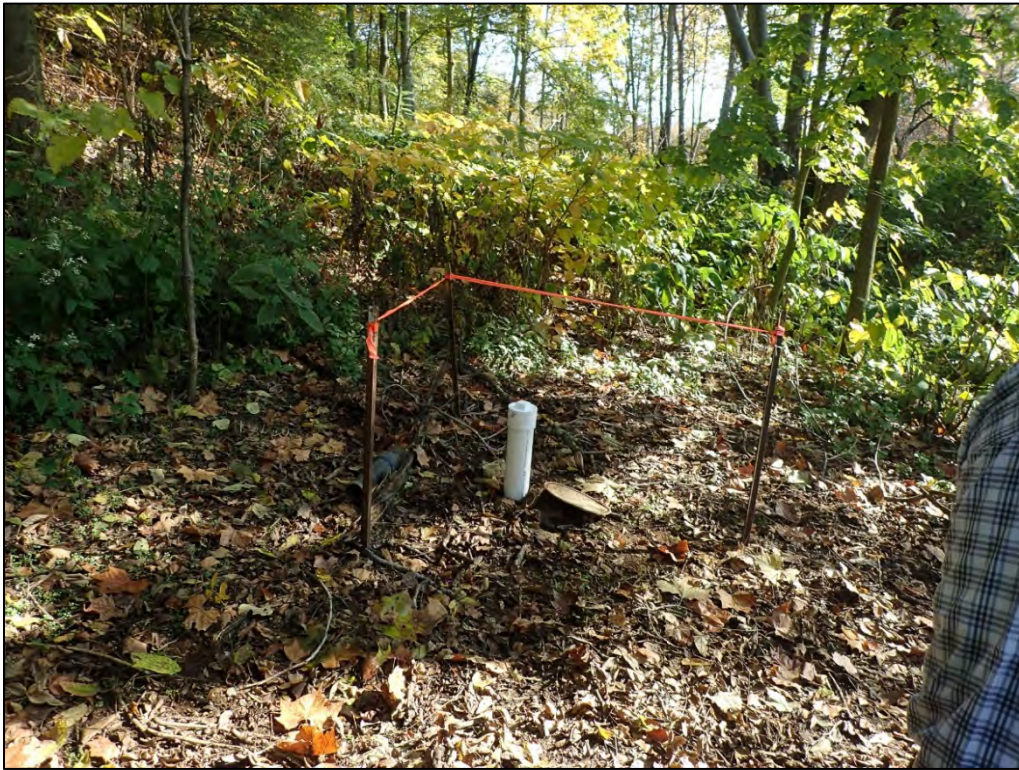
PL-3. New Pipe Installed at Boundary Monument BM1

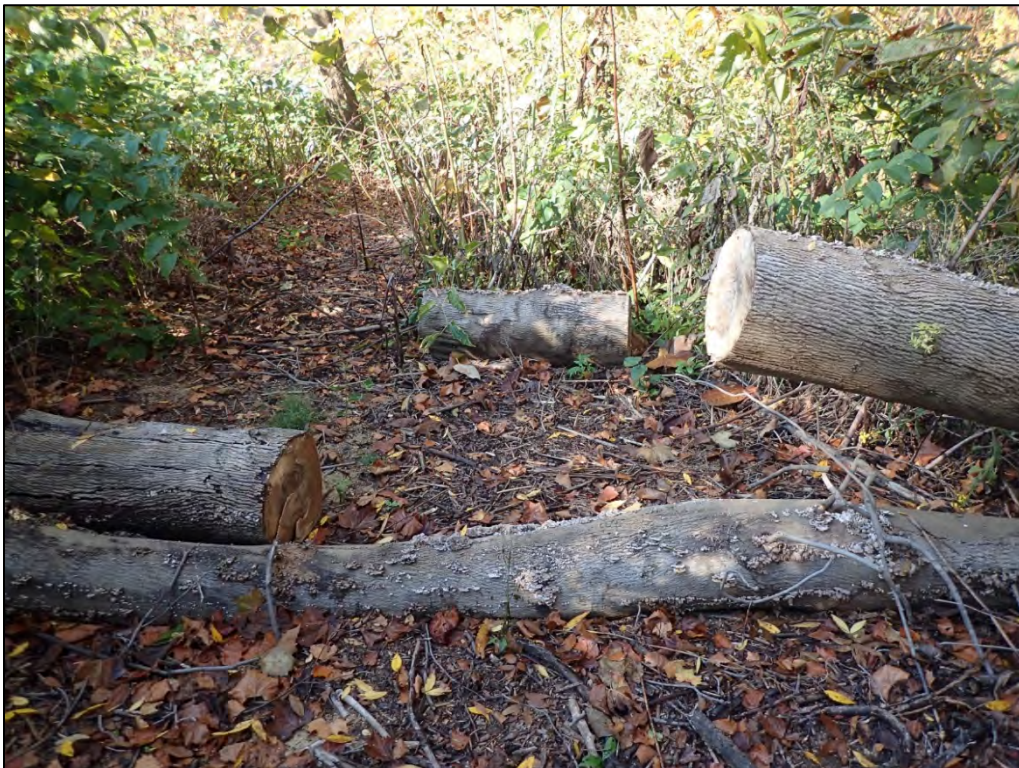
PL-4. Cleared Tree on Path to Boundary Monument BM1

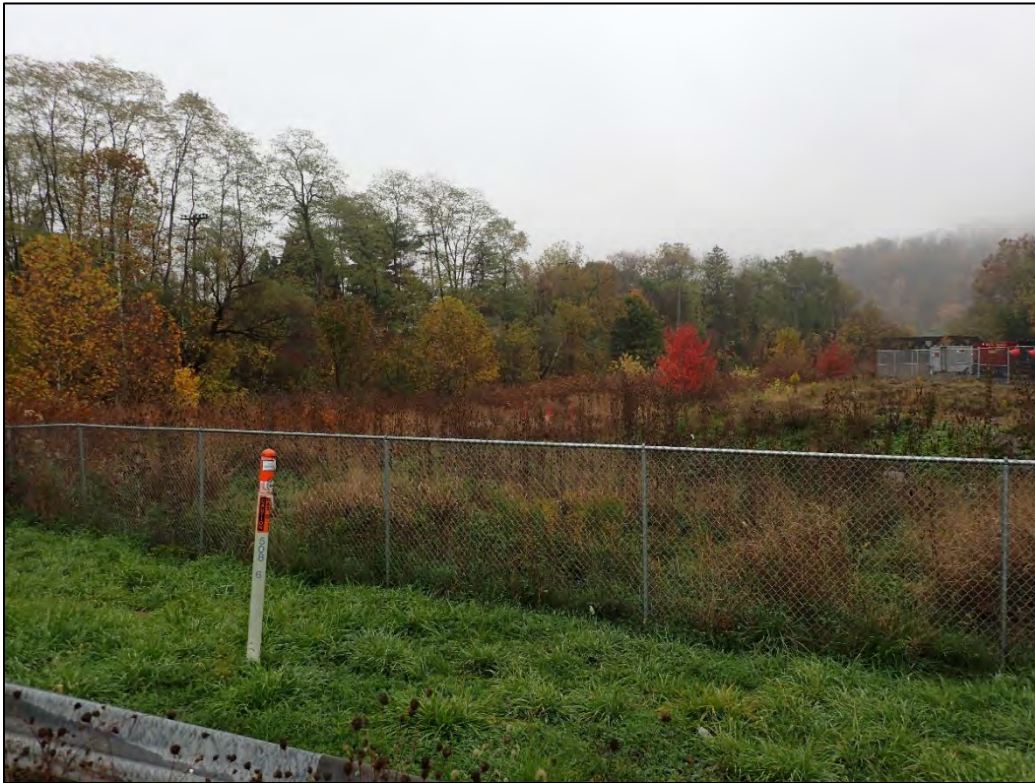
PL-11. Effective Invasive Weed Treatment Near Monitoring Well 0424 (not pictured)

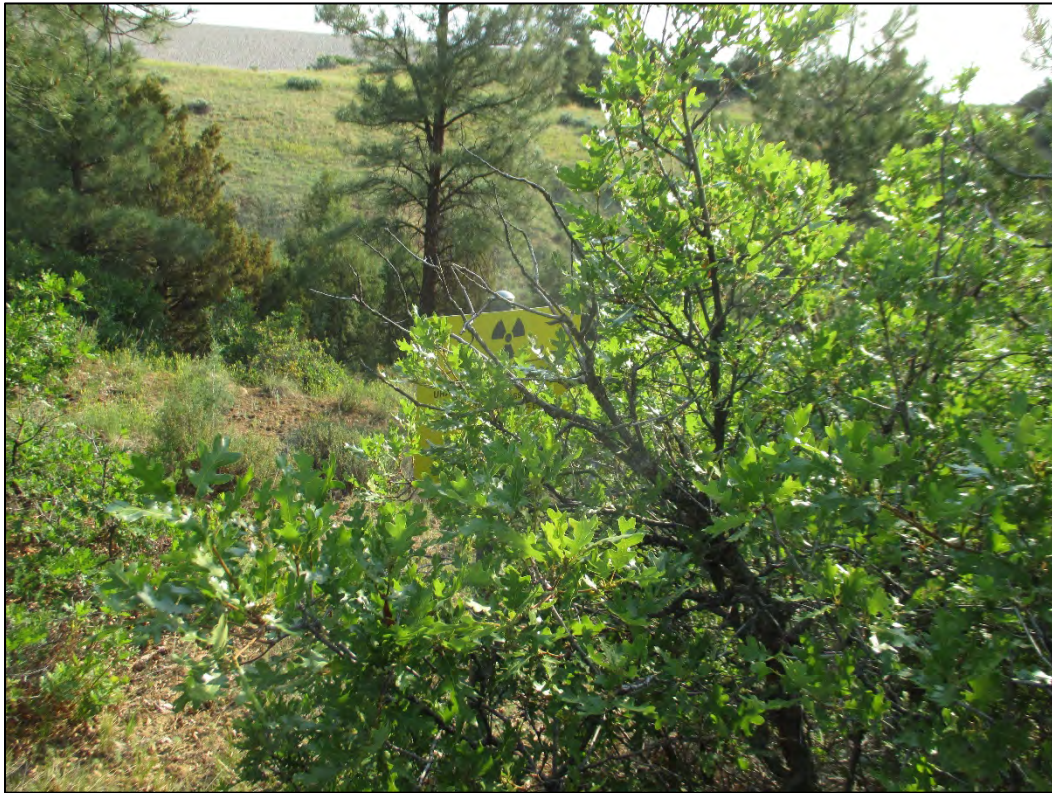
PL-3. Vegetation Surrounding Perimeter Sign P4

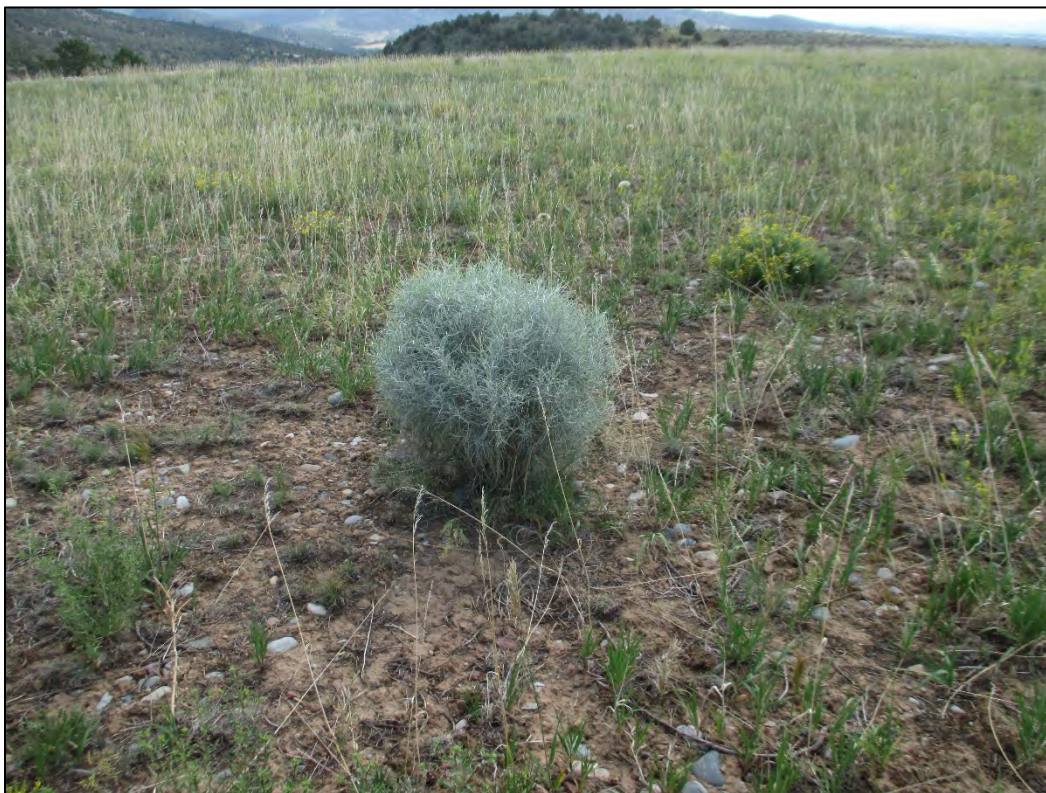
PL-7. Rabbitbrush on Cell Top Slope

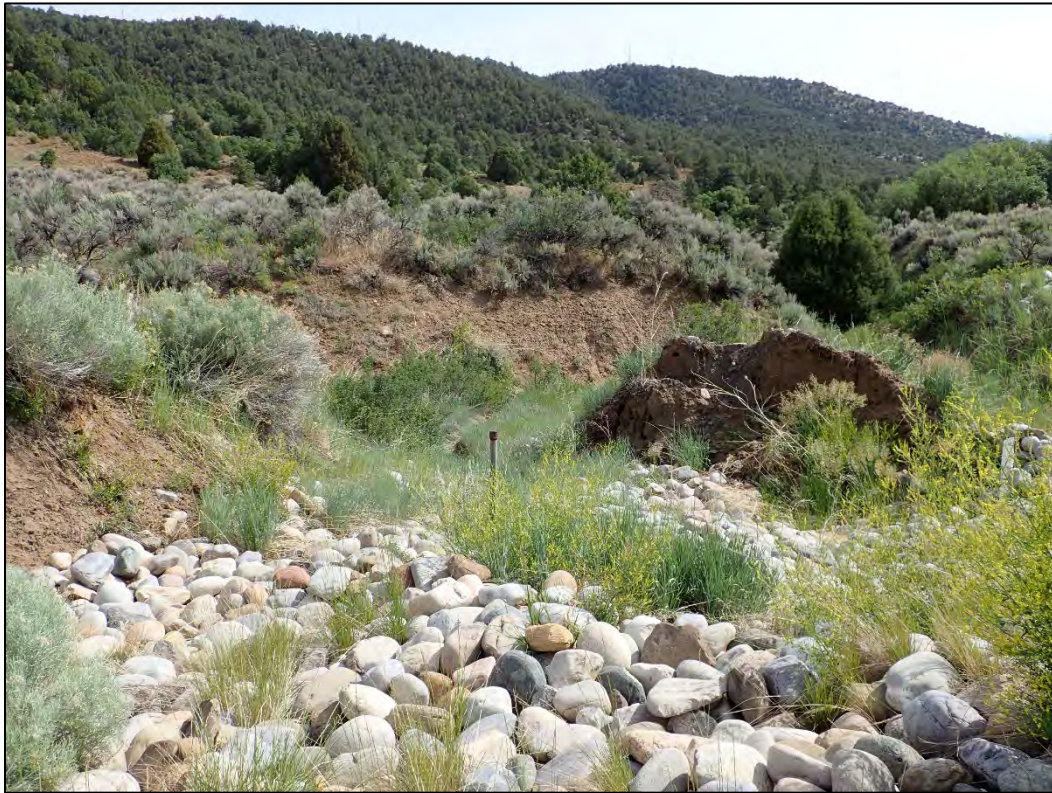
PL-8. Linear Depression in Cell Toe Slope

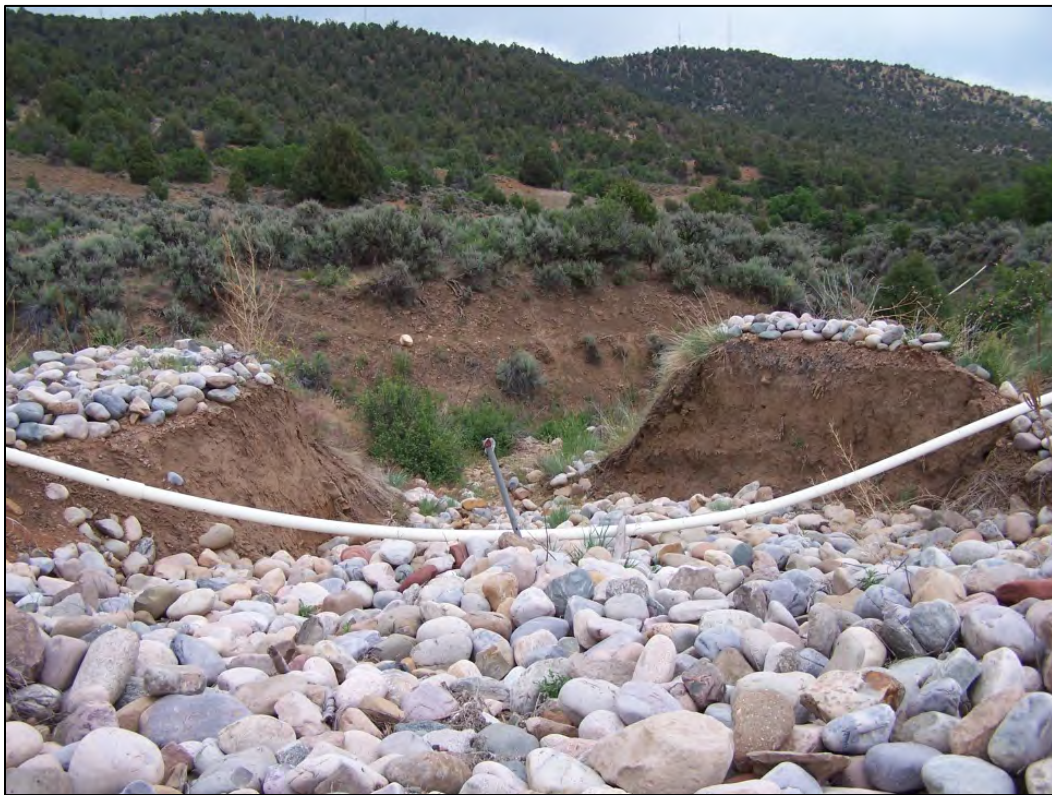
PL-9a. Northeast Outflow in 2020

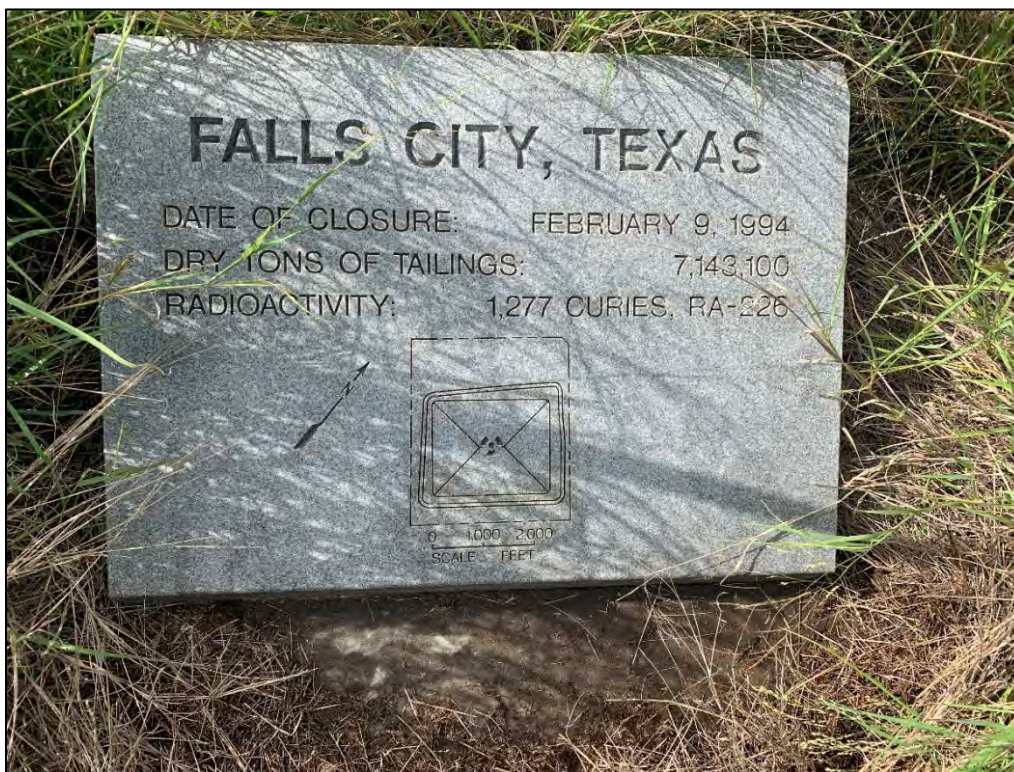
The site has two site markers. Site marker SMK-1 is just inside the entrance gate (PL-1). The corners of the concrete base around the marker are cracked. The cracks consistently are unchanged and repairs are not needed. Site marker SMK-2 is on the top slope of the disposal cell. No maintenance needs were identified.

PL-1. Site Marker SMK-1

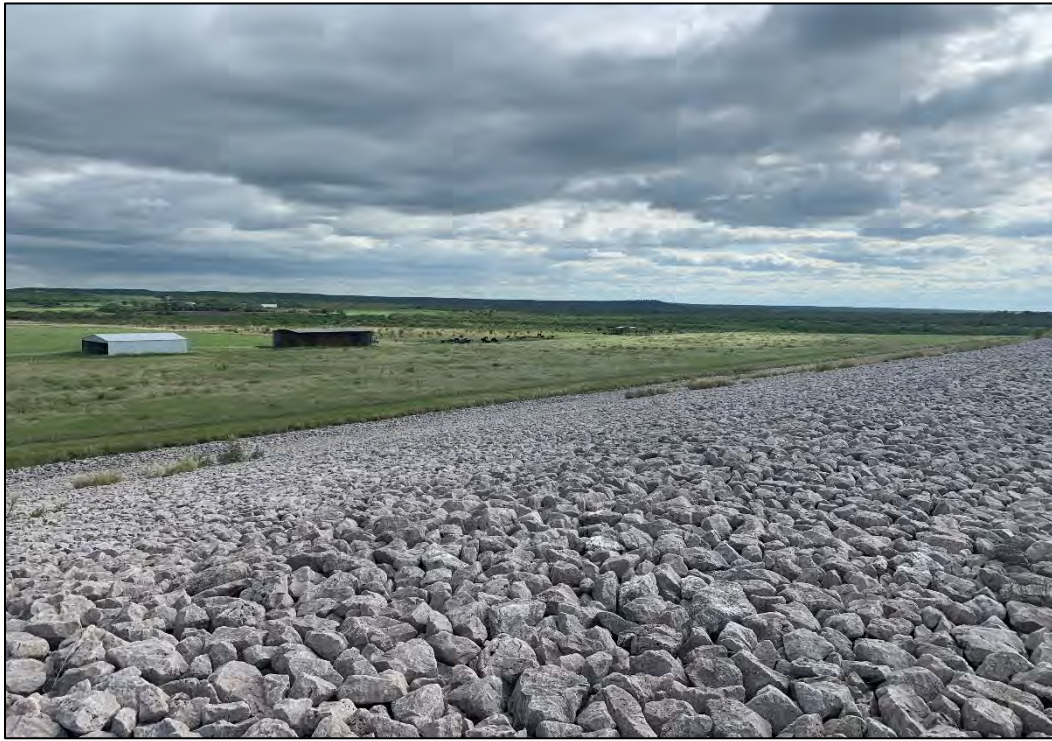
The disposal cell side slopes and a transition zone where the top slope meets the side slopes are armored with riprap (PL-3). LM has monitored several small depressions on the northwest side slope of the disposal cell since 2010. These depressions do not compromise the protectiveness of the riprap side slope, and no changes have been observed since 2010. Inspectors will continue to monitor these areas.

PL-3. South Side of Disposal Cell Side Slope

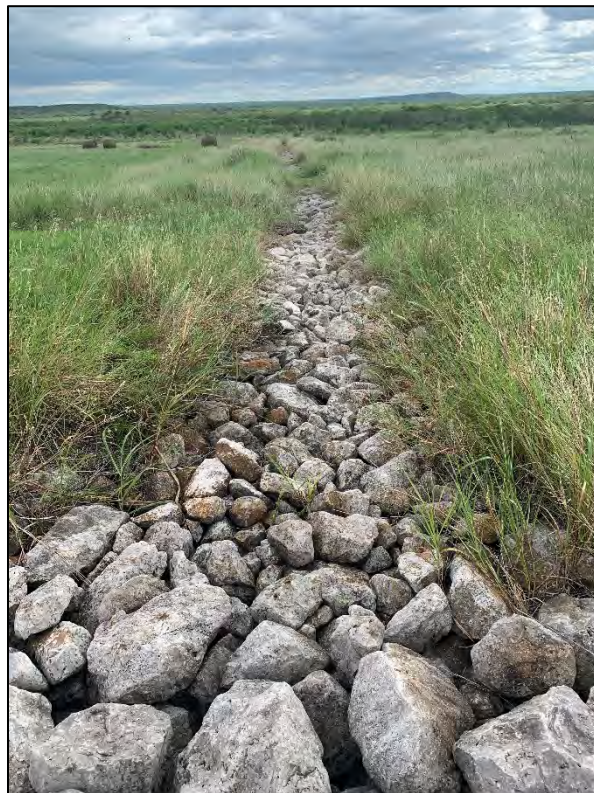
No water was flowing in the south rock drain during the inspection (PL-4). Willows that grow along the south drain are periodically removed by the maintenance subcontractor. No water was observed in the north rock drain. Vegetation is left uncut at the outlets of the rock drains to help dissipate the energy of stormwater runoff and to reduce soil erosion. Vegetation in the apron outfall, midway along the northeast side slope, was cut back before the 2020 inspection. No maintenance needs were identified.

PL-4. Rock Drain on South Corner of Disposal Cell

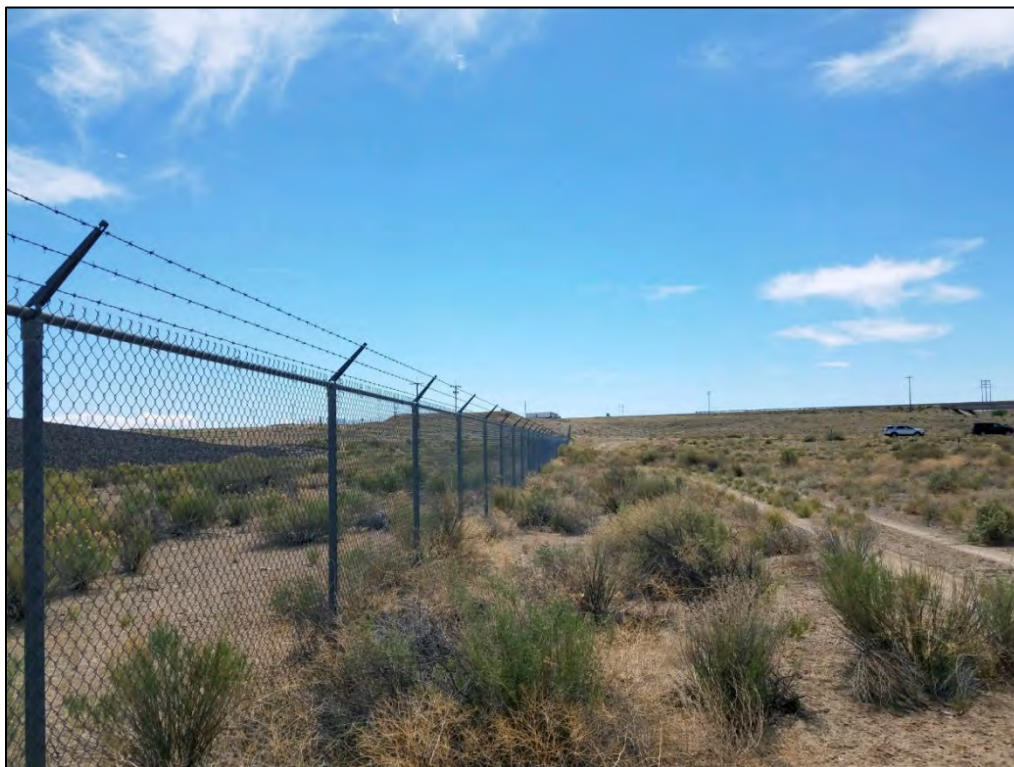
A chainlink security fence encloses the portion of the site that contains the disposal cell. Two vehicle gates are at the south and east corners of the security fence line, and a personnel gate is at the north corner of the security fence line. The security fence (PL-2) was intact, and the gates were locked. The minor erosion under the southeast fence line identified and repaired during the 2019 inspection remains stable.

PL-2. Chainlink Security Fence

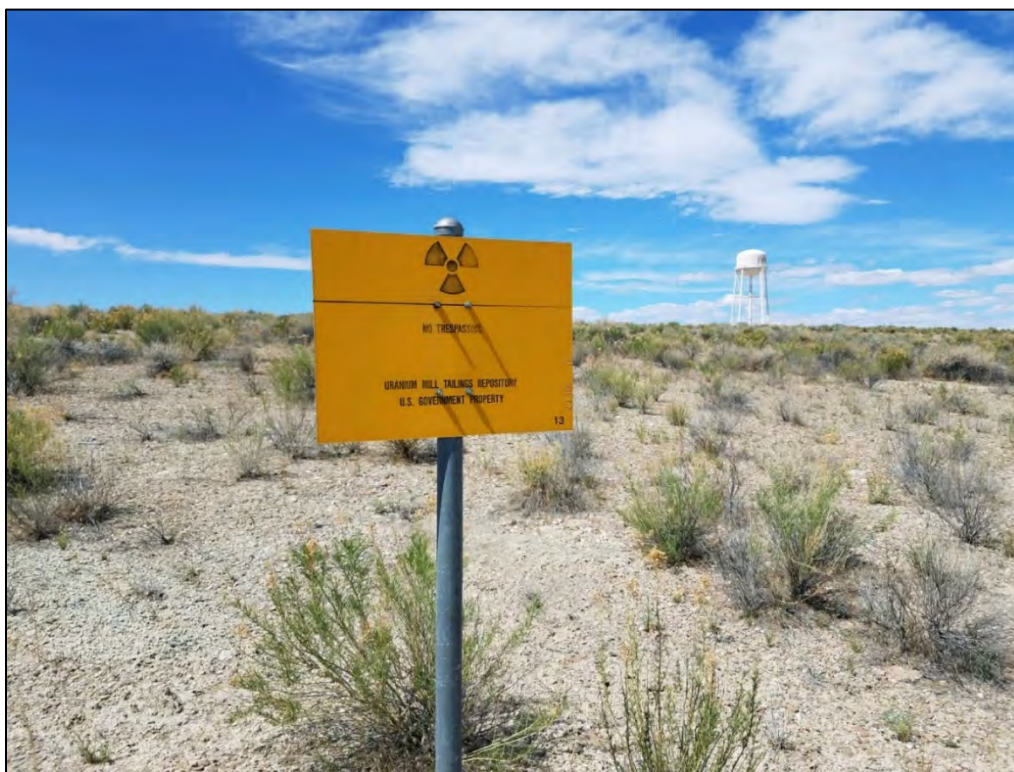
There are 17 perimeter signs (PL-3), attached to steel posts set in concrete, positioned along the unfenced property boundary. Two new unmanned aircraft system (UAS) warning signs will be installed before the next inspection. No maintenance needs were identified.

PL-3. Perimeter Sign P13

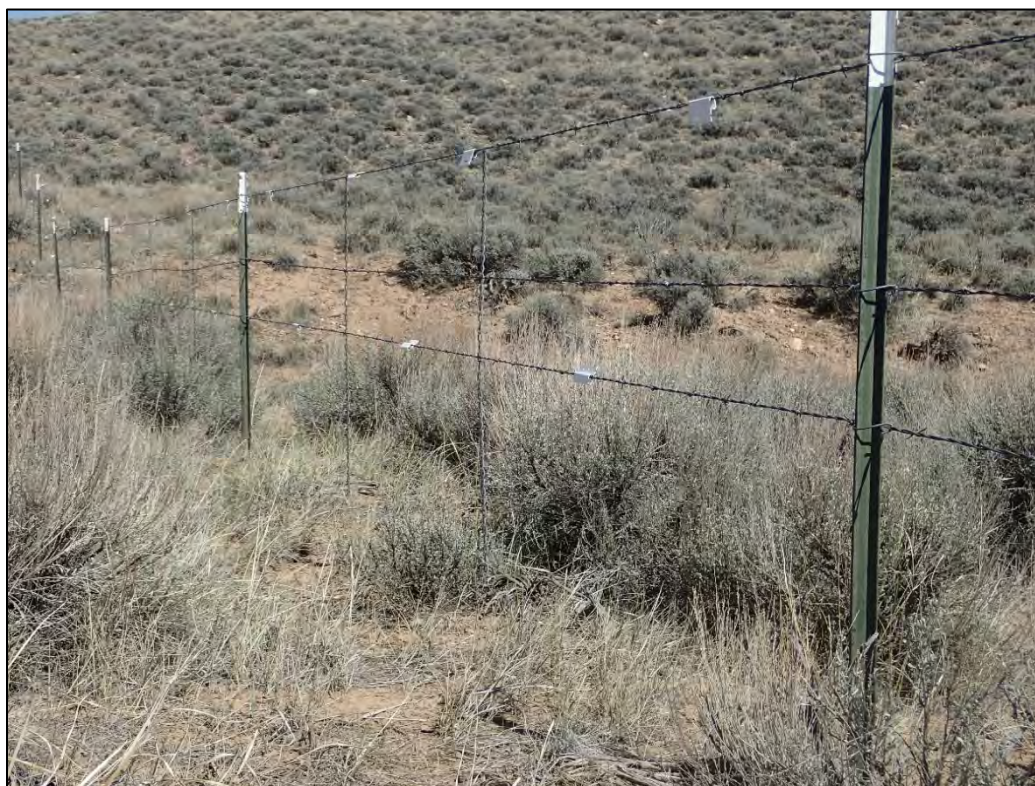
PL-2. Fence Flagging on East Fence Line

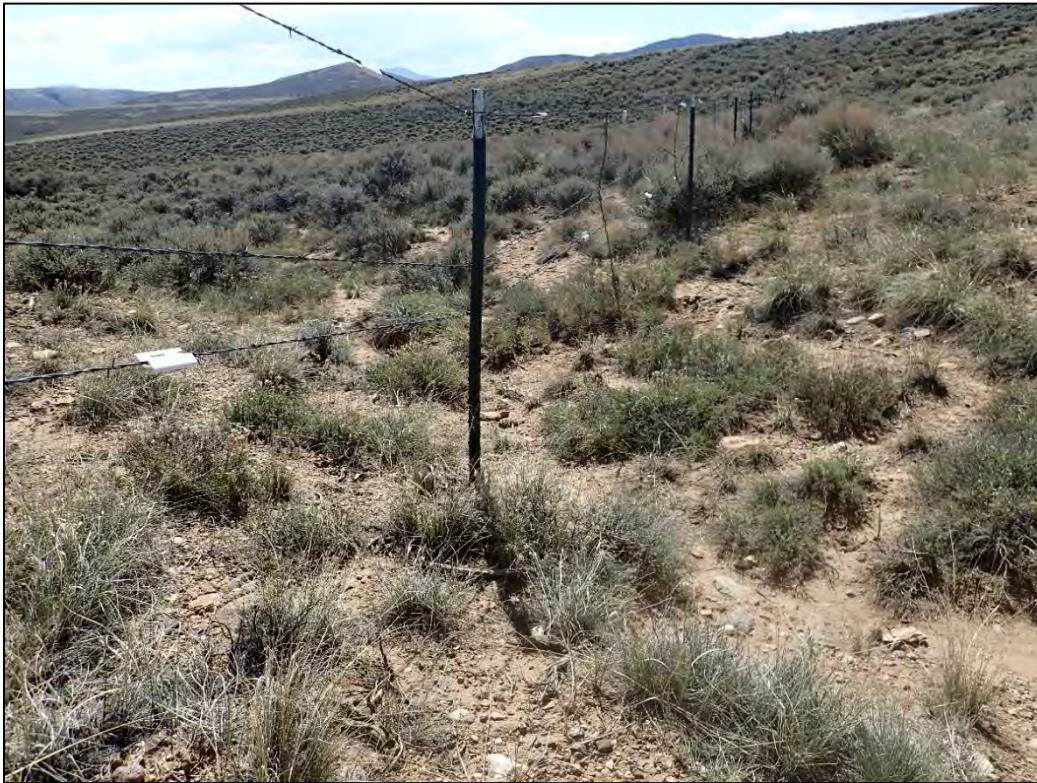
PL-3. Fence Flagging on East Fence Line

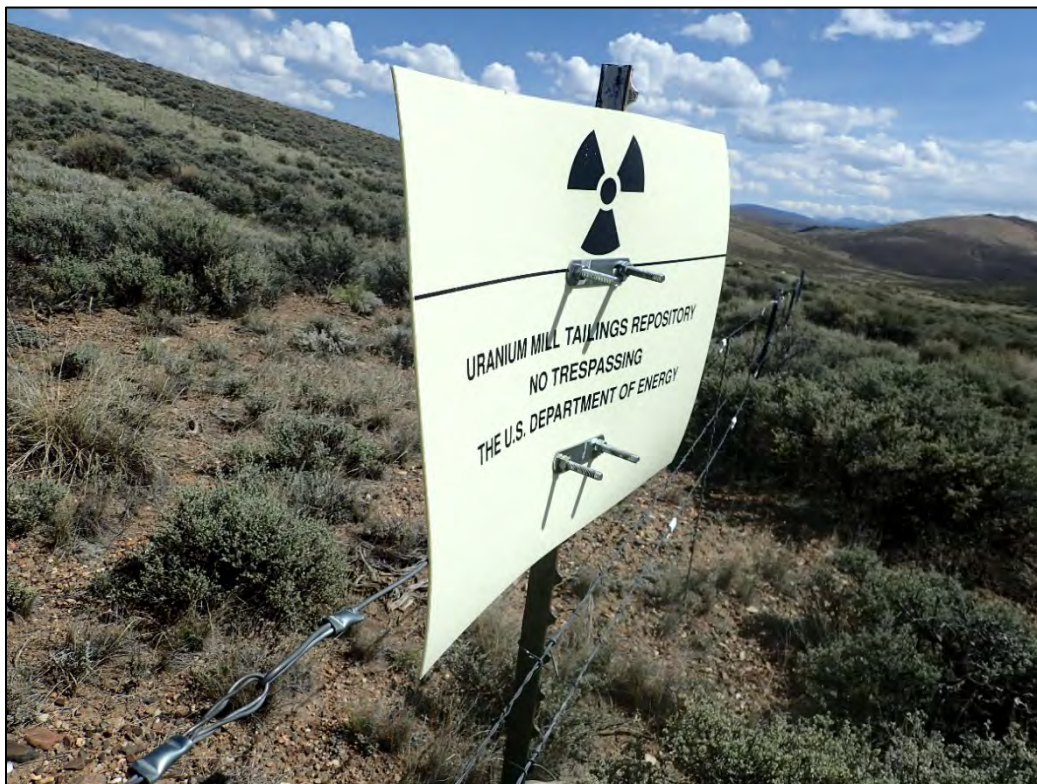
There are 45 perimeter signs bolted to the perimeter fence posts. Several perimeter signs have bullet damage but remain legible. In 2020, perimeter signs P4–P13 along the west perimeter fence were replaced. Perimeter signs P36, P37 (PL-4), P38, and P41 are constructed of plastic and are faded and curling. The plastic signs have been rescheduled for replacement with metal signs in 2021. All new signs will include the words “Gunnison Site.” Other perimeter signs that are damaged and showing wear will be replaced over the next 2 years. No other maintenance needs were identified.

PL-4. Perimeter Sign P37

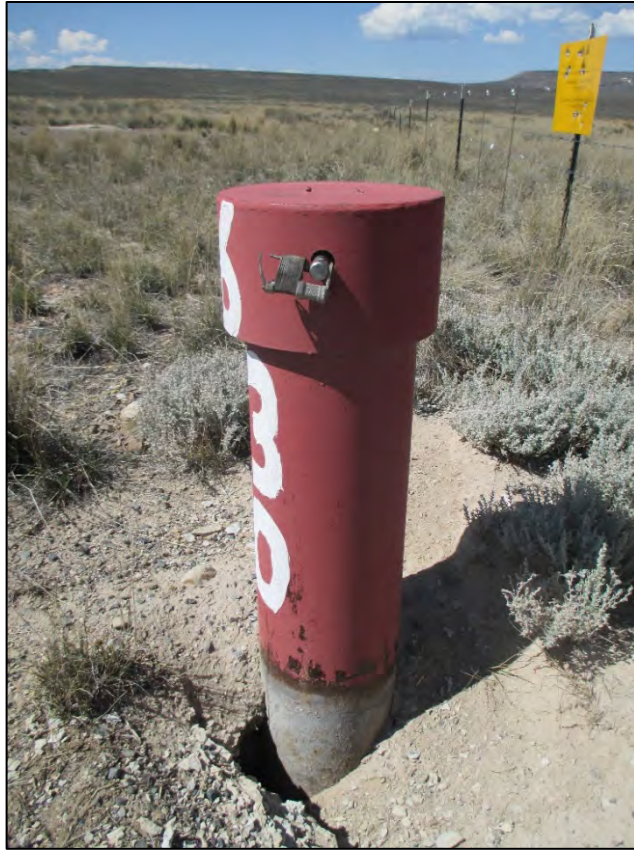
The site has 16 groundwater monitoring wells. The wellhead protectors were locked and properly labeled. Bullet damage is present on the locks of monitoring wells 0630 (PL-5) and 0712 and on the wellhead protector of monitoring well 0634. Both wells are secure, though new locks will be installed on both monitoring wells. Gunnison County landfill operators have placed concrete barriers to protect monitoring well 0716, which is on landfill property, from landfill activities. The edge of an adjacent spoil pile, although close to the concrete barriers, does not impair access to monitoring well 0716. The base of monitoring well 0709 is cracked but remains stable. Inspectors will continue to monitor these features. No maintenance needs were identified.

PL-5. Well 0630

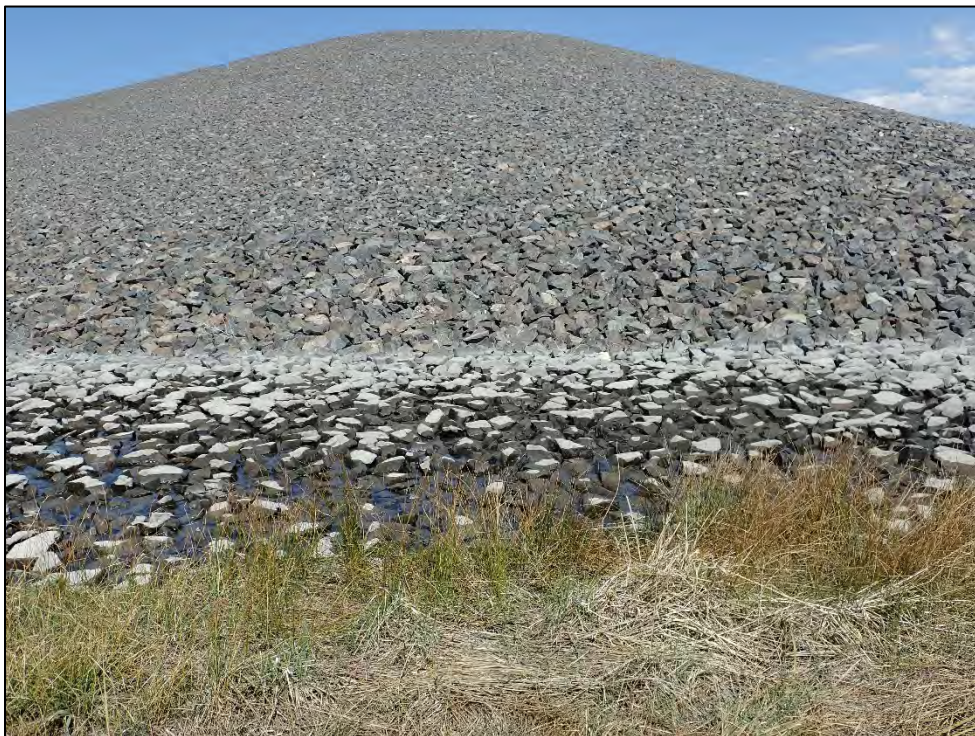
Stormwater runoff from the disposal cell occasionally ponds in a low-lying area at the southeast corner of the disposal cell; standing water was present at the time of the inspection (PL-6). The riparian-type vegetation that has become established there indicates that the area retains moisture. Water collection in this area does not pose a problem because the disposal cell surfaces are designed to drain to the southeast, and any water that ponds there is below the elevation of tailings placed under the engineered cover. No maintenance needs were identified.

PL-6. Water in Cell Apron, Southeast Corner

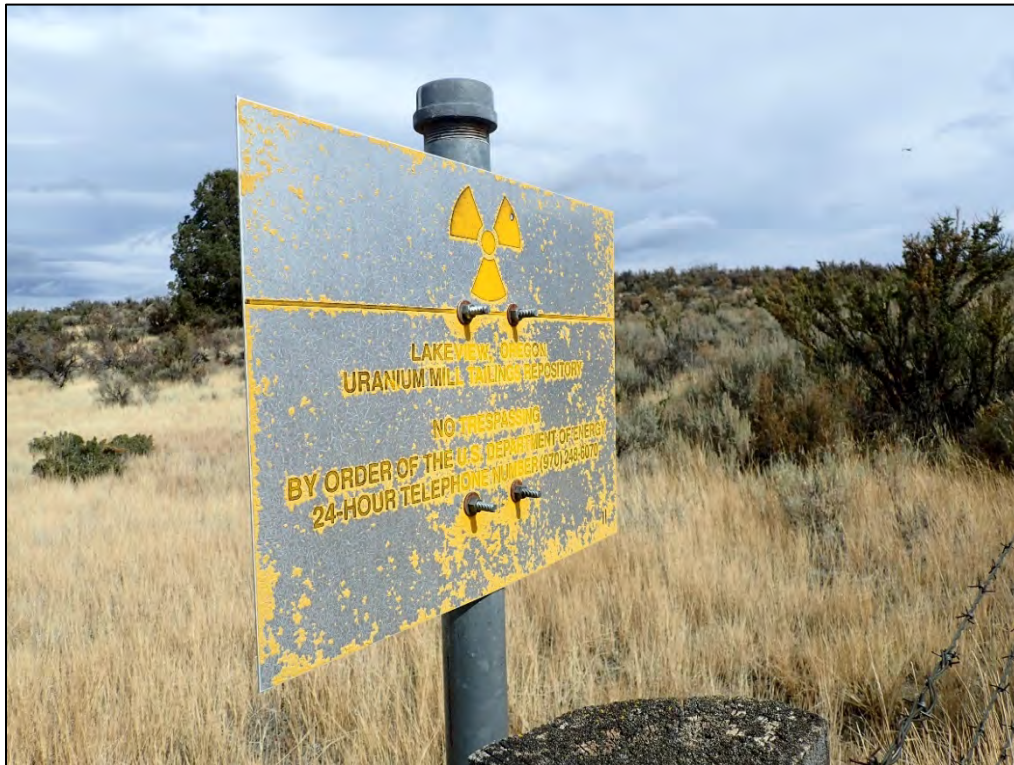
PL-2. Faded Perimeter Sign P11

- Removing the broken T-post at well 0516
- Replacing faded perimeter signs P10, P11, P12

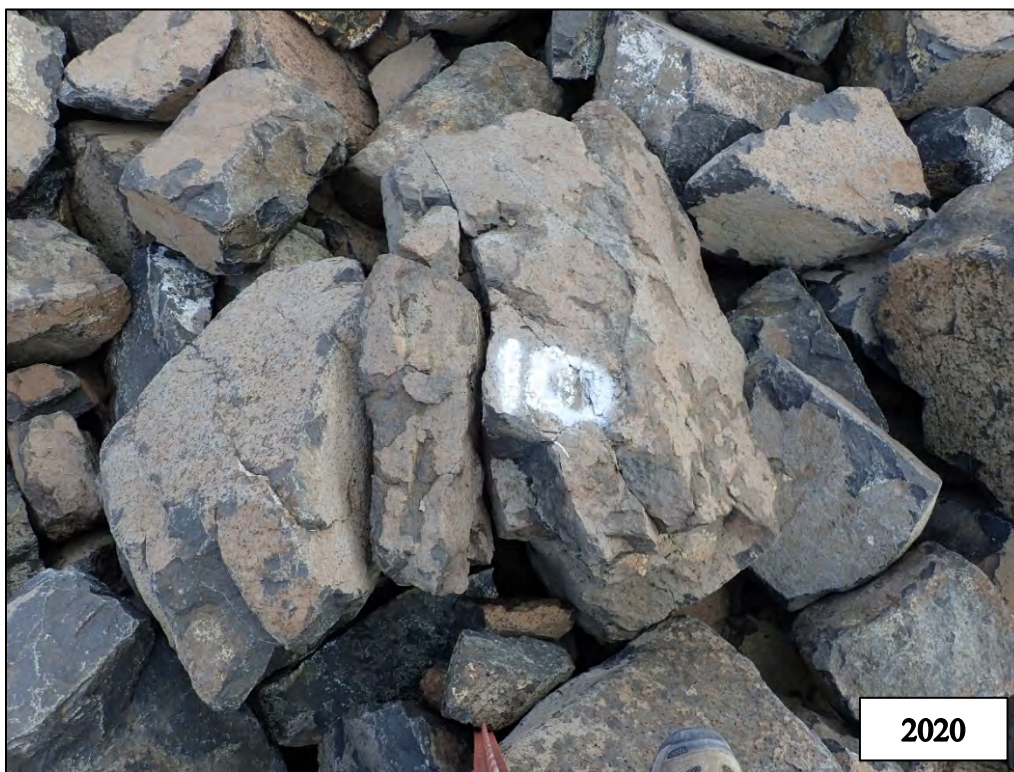
PL-9a. Riprap Monitoring Location Number 10 in Energy Dissipation Area–2020

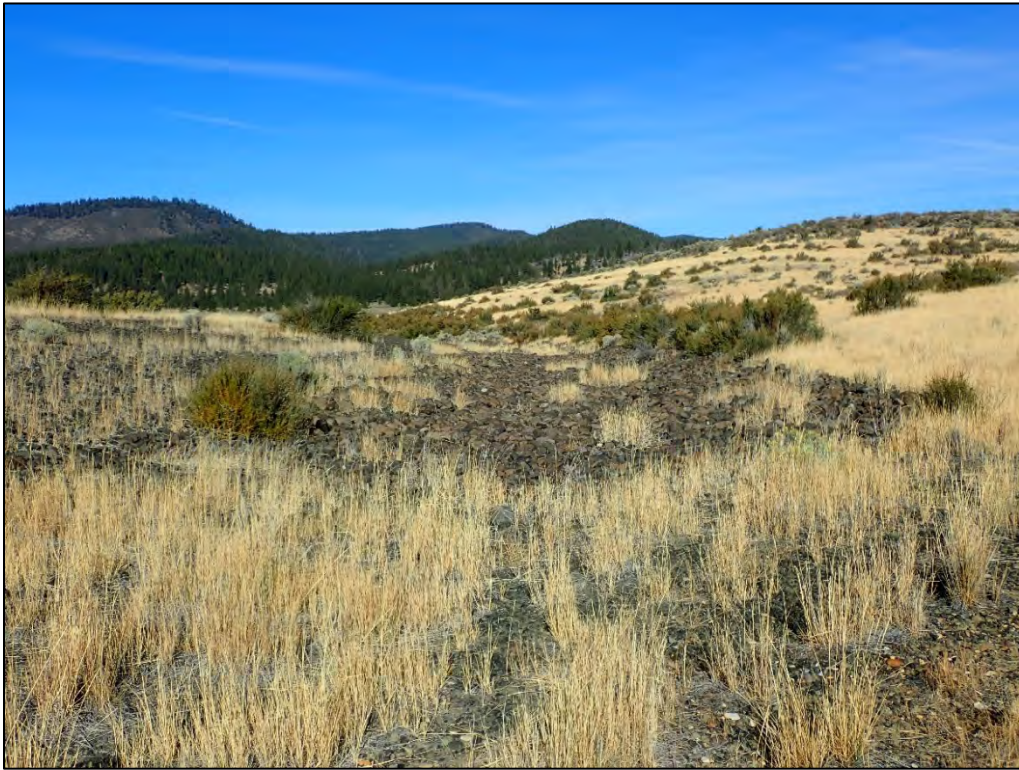
PL-10. Drainage Channel with Encroaching Vegetation

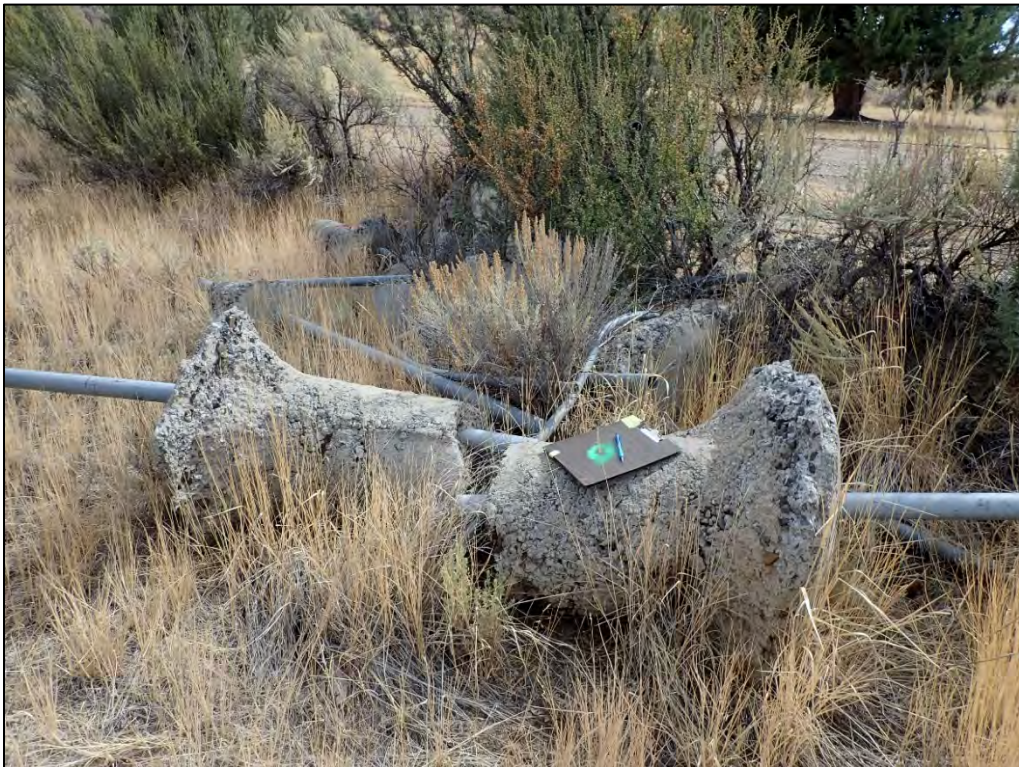
PL-11. Old Fence Posts with Concrete Bases

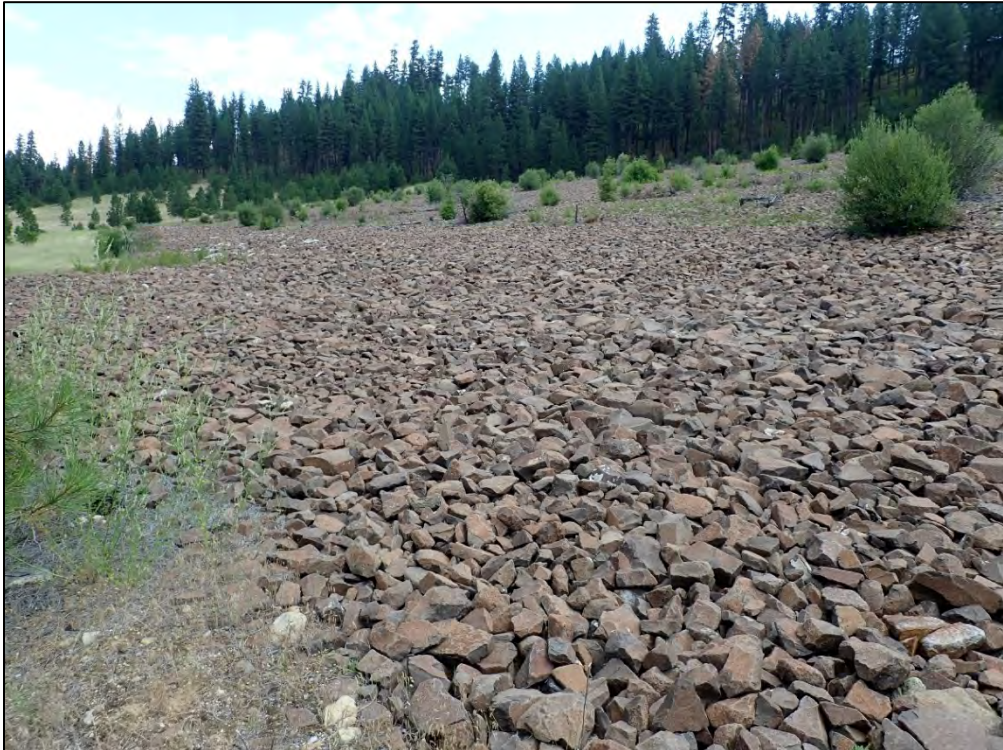
PL-5. Vegetation on Disposal Cell Cover

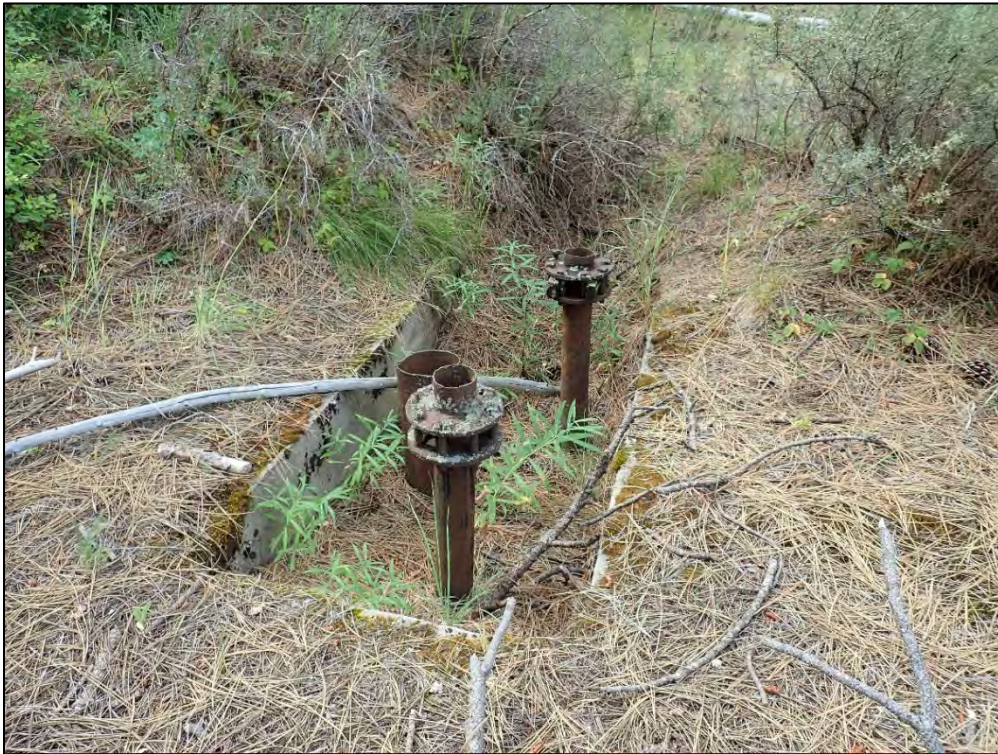
PL-6. Concrete Structure and Water Piping Remains

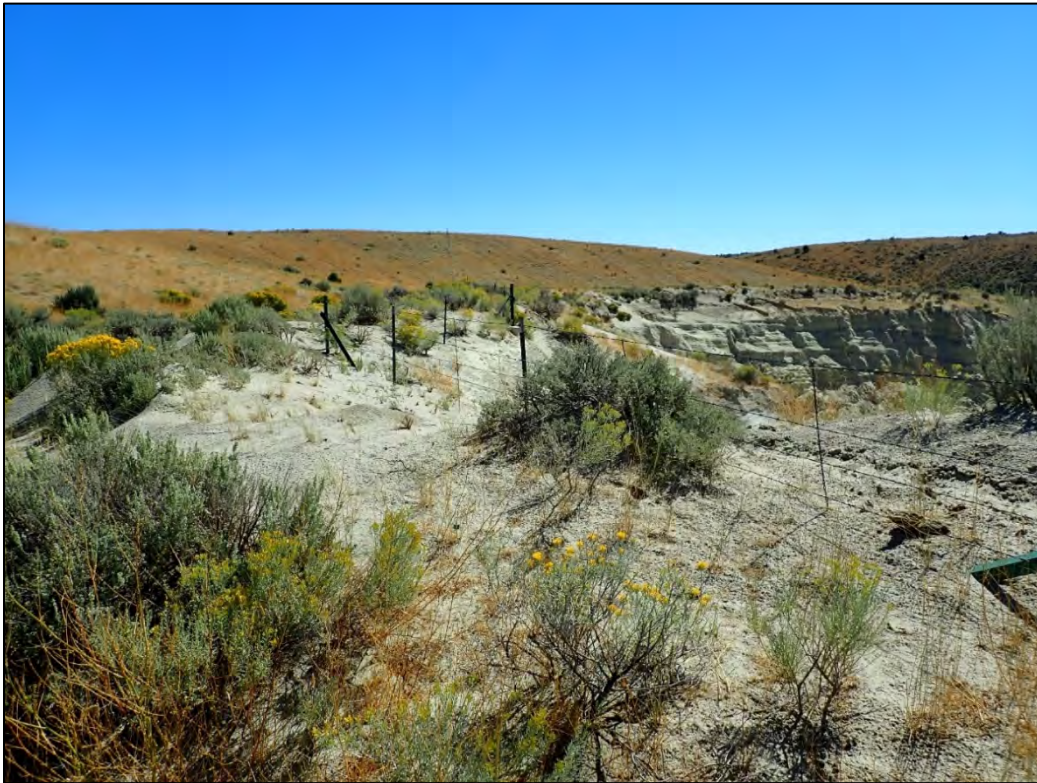
PL-15. Sand Accumulation Around Perimeter Fence near Johnson Pit

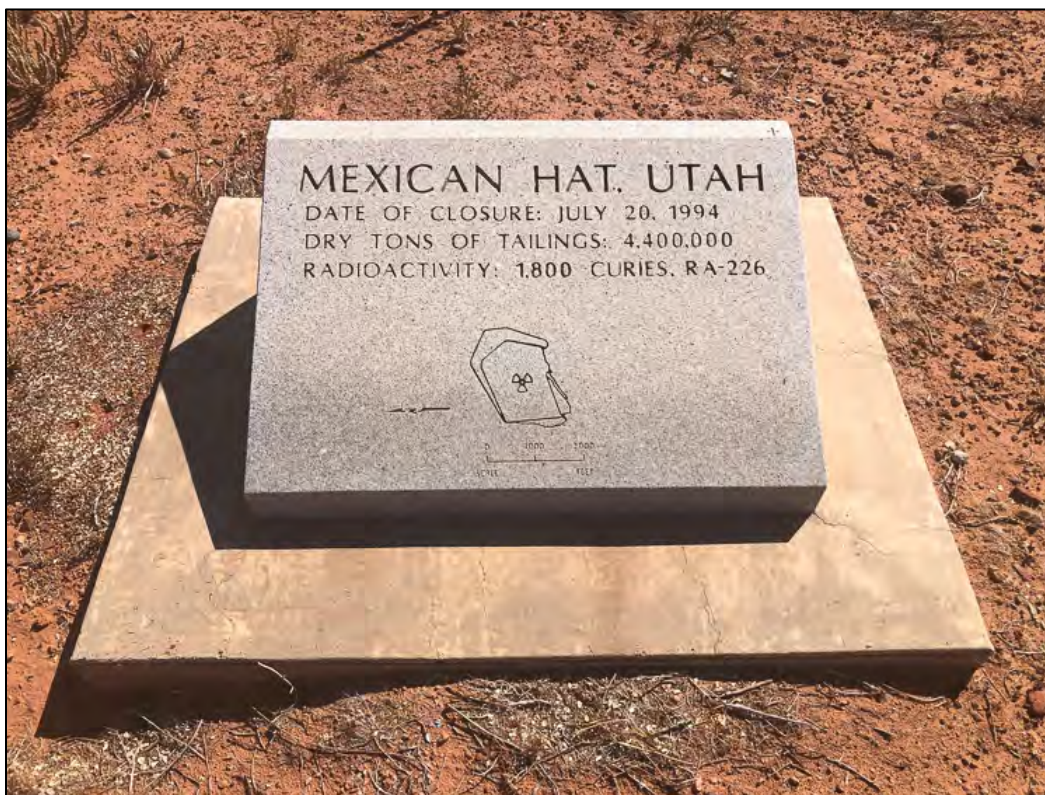
PL-5. Site Marker SMK-1

The site has two granite site markers. Site marker SMK-1 is just inside the fence near the entrance gate (PL-5); its concrete base has several minor cracks, but they do not compromise the integrity of the base, and repairs are not necessary at this time. Site marker SMK-2 is on the top slope of the disposal cell (PL-6). No immediate maintenance needs were identified.

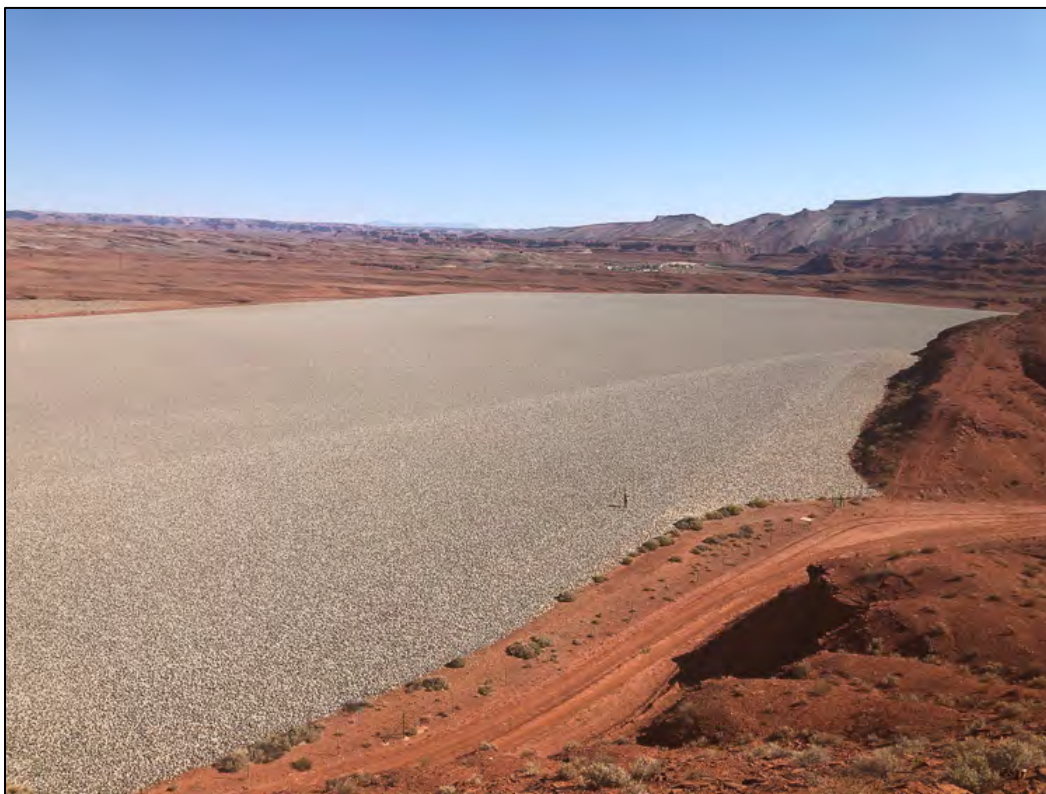
PL-8. Top of Cell – Looking Northeast

The disposal cell, completed in 1994, occupies 68 acres. The disposal cell is armored with riprap to control erosion. No erosion, settling, slumping, rock degradation, or other modifying processes that might affect the integrity of the disposal cell were evident on the top slope of the disposal cell (PL-8).
