U.S. DEPARTMENT OF
ENERGY

2020 Annual Site Inspection and Monitoring Report for Uranium Mill Tailings Radiation Control Act Title I Disposal Sites

March 2021

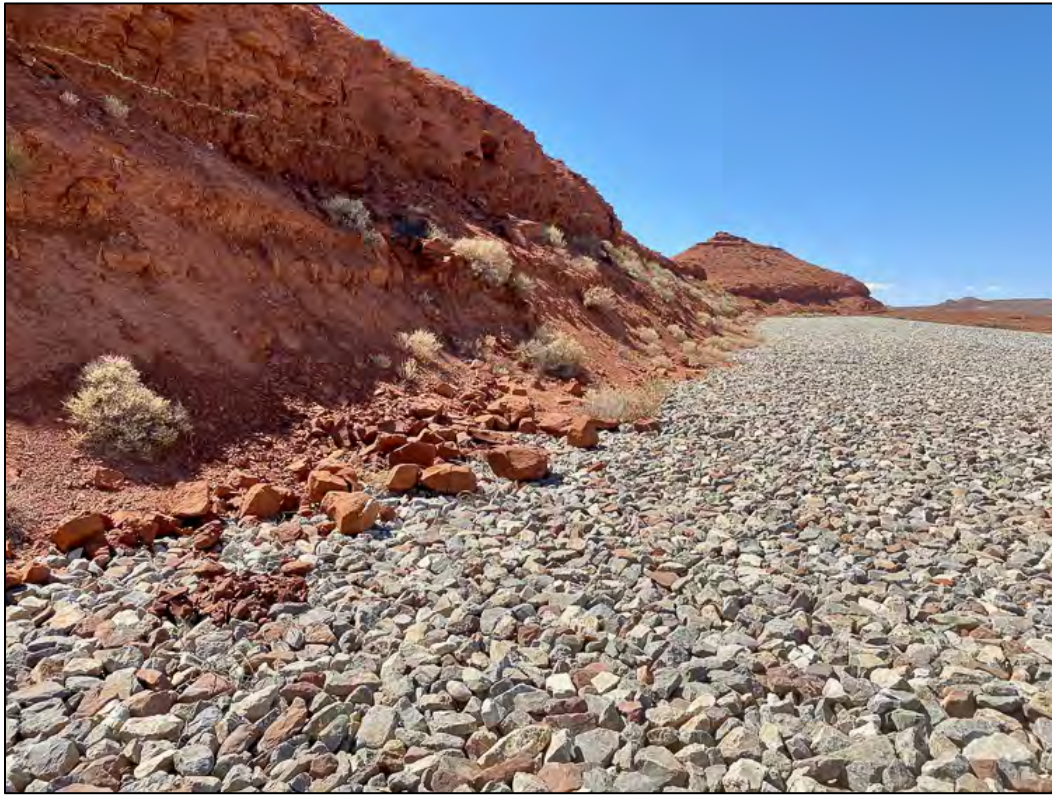
PL-9. Sloughed Rock Area on South Apron

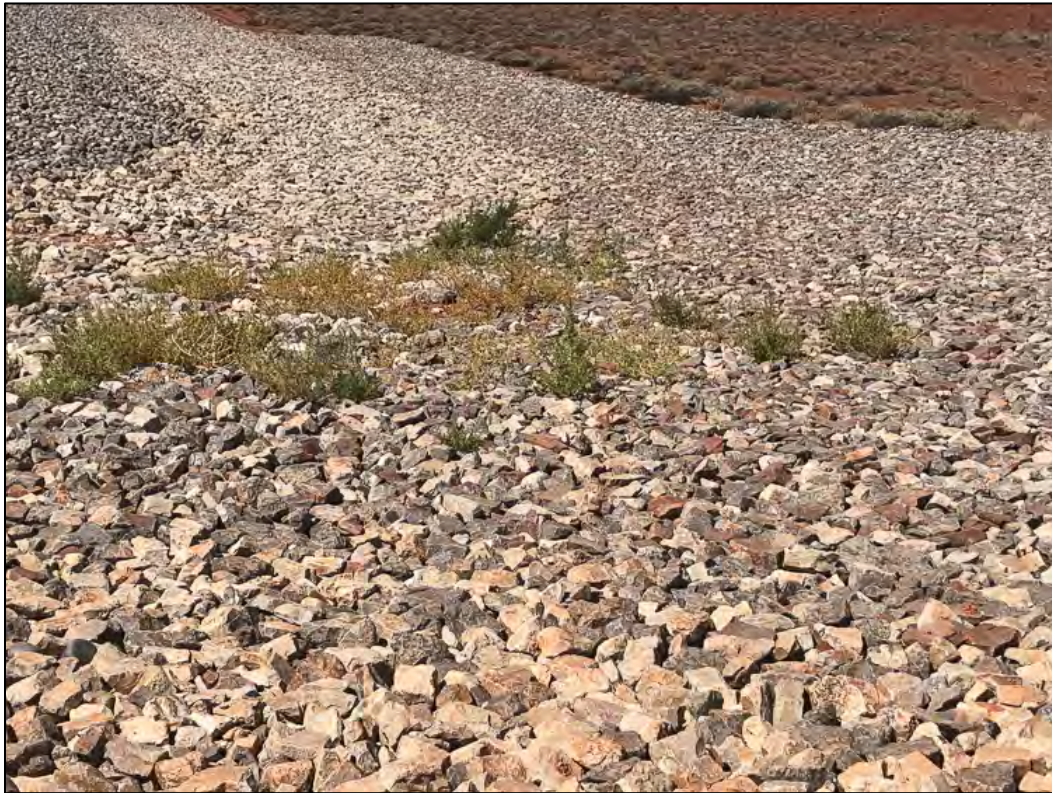
PL-11. Northeast Toe Drain

Sediment accumulation has also been observed along the transition zone from the apron to the northeast toe drain. The origin of this material is currently being evaluated and analyzed, but it may be a combination of windblown material and previously observed radon barrier erosion associated with the depression features. Visual observations during the inspection did not

identify any apparent increases in the sediment accumulation in this area compared to previous visual observations; however, increased vegetation growth was apparent in this drainage apron, at the toe of the northeast side slope (PL-11). Increased vegetation growth was most likely a result of the water used during the ICP project while moisture conditioning and compacting cover components. Inspectors will continue to monitor this area on the northeast side slope. Conversely, no sediment accumulation has been observed below the north side slope where one depression and radon barrier erosion have been identified. No immediate maintenance needs were identified.

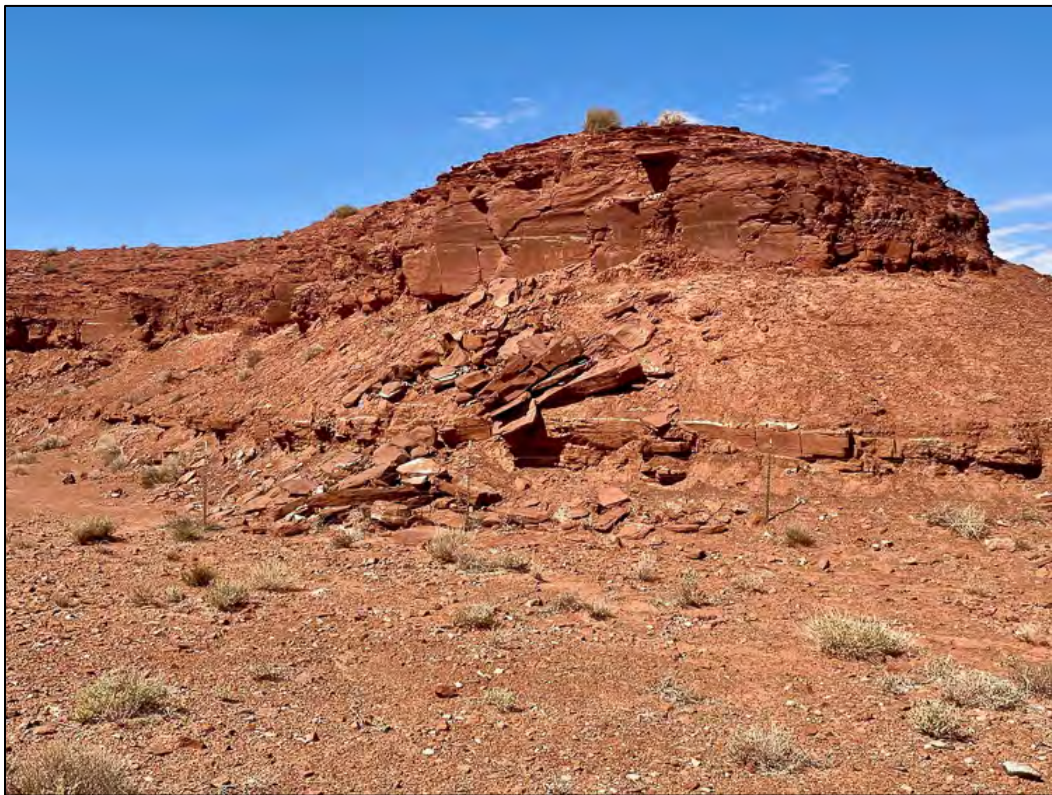
Sloughed rock from an overhanging shelf continues to be observed along the southern perimeter of the site (PL-12). Although no visual changes were evident, and this material currently appears to be stable, this rock is approaching the barbed-wire fence between perimeter signs P22 and P23 and will likely need to be removed or secured in the future to protect the fence from damage or a potential breach.

PL-12. Sloughed Rock Approaching Fence

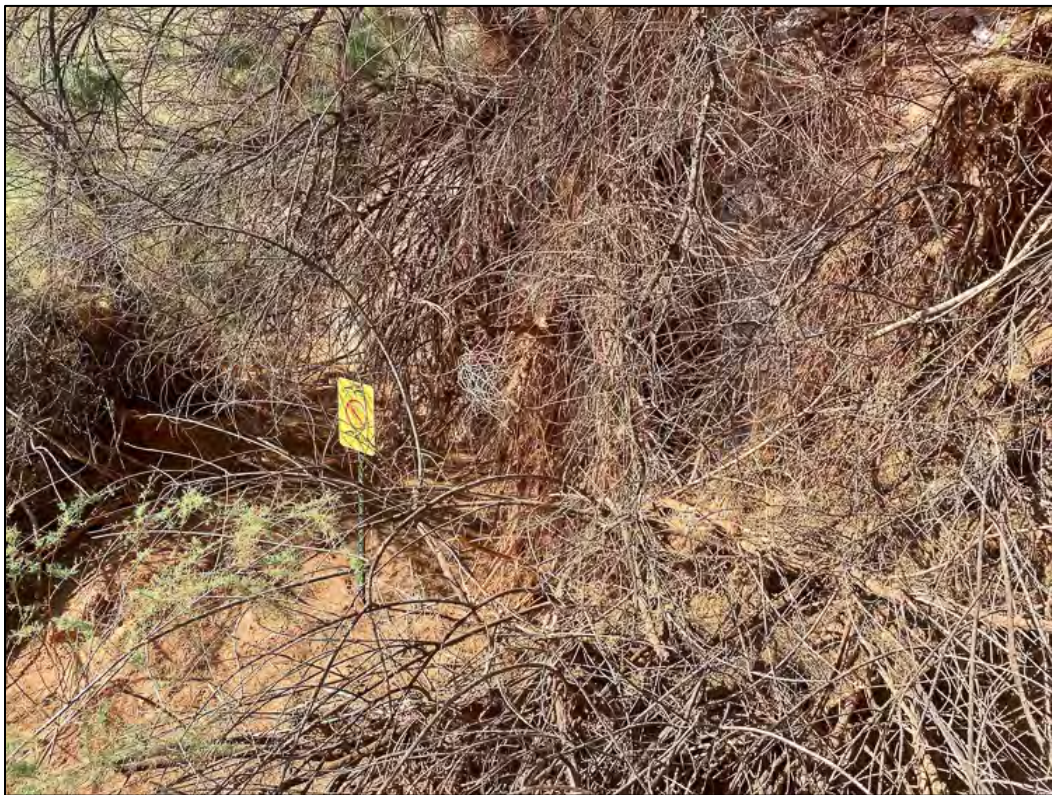
PL-16. Seep 0248

LM conducted annual observational monitoring consisting of photographic documentation and observational description of seven designated seeps during the annual inspection. Seep 0248 (PL-16) exhibited typical conditions and was dripping, upgradient (background) Seep 0261 (PL-19) was flowing, and the remaining seeps were dry. Ephemeral drainages along the perimeter of the site were dry. Groundwater monitoring is not required.

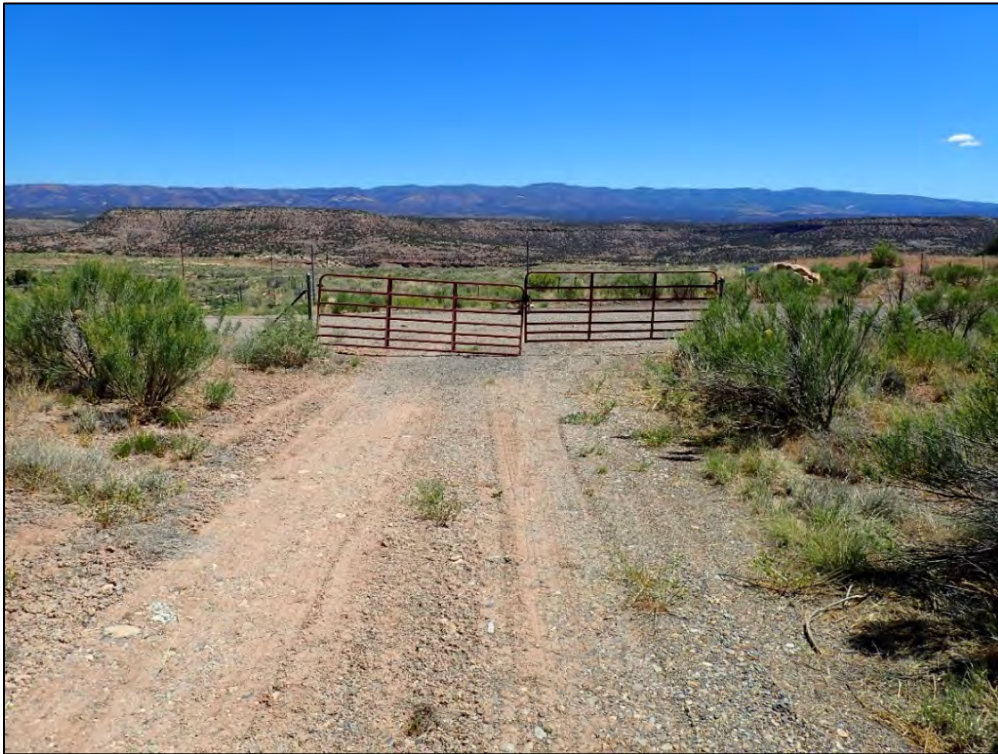
PL-1. Site Entrance Gate with Detached Hinge

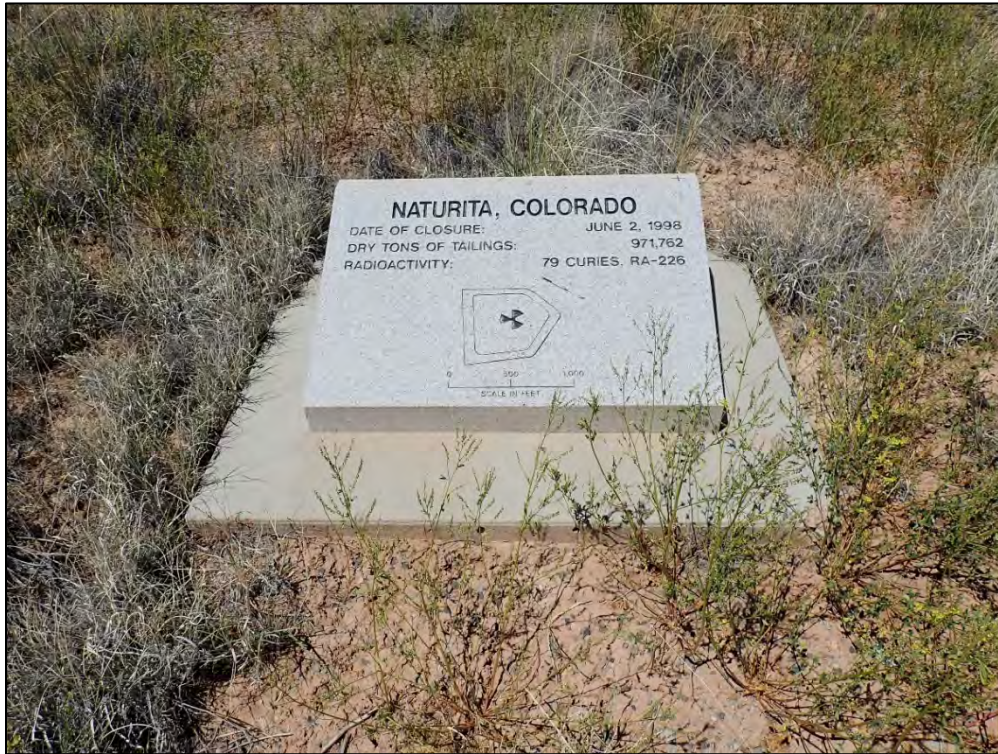
PL-3. Site Marker SMK-1

The site has two granite site markers. Site marker SMK-1 (PL-3) is just inside the entrance gate, and site marker SMK-2 is on the top slope of the disposal cell. No maintenance needs were identified.

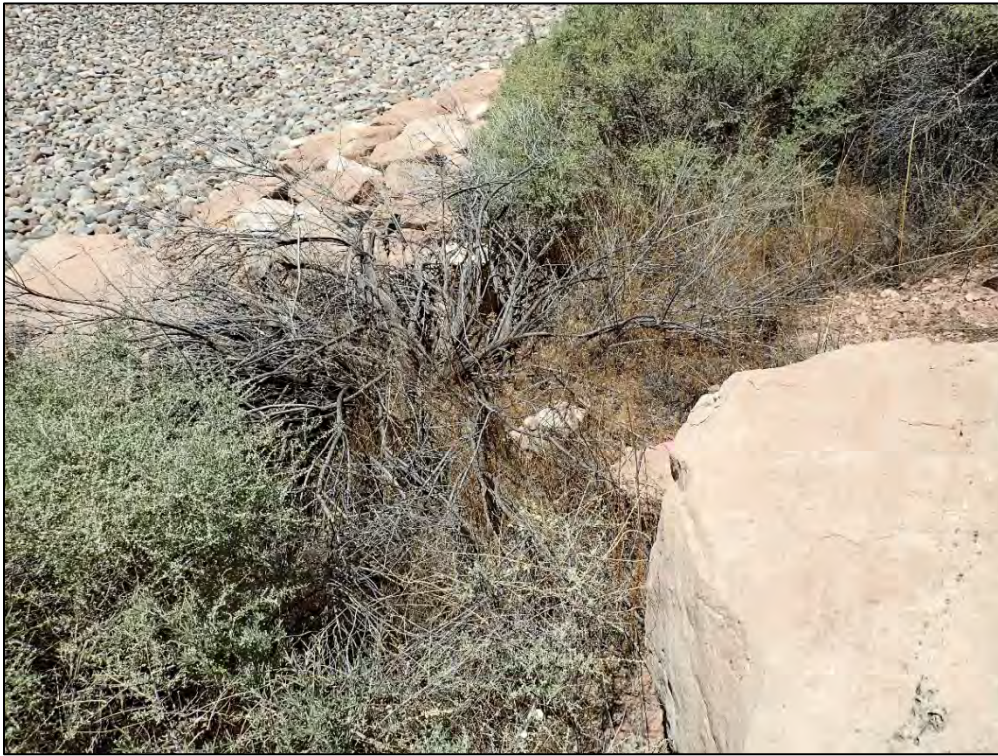
PL-5. Overgrown Vegetation Around Well BR95-1

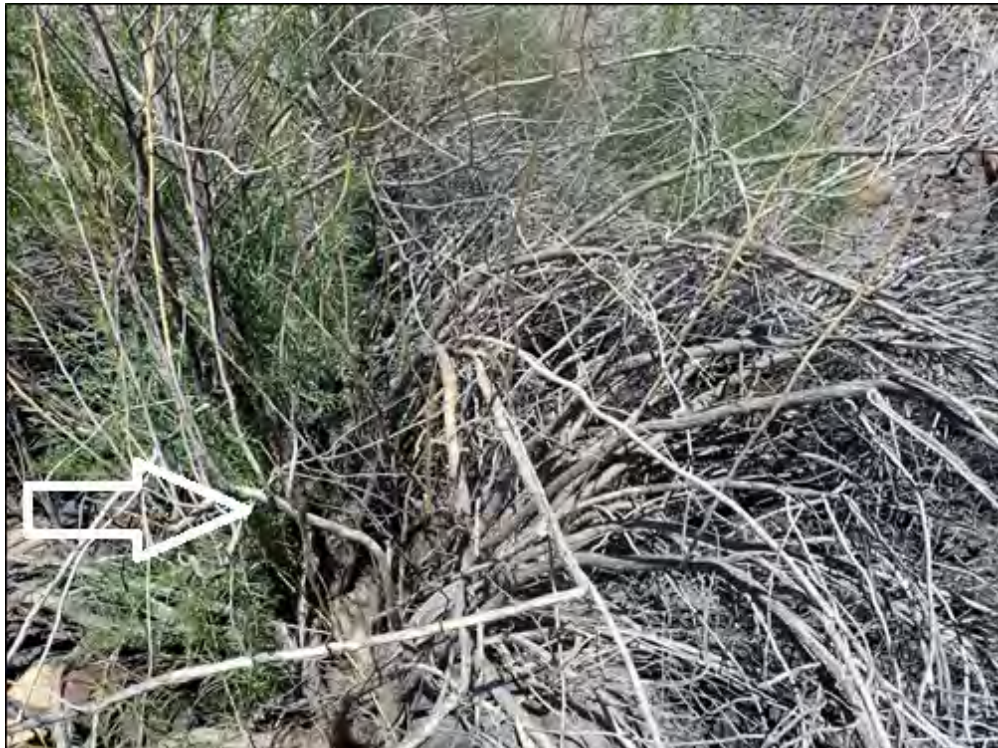
PL-6. Overgrown Vegetation Around Well CM93-1

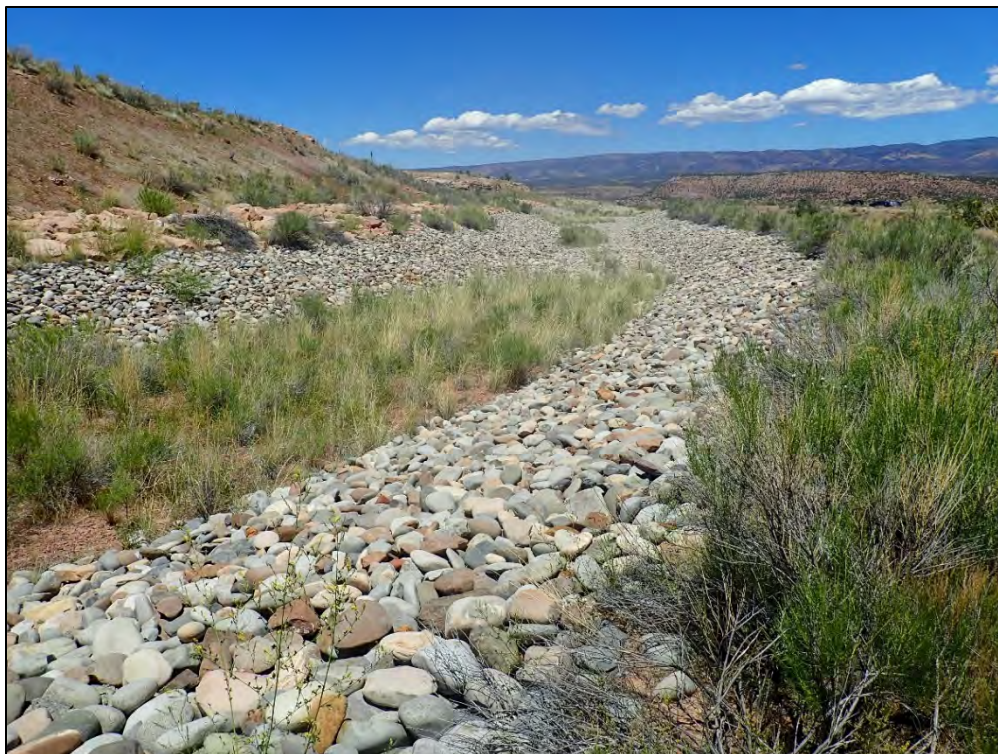
PL-8. Sediment Accumulation and Vegetation in Interceptor Channel

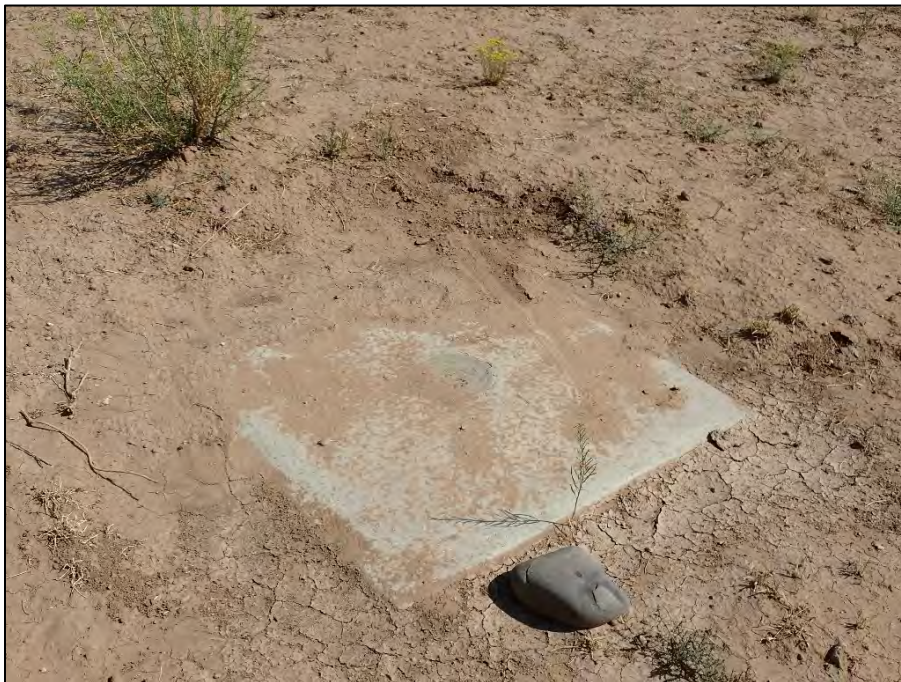
Nine aerial survey quality control monuments installed in 2019 were inspected during the 2020 annual inspection. Inspectors noted sediment accumulation on quality control monument QC8 and vegetation growth around quality control monument QC9, obstructing their visibility (PL-4 and PL-5). T-posts will be installed to help locate the quality control monuments. No other maintenance needs were identified.

PL-4. Quality Control Monument QC8 Covered with Sediment

- Repair damaged stock fence
- Install T-posts next to quality control monuments
- Treat the two rabbitbrush plants on top of the disposal cell with herbicide

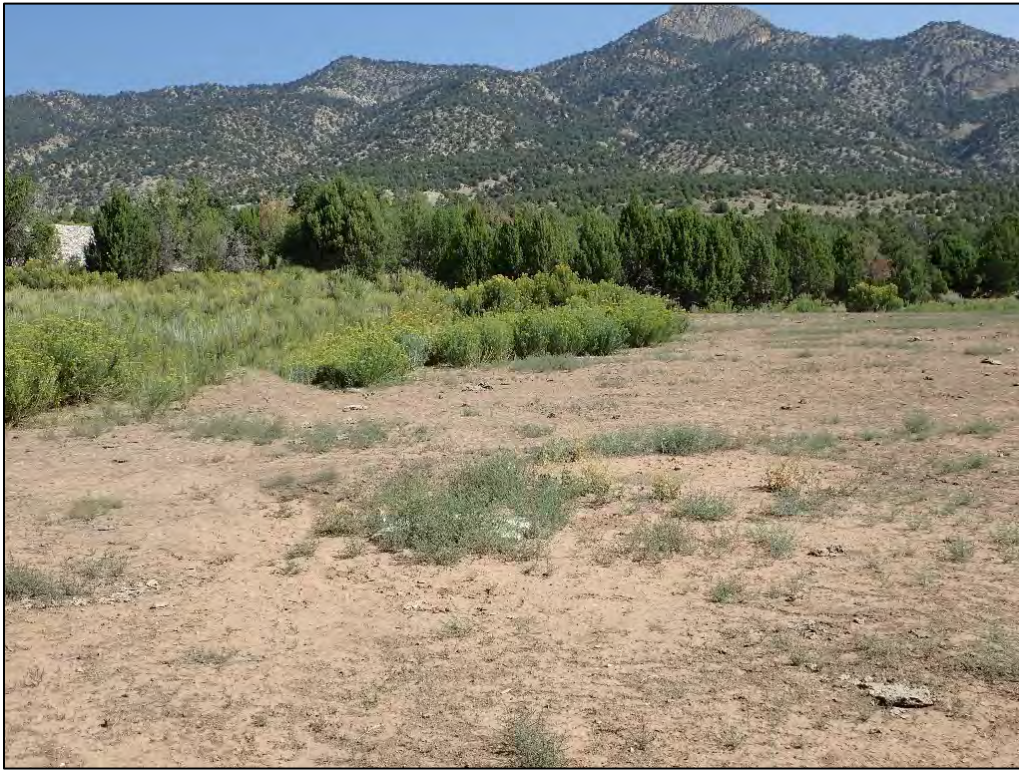
PL-5. Quality Control Monument QC9 Obscured by Vegetation

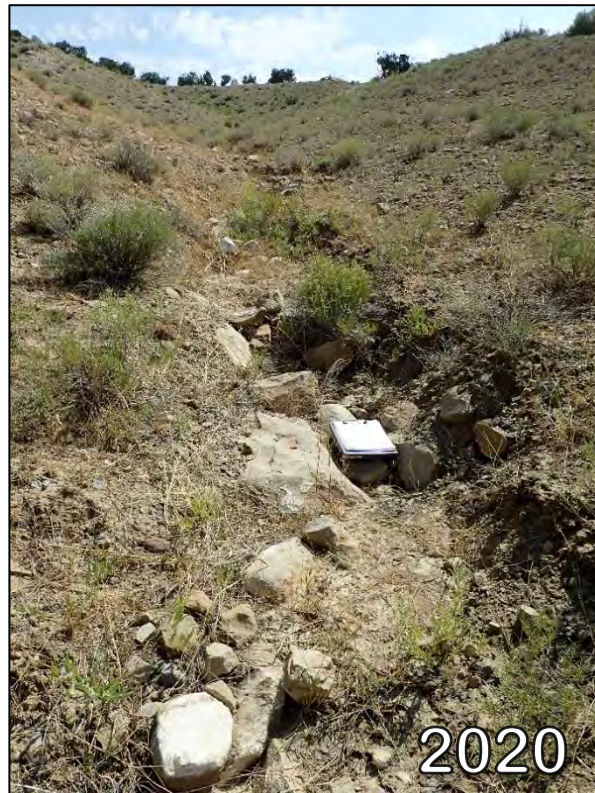
PL-7a. Minor Gully Erosion at Interceptor Trench in 2020

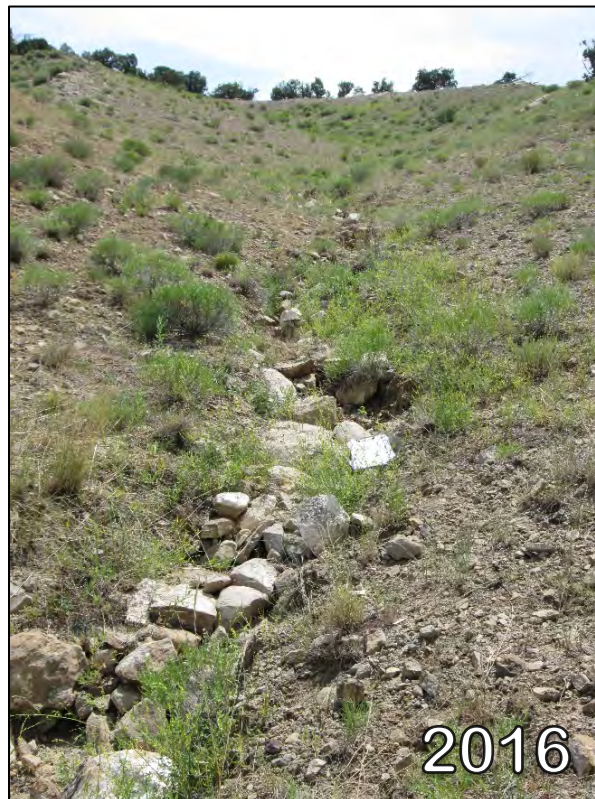
PL-7b. Minor Gully Erosion at Interceptor Trench in 2016

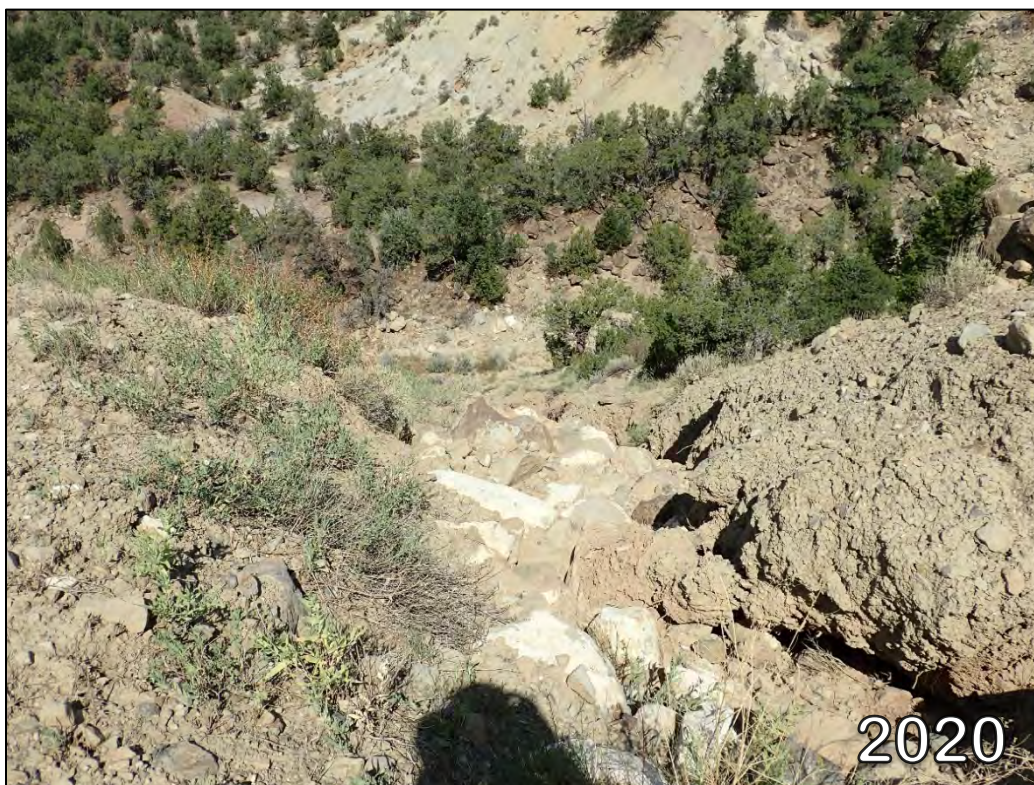
PL-8a. Major Gully Erosion in Interceptor Trench Outfall in 2020

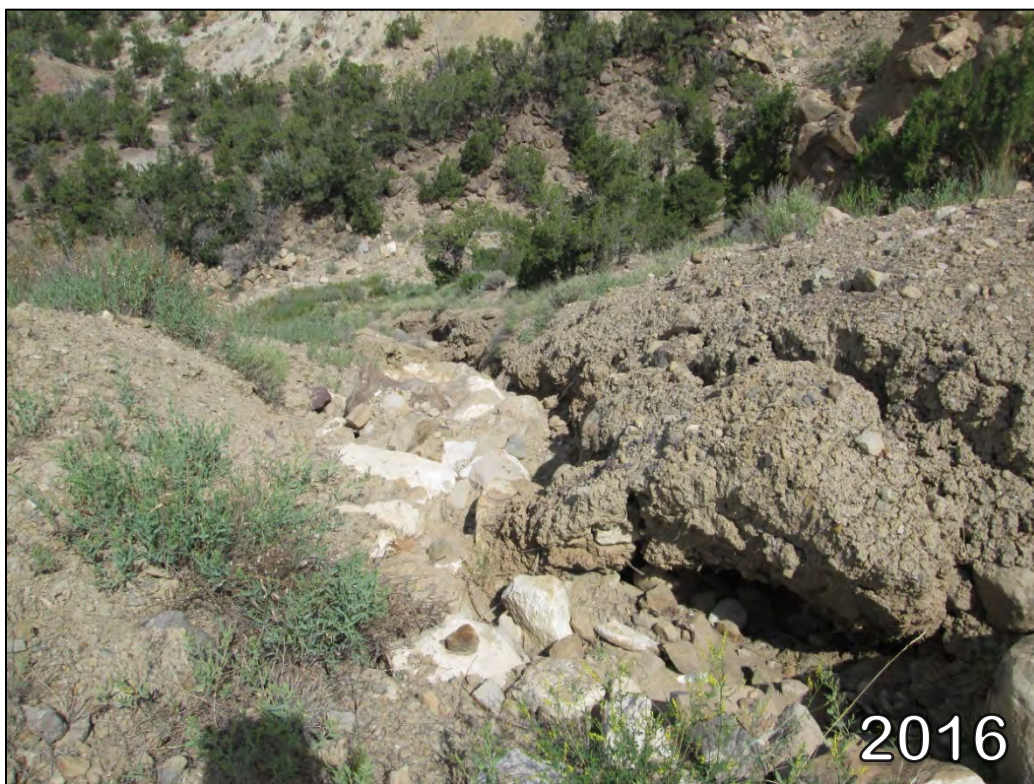
PL-8b. Major Gully Erosion in Interceptor Trench Outfall in 2016

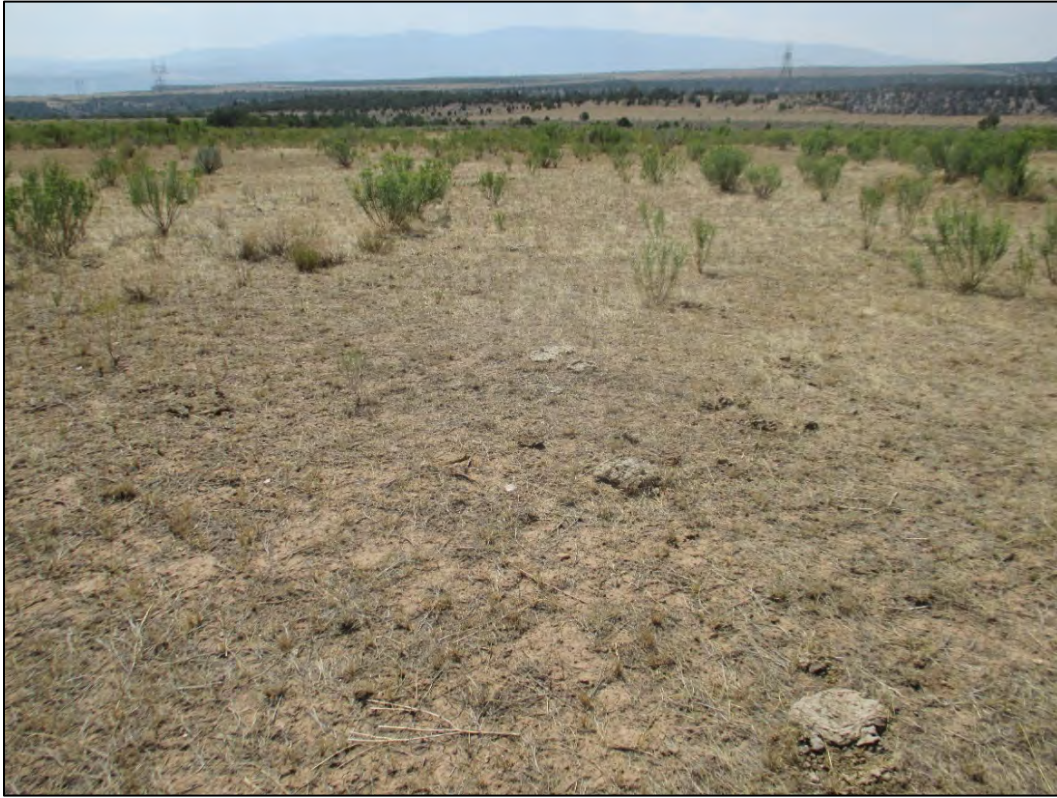
Disturbed areas around the edges and south of the disposal cell were reseeded in 1996 and, overall, have been successfully reclaimed. Before 2012, there was little evidence of cattle or sheep grazing within the site boundaries. Since 2012, however, heavy grazing by cattle has been observed regularly. Because the site was deemed unsuitable for livestock grazing, LM contacted BLM in 2018 to address this issue while inspectors noticed continued evidence of significant grazing on the site in 2020 (PL-9). LM has met with BLM and the grazing lessee and will continue monitoring and discussing BLM practices.

PL-9. Heavily Grazed Vegetation

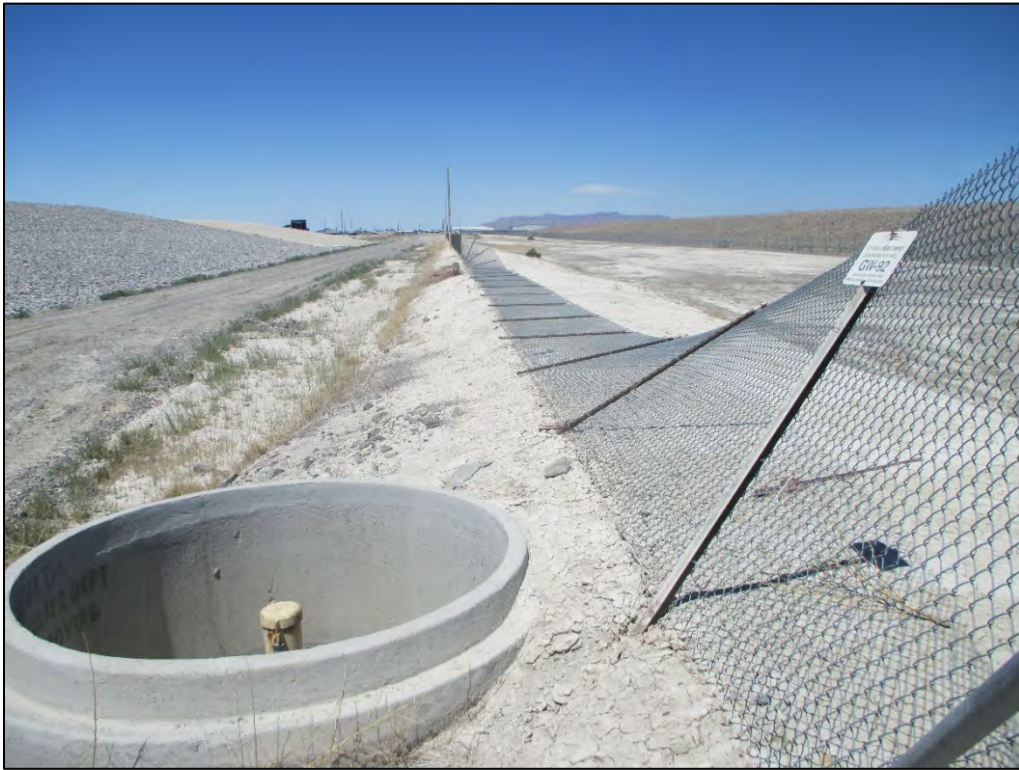
PL-1. EnergySolutions Fence Down

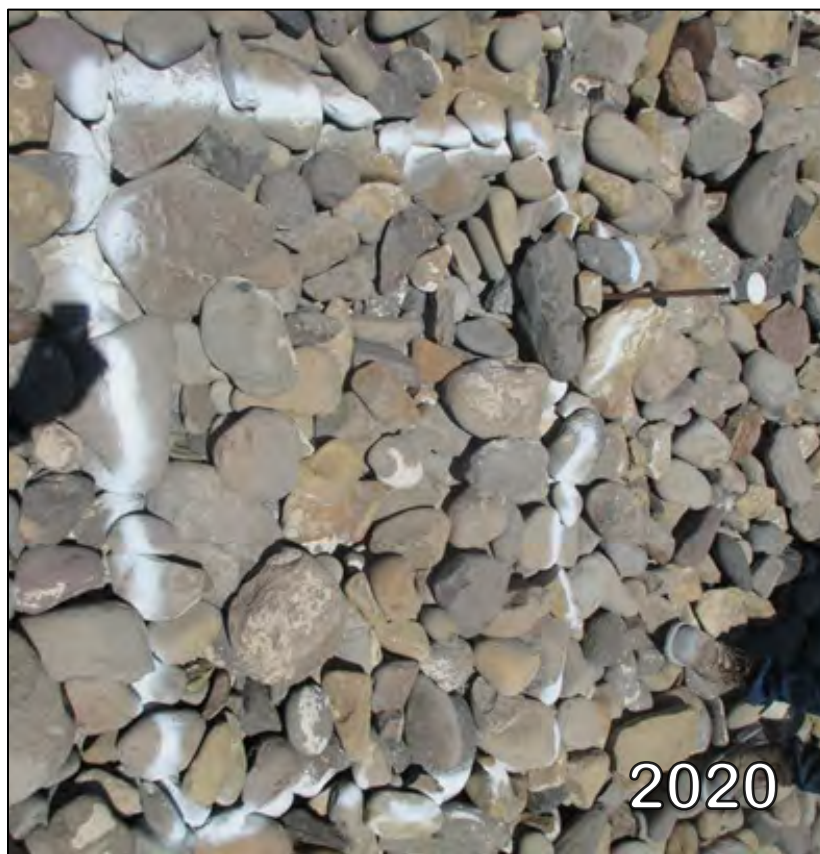
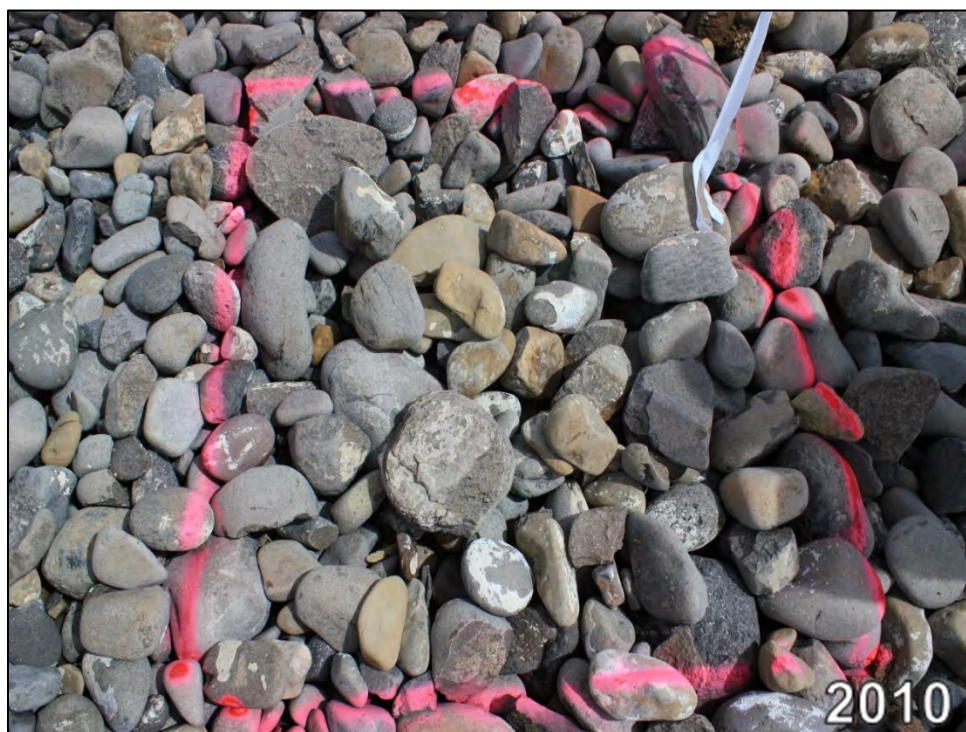
One of several types of rock used for the disposal cell erosion-protection riprap layer has exhibited minor degradation since the disposal cell was constructed. As a result, eight rock-quality monitoring plots, each measuring 1 square meter (indicated by Roman numerals I–VIII in Figure 15-1), were established in 2010 to monitor for continued rock degradation.

PL-7. (a) Rock Quality Plot No. I—2020

PL-7. (b) Rock Quality Plot No. I—2010 Photo for Comparison

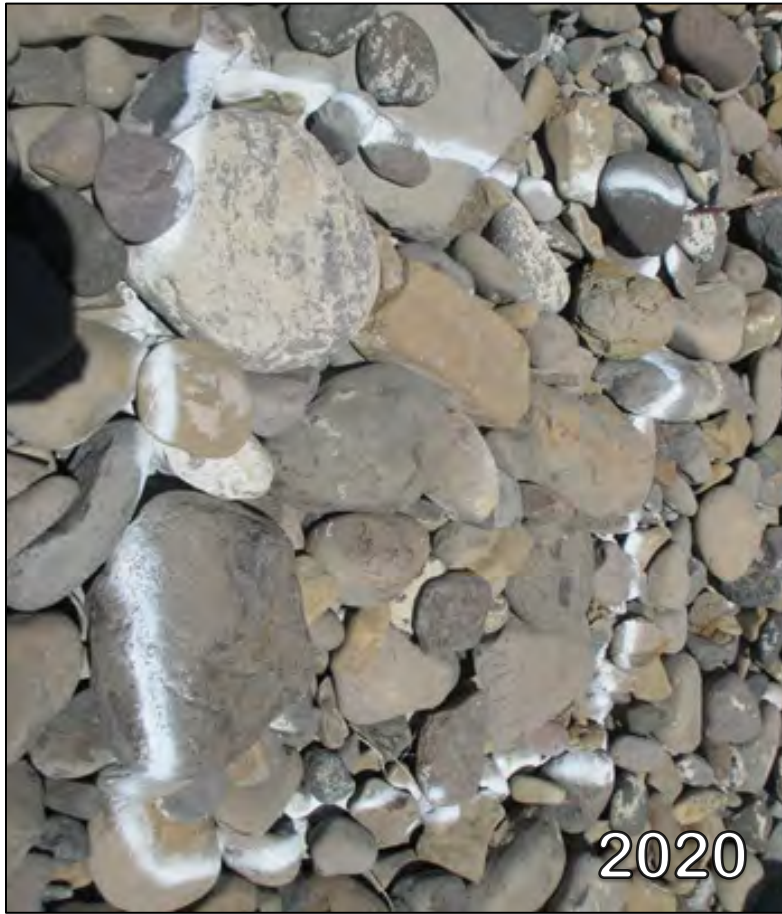
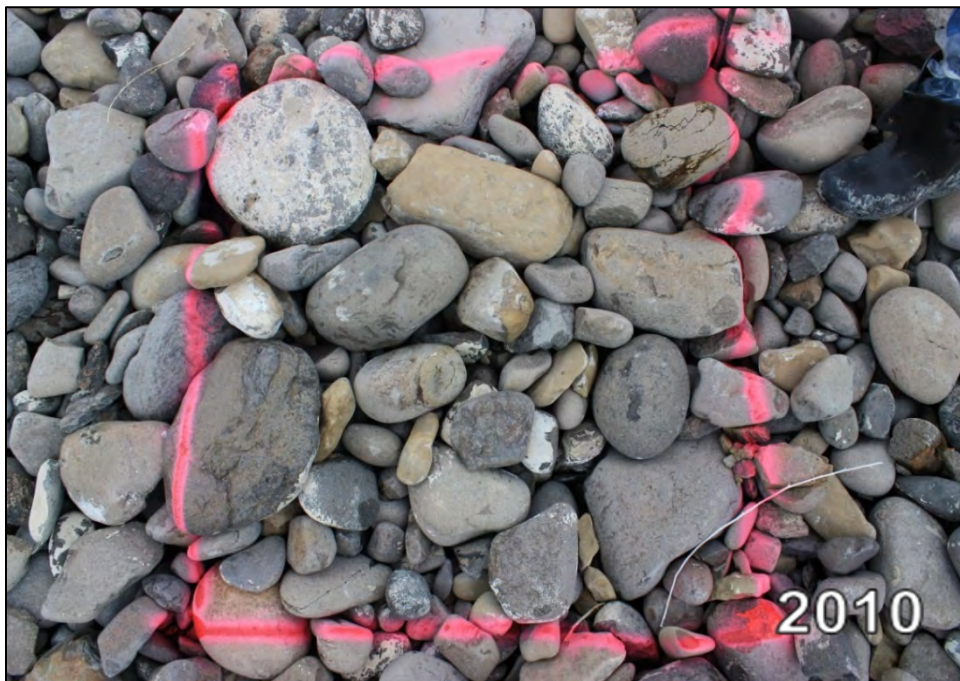
PL-8. (a) Rock Quality Plot No. II—2020

PL-8. (b) Rock Quality Plot No. II—2010 Photo for Comparison

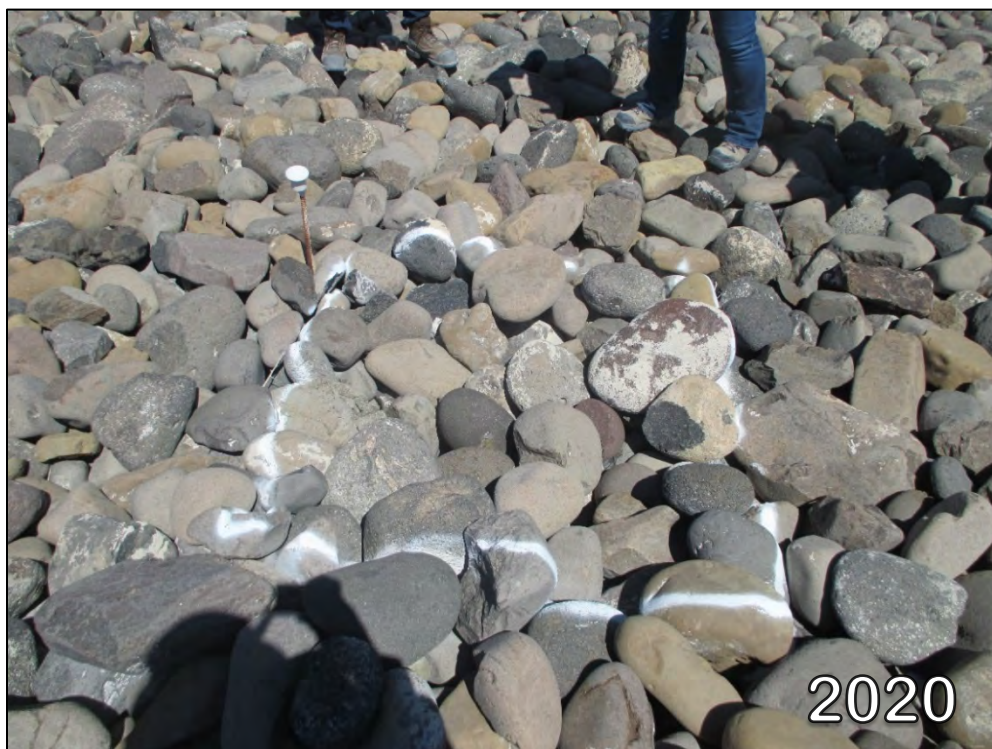
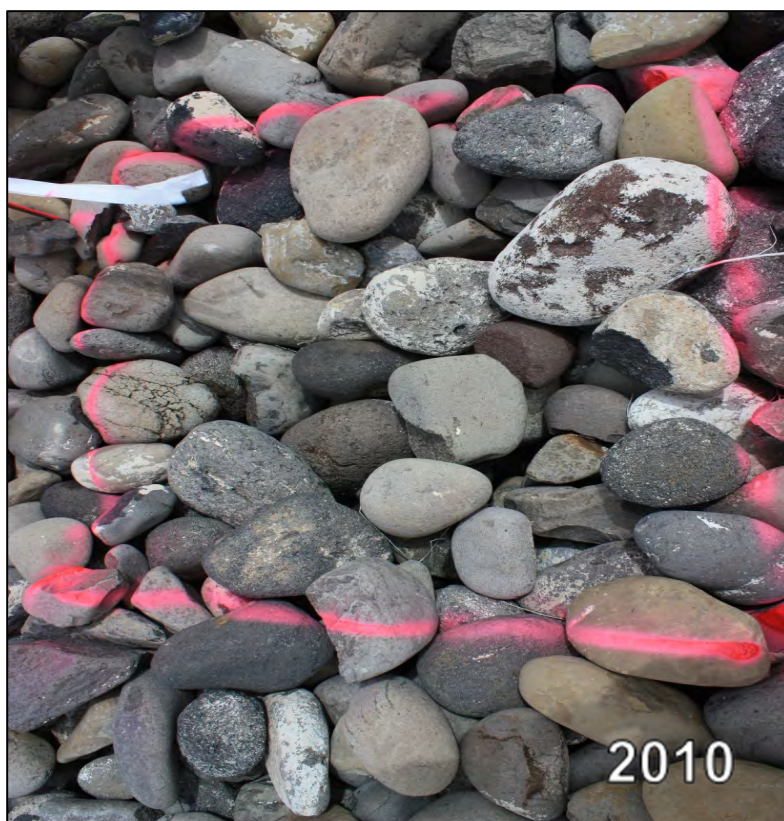
PL-9. (a) Rock Quality Plot No. III—2020

PL-9. (b) Rock Quality Plot No. III—2010 Photo for Comparison

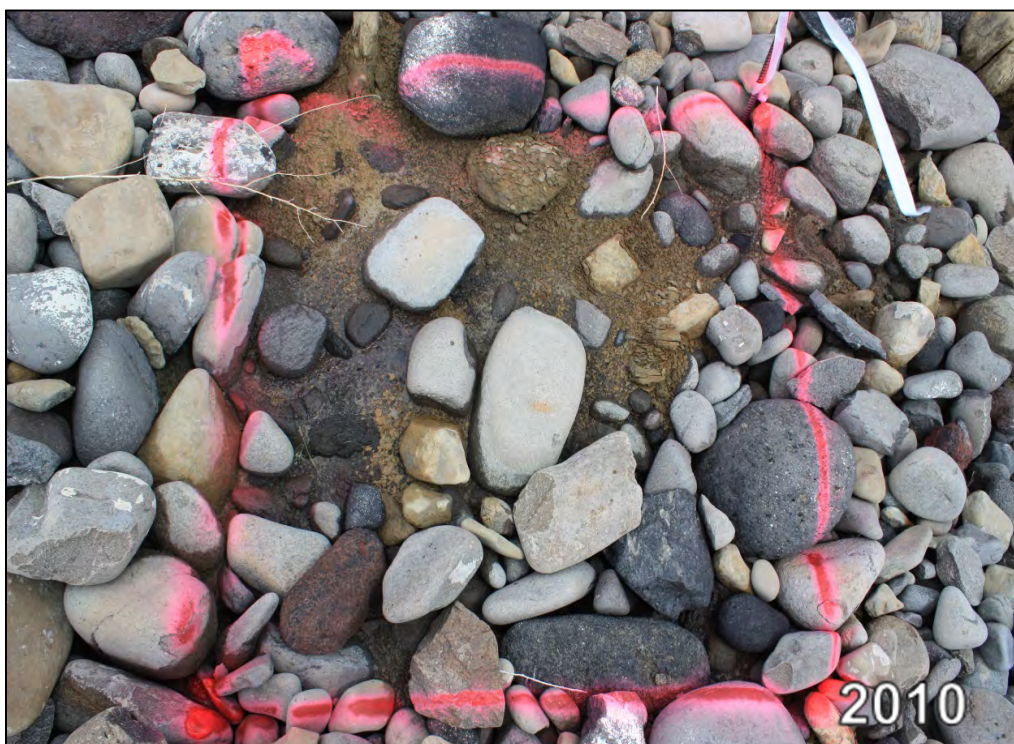
PL-10. (a) Rock Quality Plot No. IV—2020

PL-10. (b) Rock Quality Plot No. IV—2010 Photo for Comparison

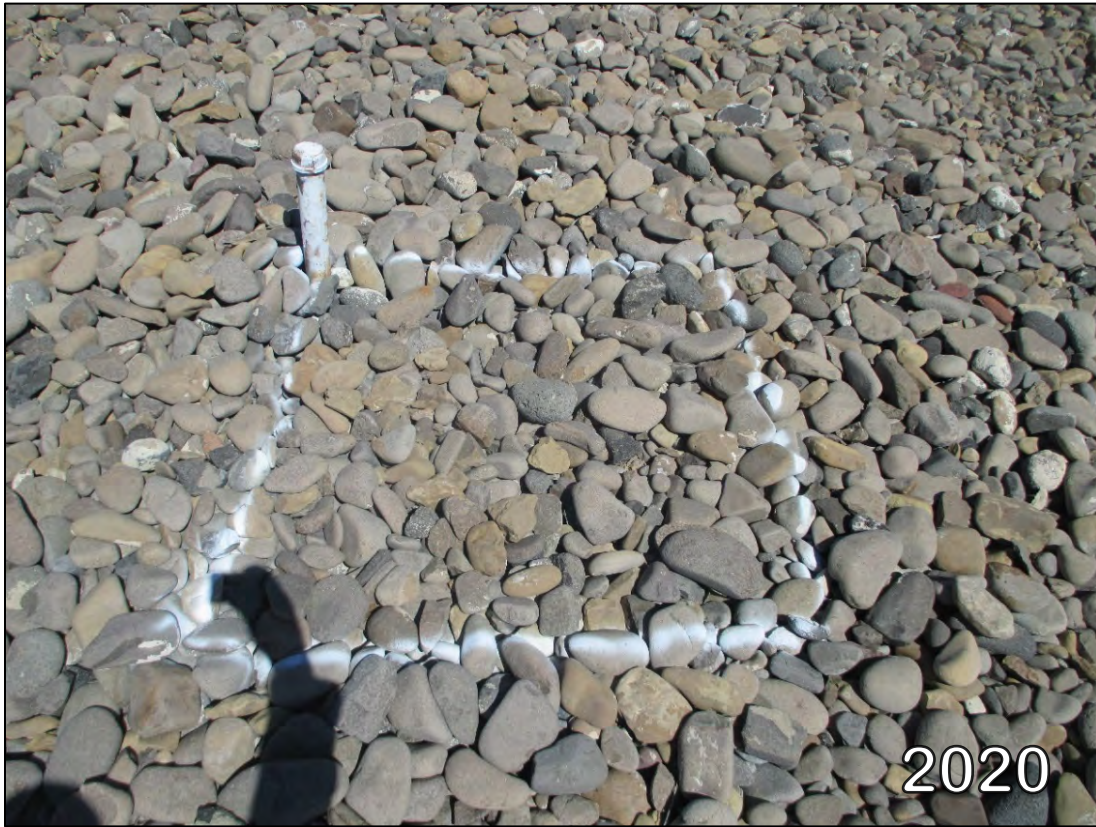
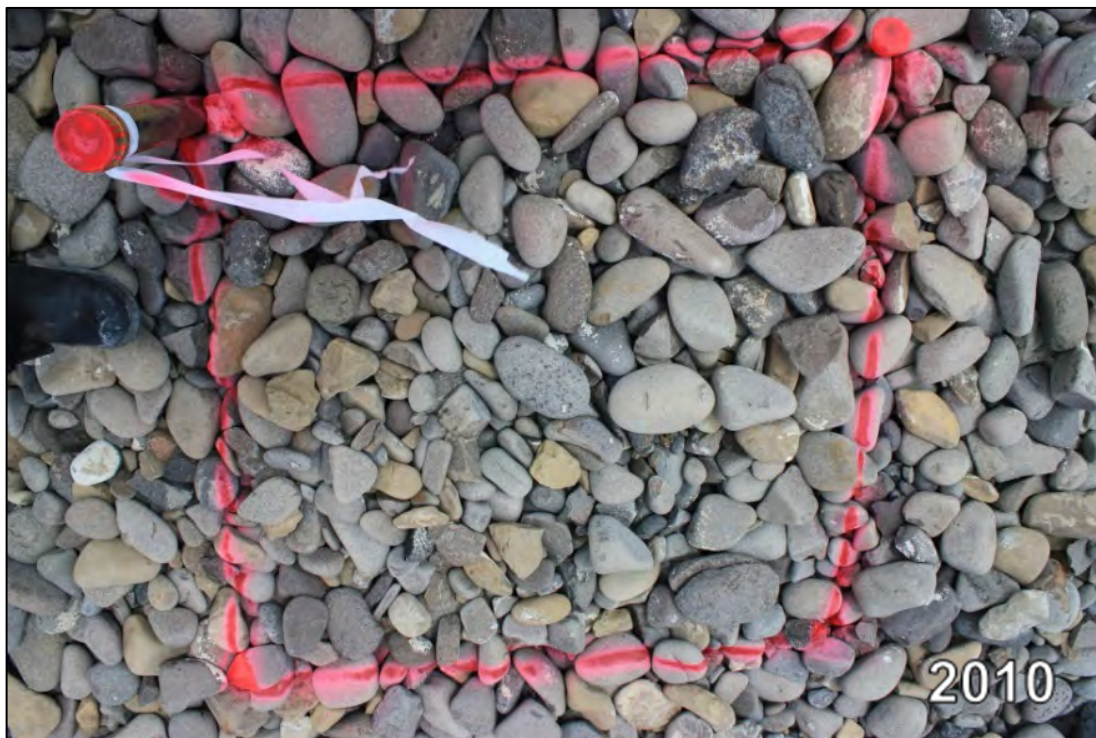
PL-11. (a) Rock Quality Plot No. VII—2020

PL-11. (b) Rock Quality Plot No. VII—2010 Photo for Comparison

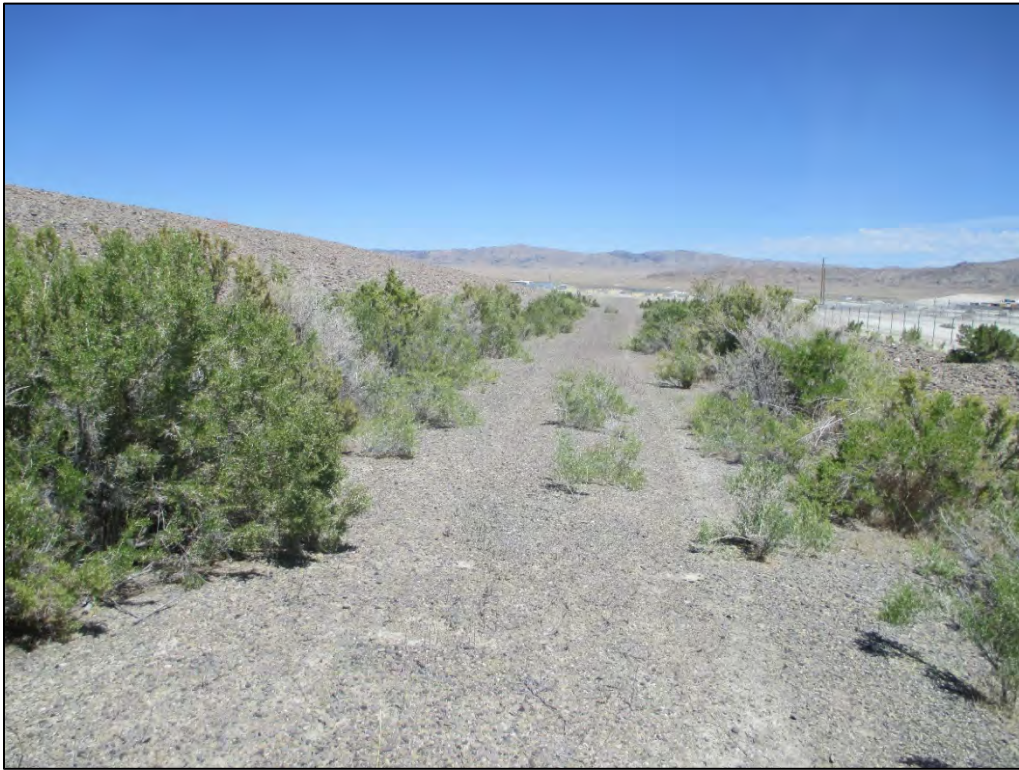
PL-12. Vegetation on Cell Perimeter Road

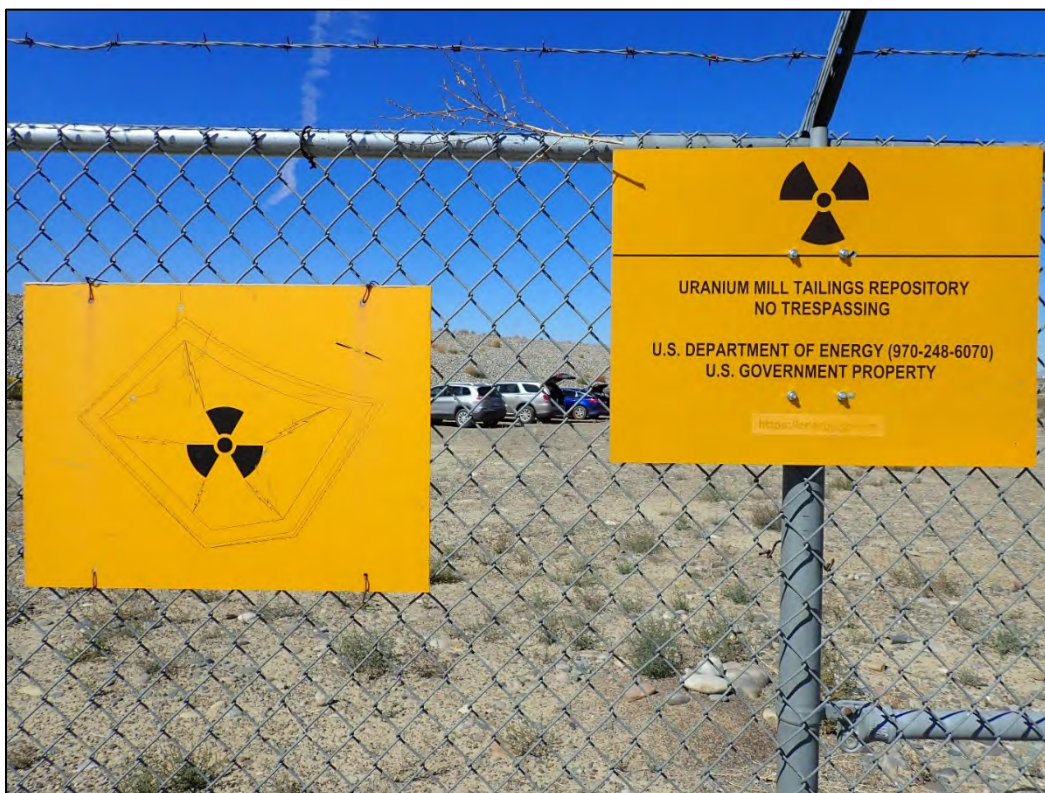
PL-1. Pictorial Sign and Perimeter Sign P2 with Faded Information

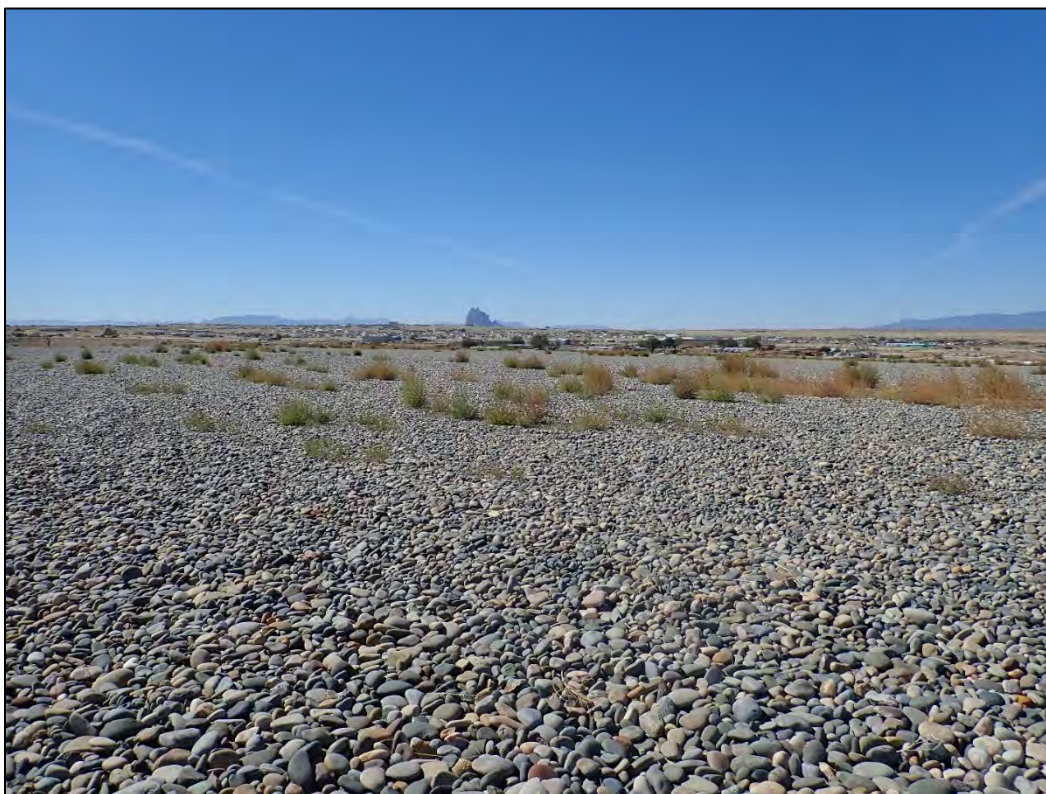
PL-6. Disposal Cell Top Slope with Growing Vegetation
