U.S. DEPARTMENT OF
ENERGY

2020 Annual Site Inspection and Monitoring Report for Uranium Mill Tailings Radiation Control Act Title I Disposal Sites

March 2021

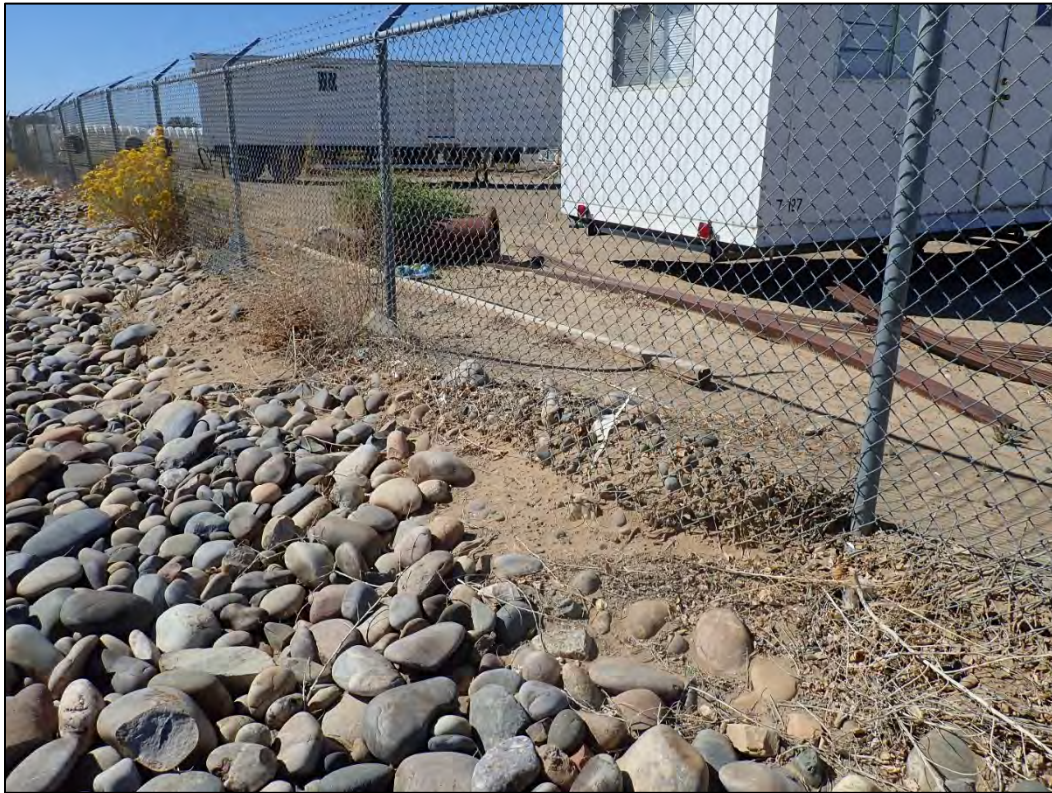
Dirt accumulation that was previously observed in the channel and along the fence on the southern side of the site was removed before the 2020 inspection. Inspectors will continue to monitor these areas. Regular maintenance to keep the perimeter fence lines free of trash, tumbleweeds, or other debris will continue. No other maintenance is needed at this time.

PL-7. Sediment Accumulation Near Southwest Fence Line

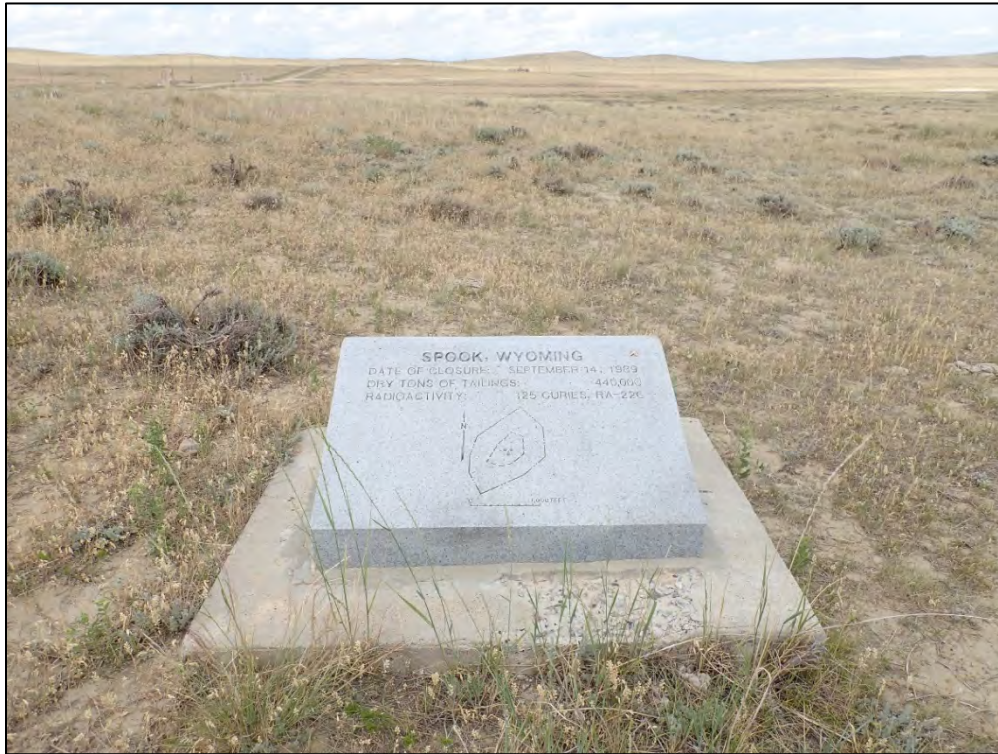
The site has two granite site markers. Site marker SMK-1 is at the south side of the disposal cell (PL-3). Its concrete base is damaged due to spalling but is stable; there were no apparent changes from the previous year. Site marker SMK-2 is at the north side of the disposal cell. No maintenance needs were identified.

PL-3. Site Marker SMK-1

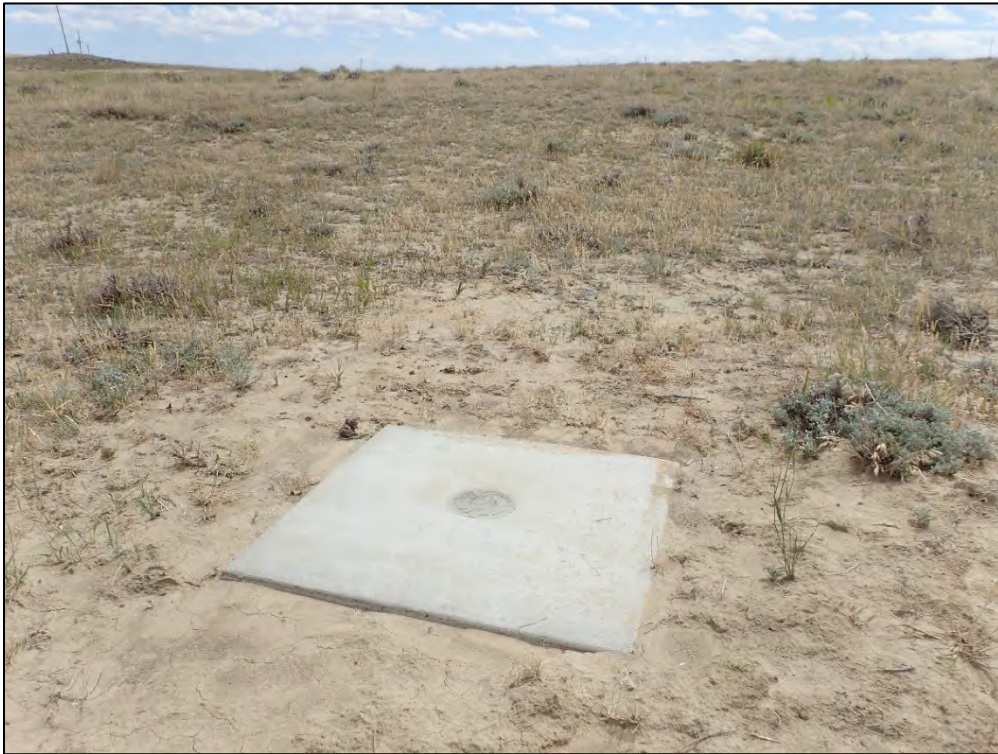
Four aerial survey quality control monuments were installed in 2019 following the site inspection (PL-5). The quality control monument locations are shown in Figure 18-1. No maintenance needs were identified.

PL-5. Quality Control Monument QC3

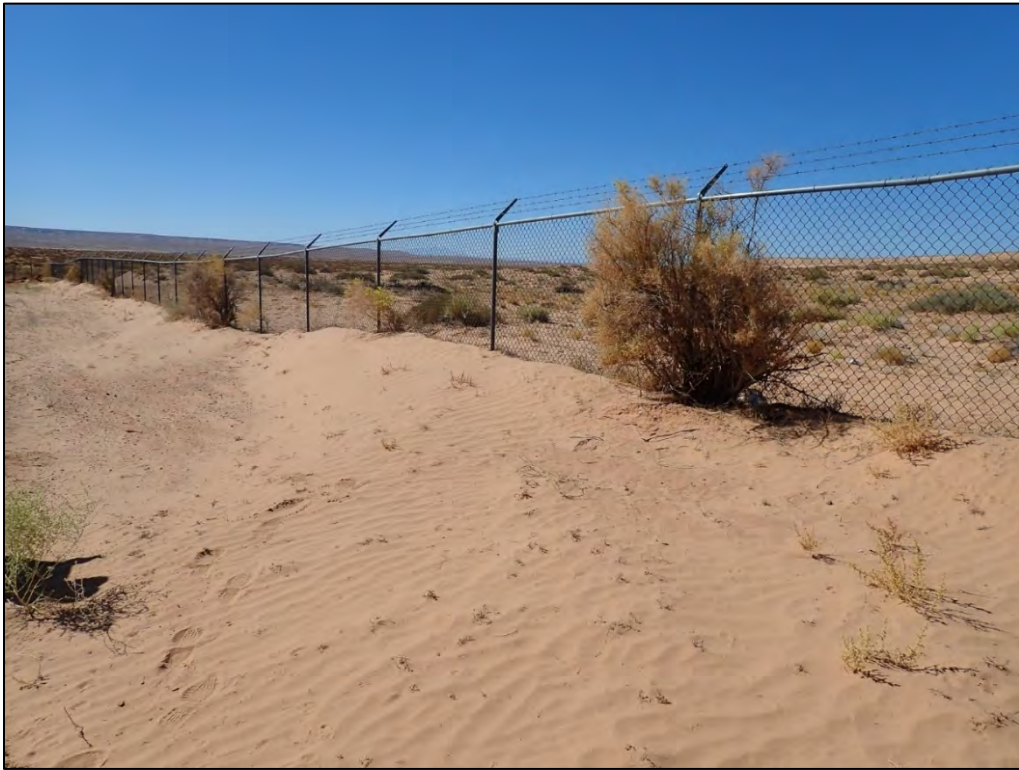
PL-1. Sand Accumulation and Treated Woody Vegetation Along West Fence

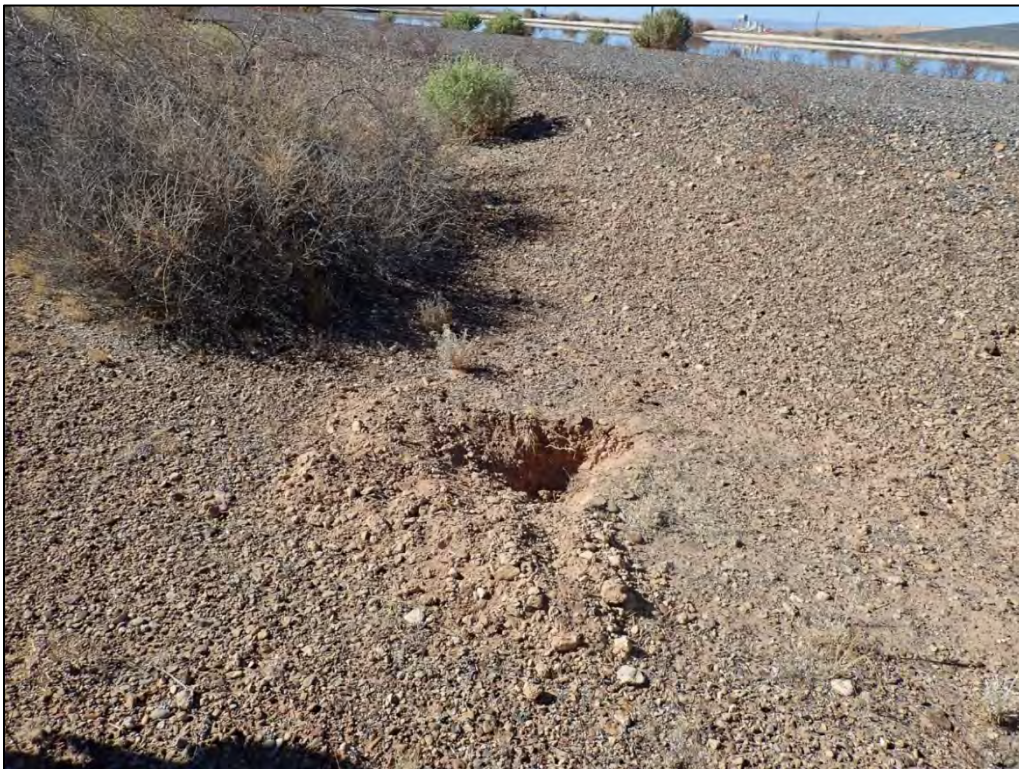
PL-2. Animal Burrow

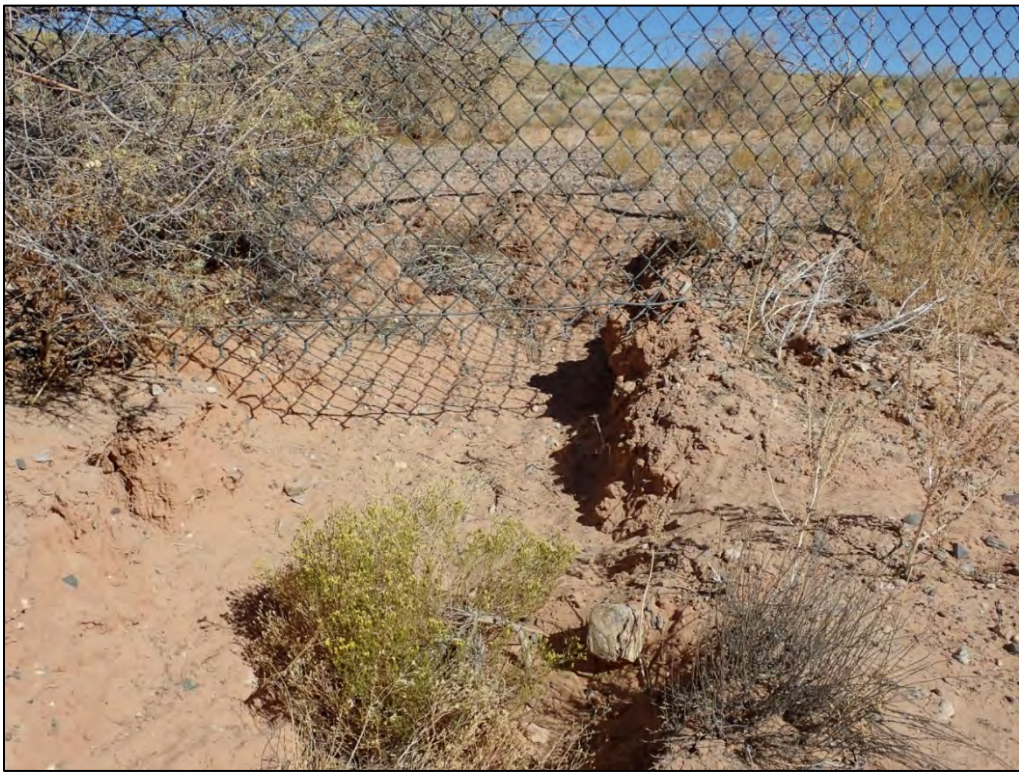
PL-3. Erosion Under Fence

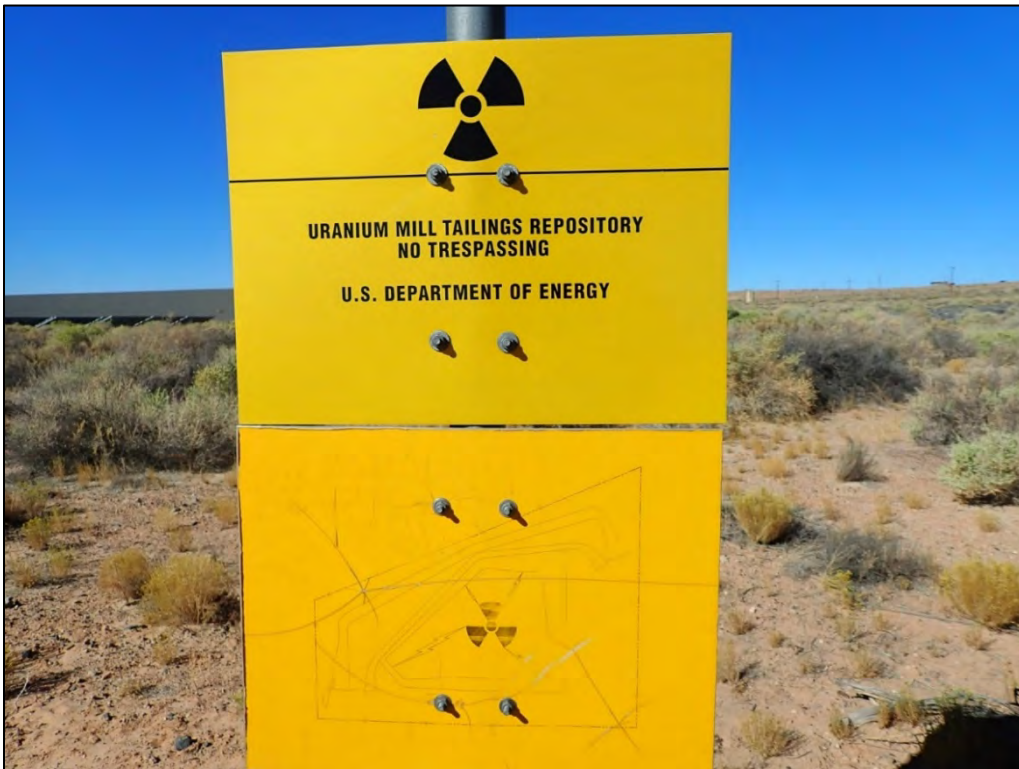
PL-4. Faded Pictorial Perimeter Sign P24

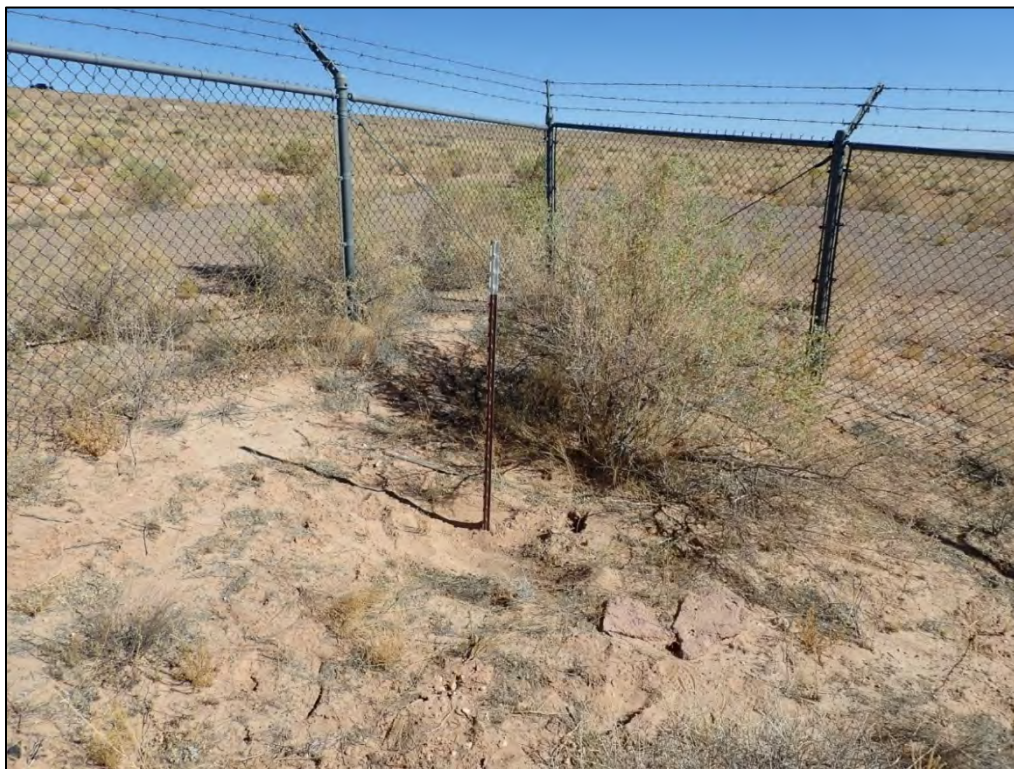
PL-6. Survey/Boundary Monument SM/BM-3 with Sand Accumulation

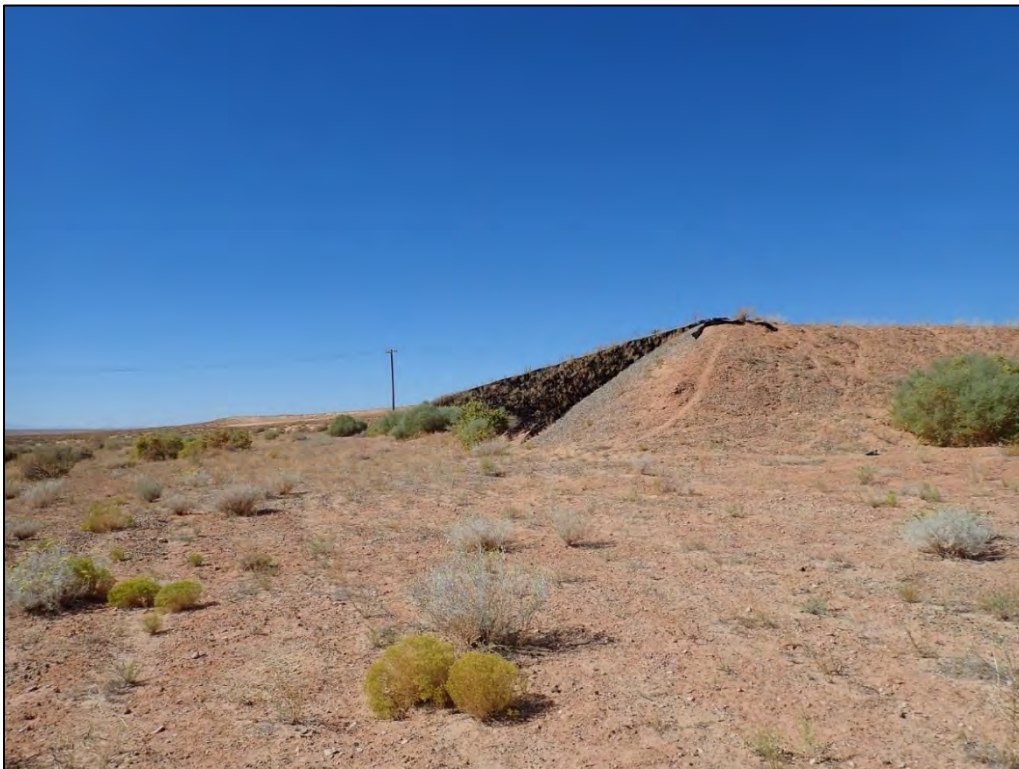
PL-10. Exposed Geofabric on South Side of Inactive, Lined Evaporation Pond

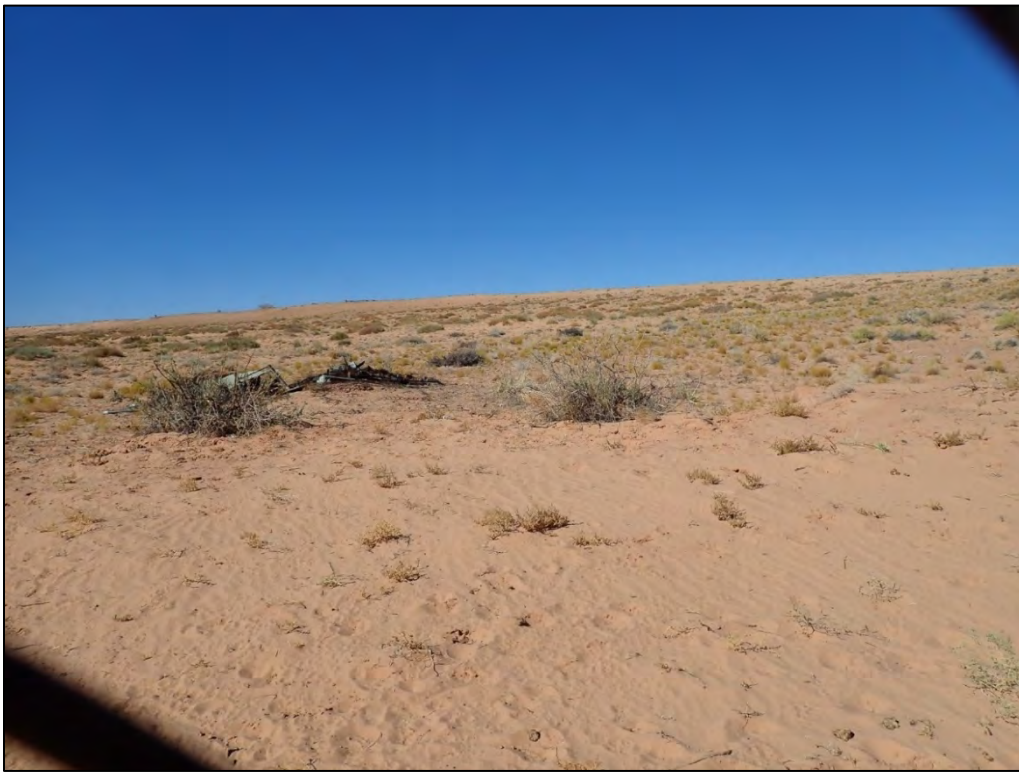
PL-11. Offsite Trash and Debris Pile
